TOWN OF HANOVER

Volume 2-Appendix

Municipal Facilities Assessment-2011
Capital Improvement Committee
Hanover, Massachusetts
September 2011

Building Study

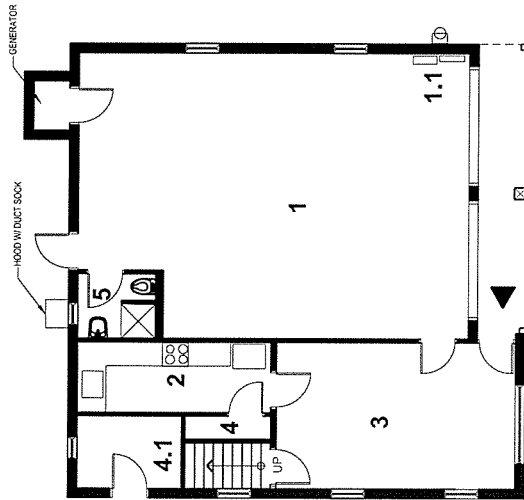
FIRST FLOOR PLAN

ROOM LEGEND		
1. FIRE ENGINE GARAGE	1.1 ELEC. PANELS AND METER	
2. KITCHEN		
3. COMMON ROOM		
4. CLOSET	4.1 BOILER ROOM	
5. TOILET ROOM		
6. DORM ROOM		
7. RECREATION ROOM		
GRAPHIC LEGEND		
▶ - MAIN ENTRANCE LOCATION

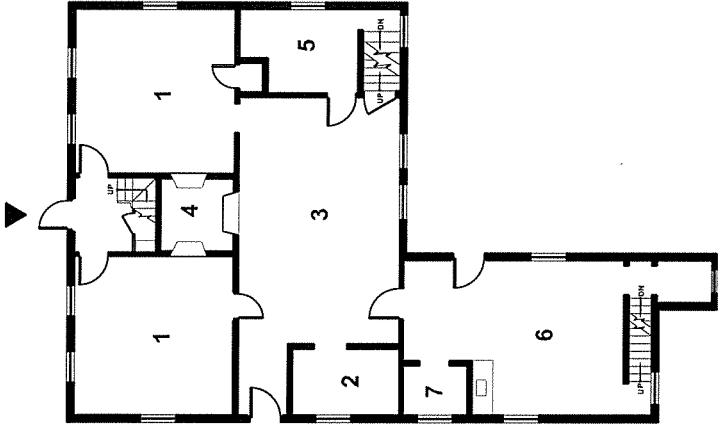
FIRST FLOOR PLAN

ROOM LEGEND	
1. PARLOR	
2. OFFICE	
3. DINNING	
4. FIRE PLACE	
5. HISTORIC ARCHIVES STORAGE/OFFICE	
6. KITCHEN	
7. GIFTS	
8. BEDROOMS	
9. ARTIFACT/ STORAGE	
10. HALL	
11. CLOSET/ HISTORICAL COSTUMES	
12. TOILET ROOM	
GRAPHIC LEGEND	
▶	- MAIN ENTRANCE LOCATION
