**Municipal Facilities Assessment-2011  
Capital Improvement Committee  
Hanover, Massachusetts  
September 2011**

# Building Study

# **Town of Hanover - MUNICIPAL FACILITIES ASSESSMENT - 2011**

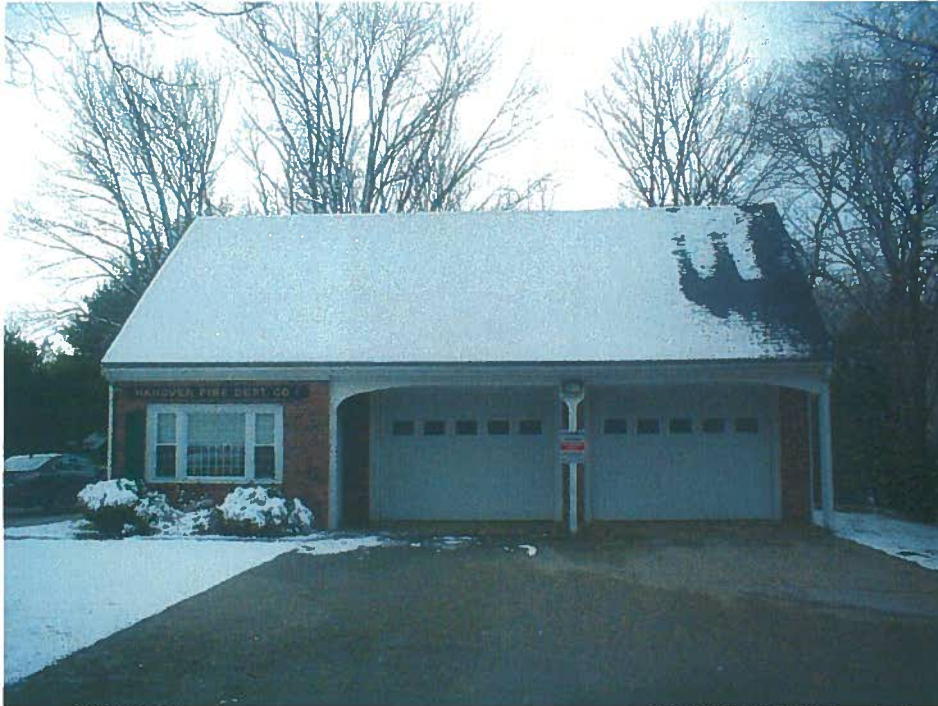
Exterior, main front entrance; fair condition, missing shutter at bay window. Snow melt pattern on roof indicates added insulation.

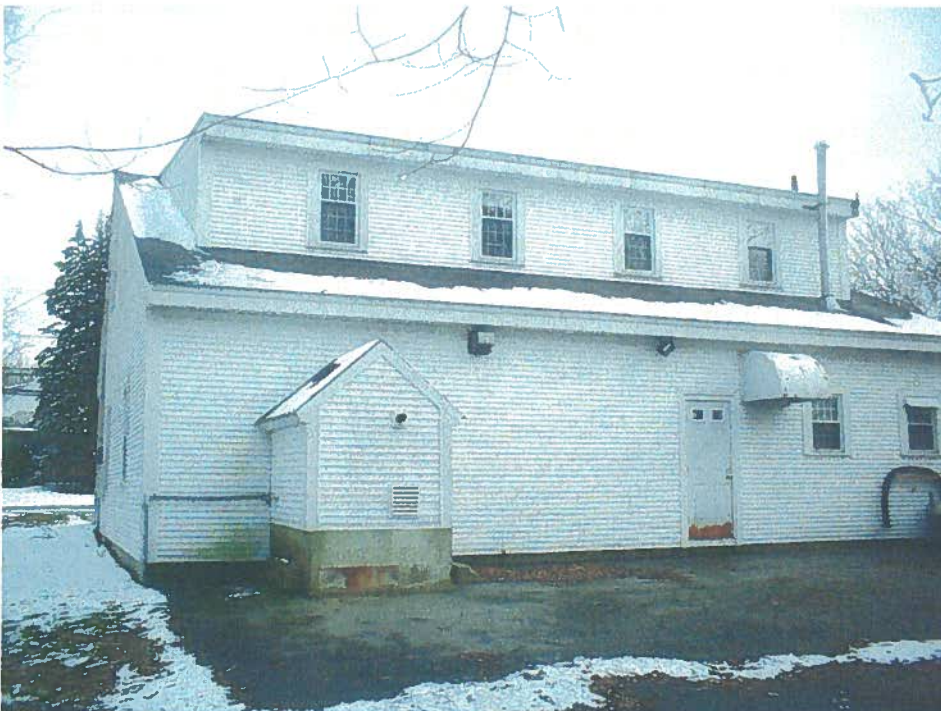
Exterior, back northwest facing facade. The “doghouse” structure houses the emergency generator.

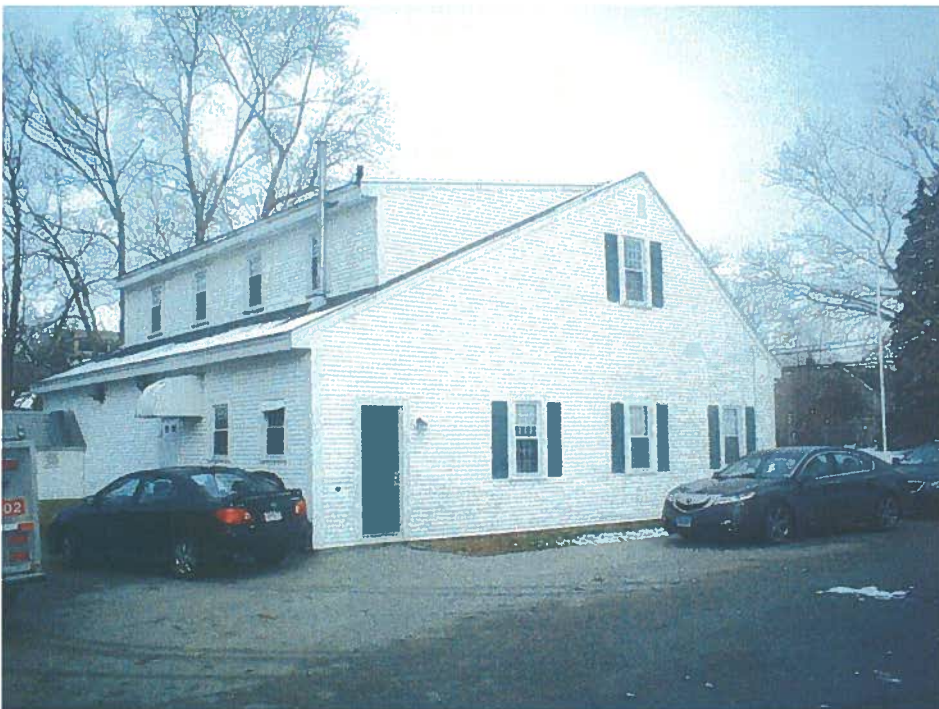
Exterior, west corner; paved parking area.

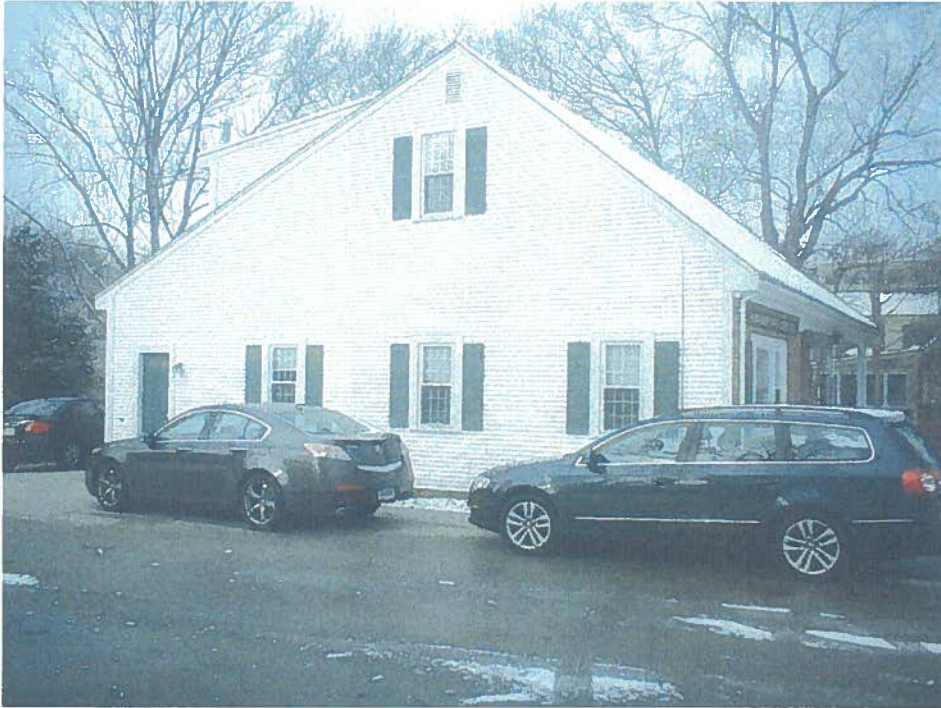
Exterior, southwest facade

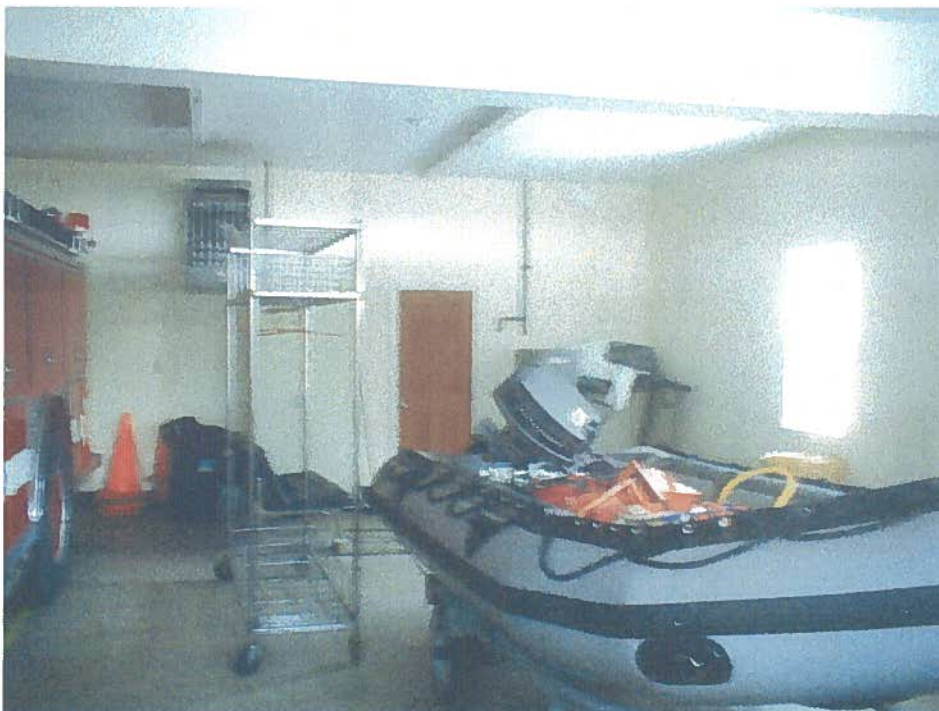
Interior, fire engine garage, view of rescue boat in north bay, and door to generator.

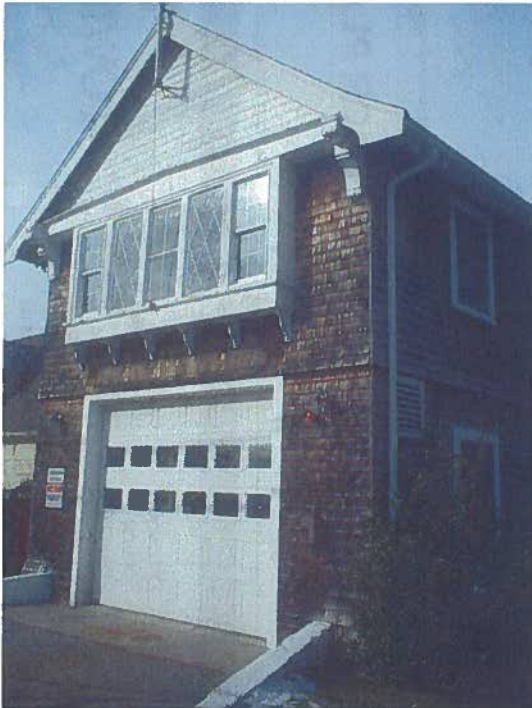
Exterior view of front elevation (facing street); single equipment bay.

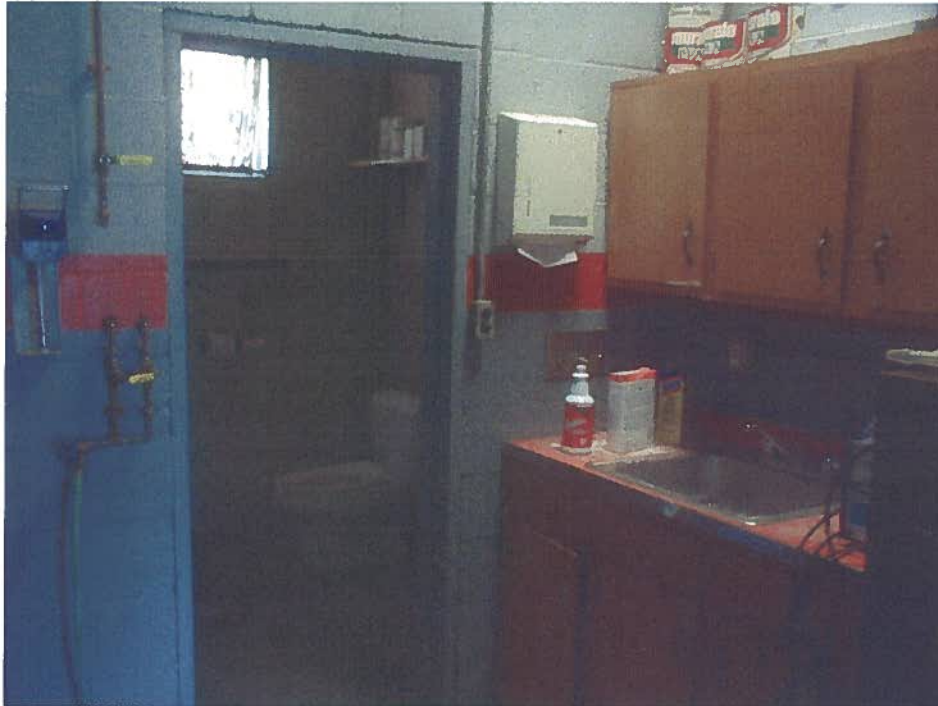
- No Kitchen; no staff overnight living area; cabinets at rear counter area are old and worn and should be refinished or replaced.
- Sink in counter at rear is non-accessible.
- temporary construction enclosing lounge area interferes with potential to store larger vehicles, and is constructed of combustible materials and without proper consideration for power, lighting, and ventilation
- Suspended ceiling is old
- Paint is generally old and in poor condition

Interior view looking from kitchen towards the bathroom-non accessible.

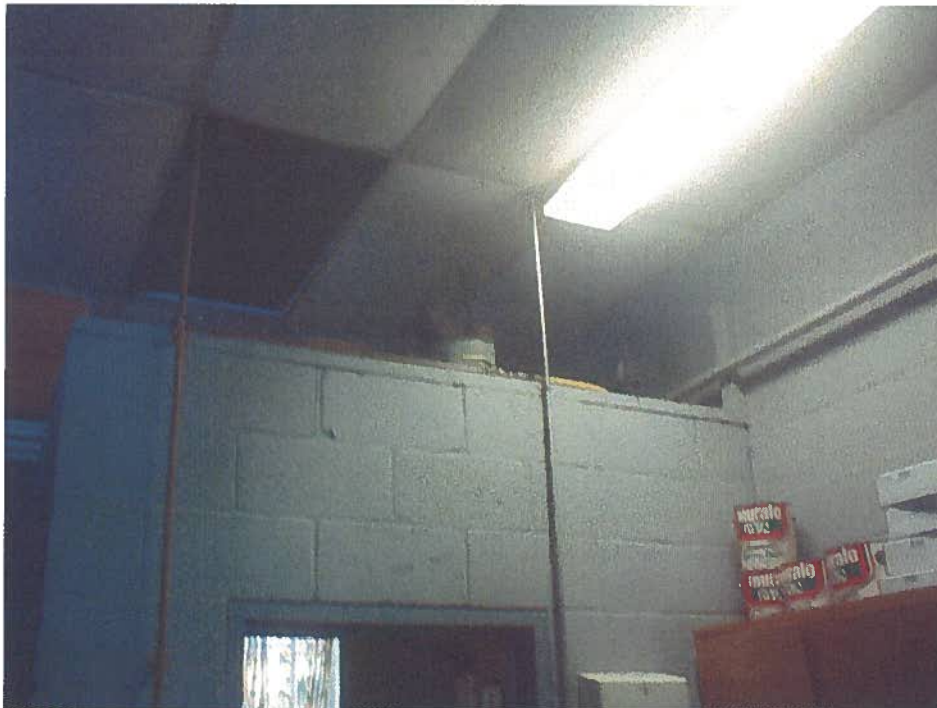
Detailed interior view of ceiling.

- Remove old bolt anchors at front elevation.
- Replace old suspended ceiling
- Reset one loose block at top of pipe chase at rear side of building.
- Repaint rear exterior door and remove early rust.
- Paint exterior.
- Relocate power pole in center of front apron; it is a problem for equipment to maneuver around.

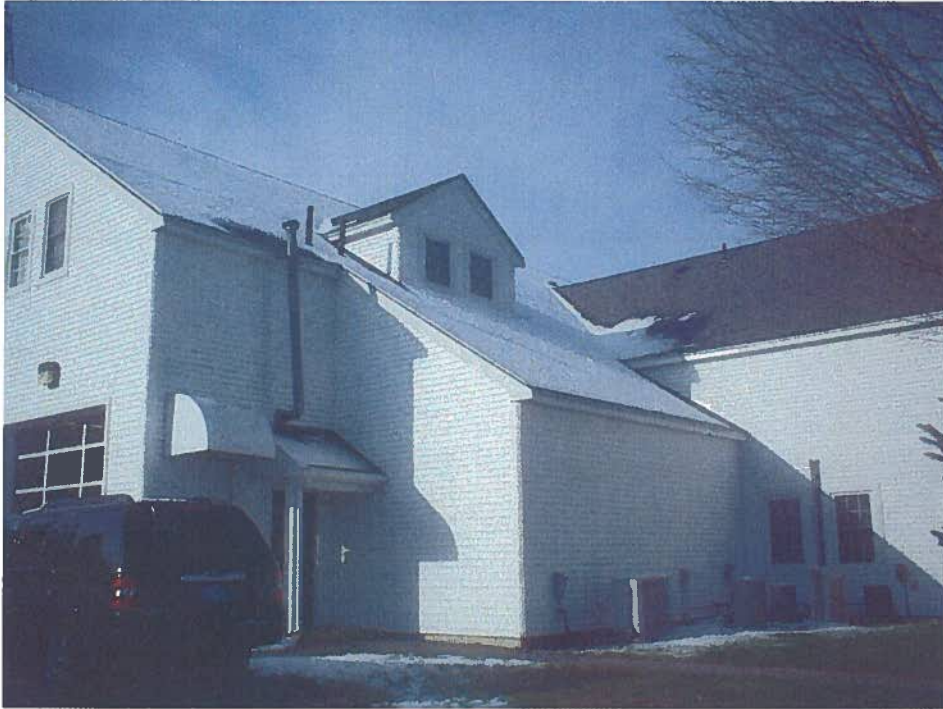
Detailed view of exterior east corner, heat vent needs bracing.

- Brace exhaust flue.
- Repair siding in damaged areas.
- Repair catch basin to prevent ponding on west side of entry drive.

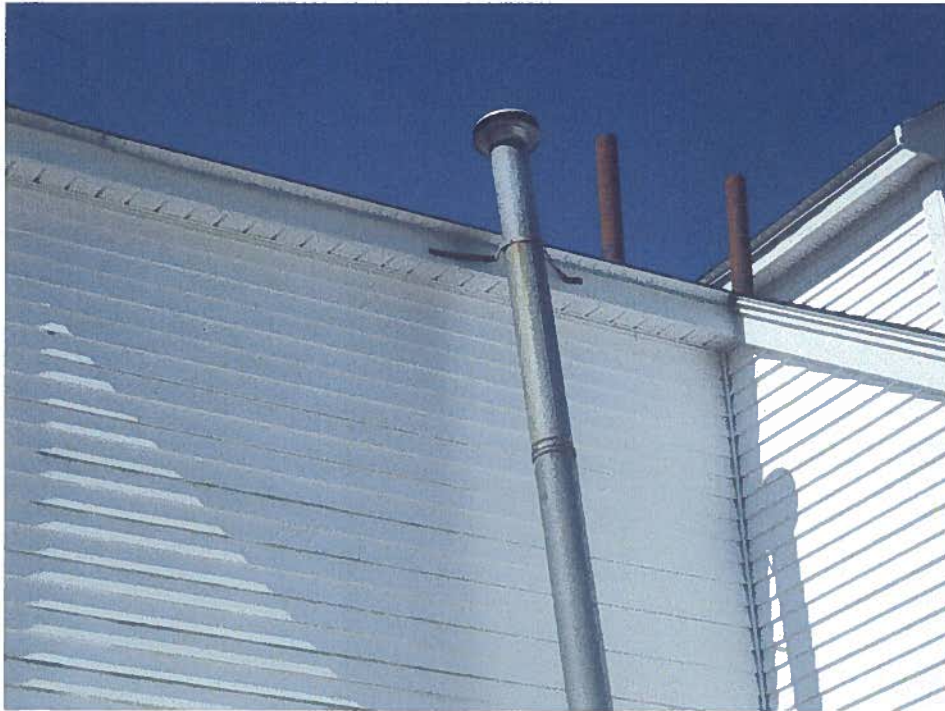
Detail at vent pipes-heat pipe needs bracing.

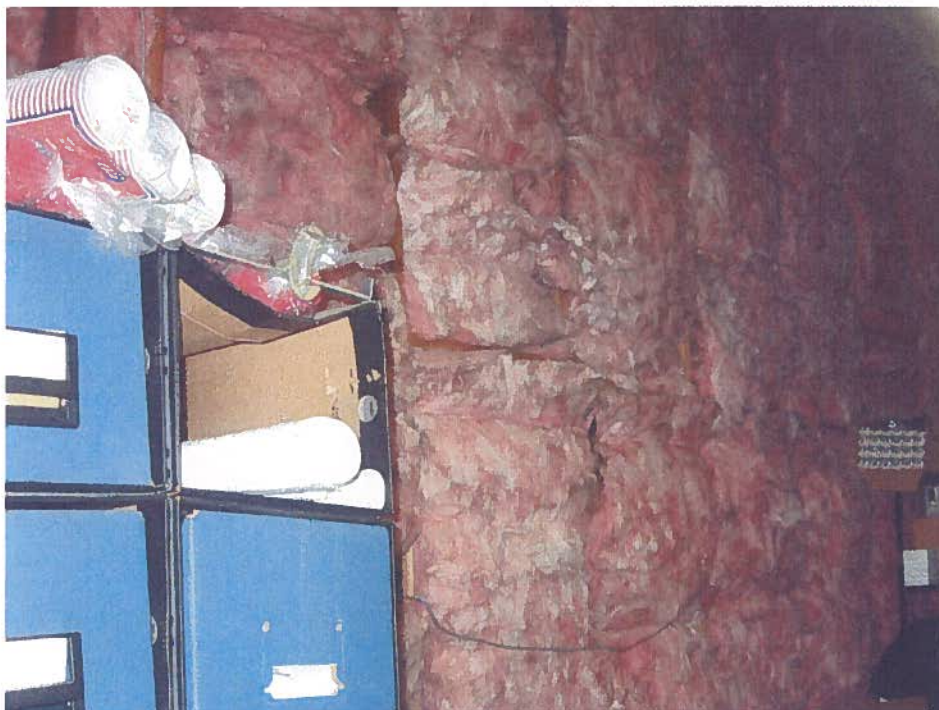
First, there is evidence of moisture damage from above the upper floor. The assumption is that this damage is from a leaking roof. However, it was also noted that ventilation louvers have been blocked up at the attic level in response to wind-blown rain penetration during occasional storms. This may have caused a condensation problem on the underside of the existing roof, due to inadequate fresh air ventilation.

Interior view at exposed insulation.

- Install electronic keyless entry security control systems at all ground level doors, with data logging capability, activated by swipe card or other similar system.
- Replace the overhead doors
- Replace two broken windows in middle bay overhead door at the back.
- Re-insulate entire attic floor.
- Add additional air-cooling capacity for the upper level living spaces.
- Install sprinklers; desired, particularly in equipment bay area. Desires auto-extinguishing system on stovetop in dayroom upstairs.
- Verify ability of emergency generator to perform adequately in an emergency situation.
- Add fire detectors in the attic.
- Add two additional cameras to the security system.
- Additional heating at the first floor bathrooms needed.

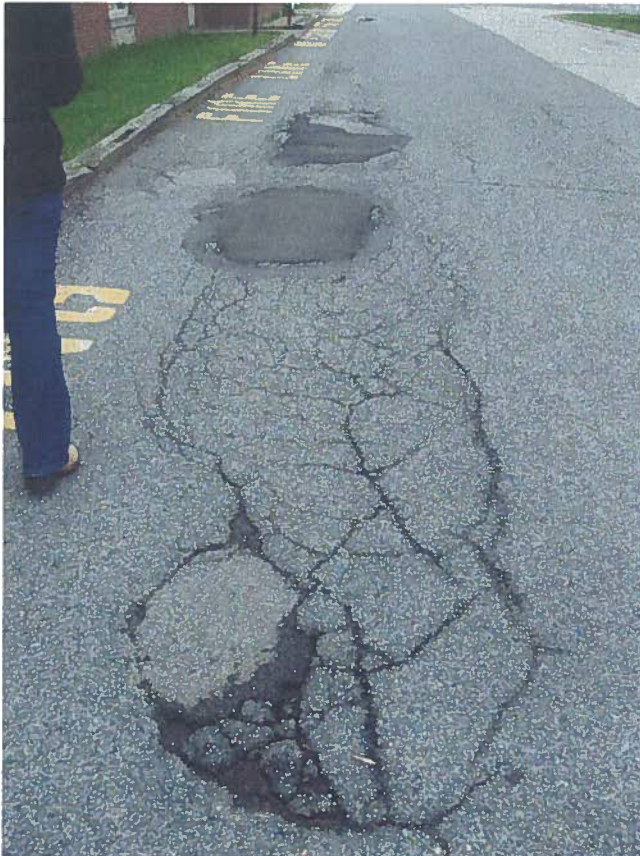
Deteriorated and patched paving.

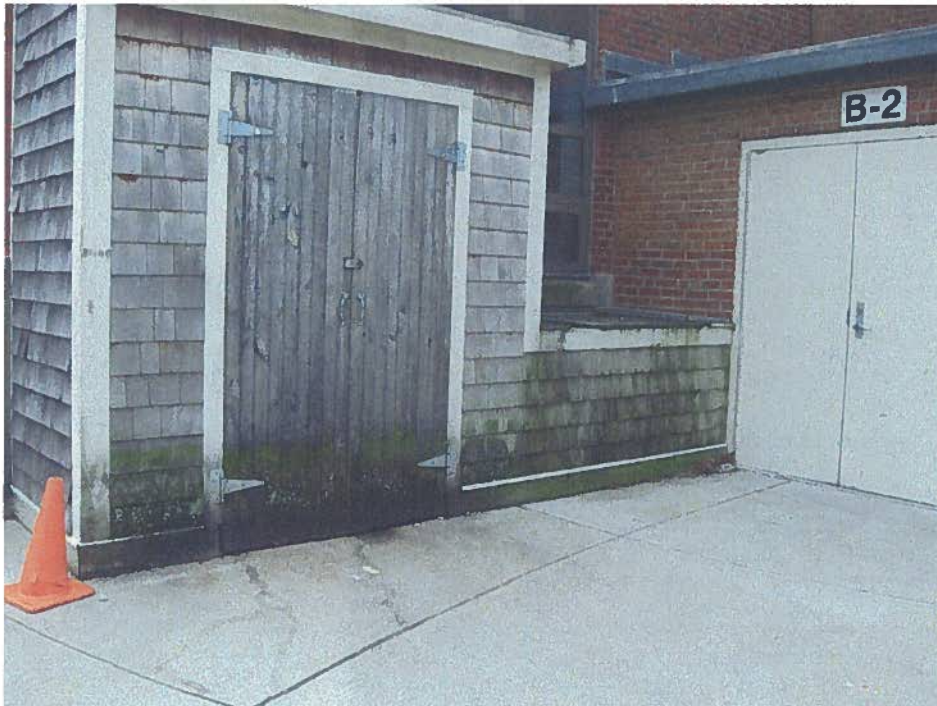
Mold on wall.

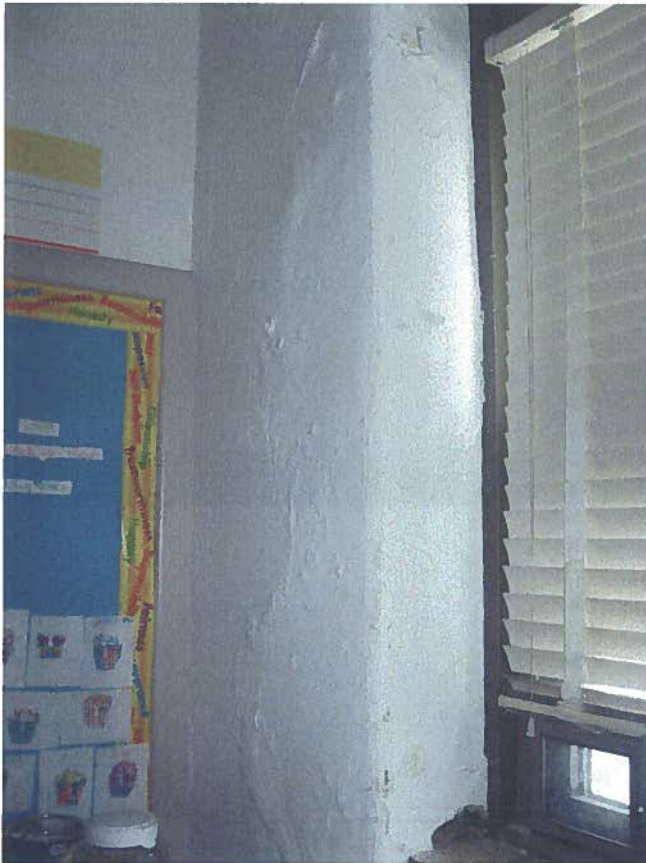
Wall with water damage.

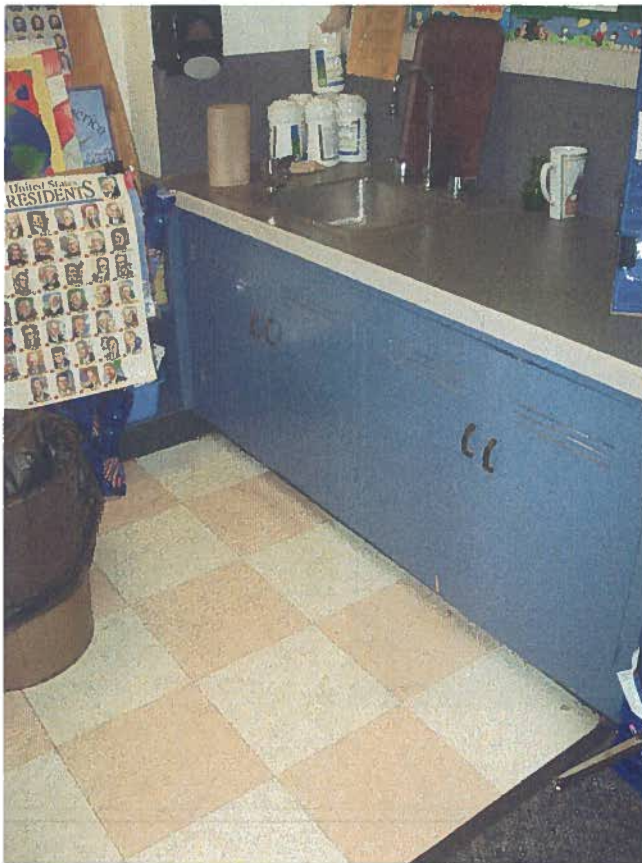
Interior, kitchen area. Non-accessible sink

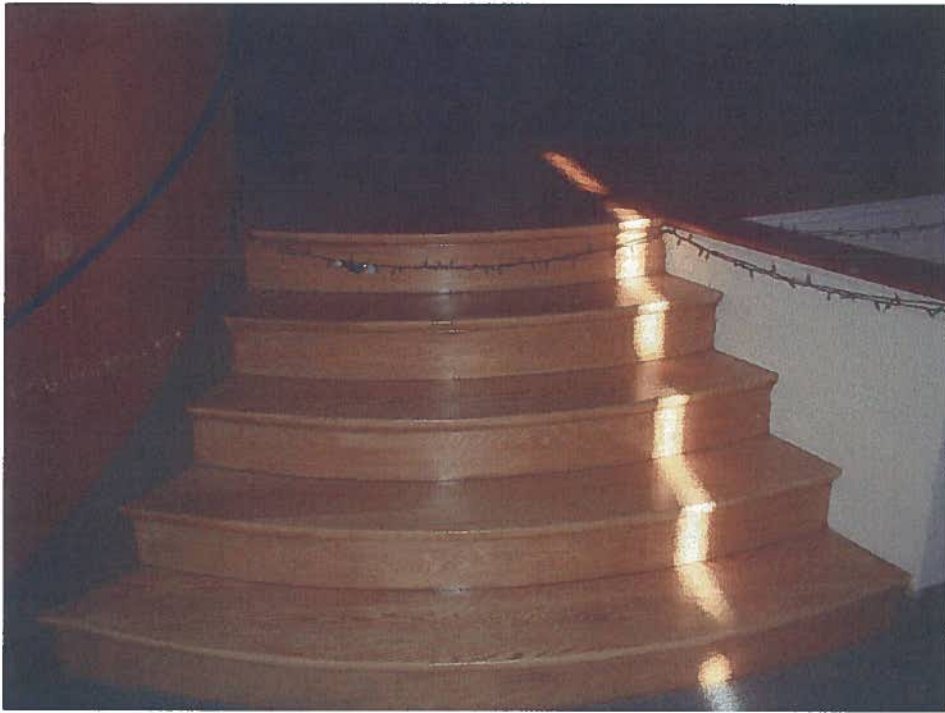
Steps to stage with non-compliant handrails.

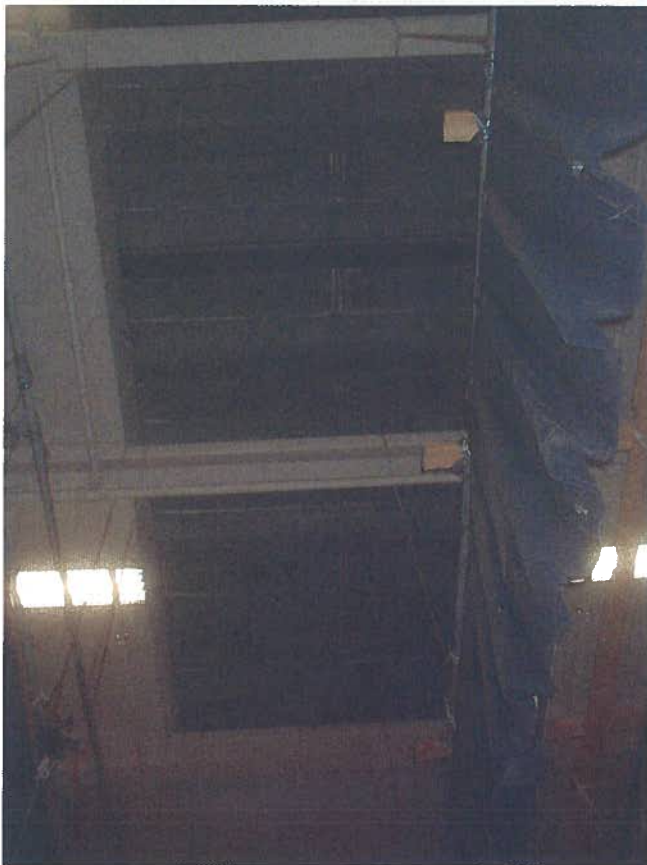
- Broken ladder to gymnasium roof level at second access hatch
- No cages on ladders over 20'
- Smoke ventilators above stage – frozen blades, tremendous heat loss, does not look very waterproof (pivoting blades of the device appear to be stuck in the open position. These should normally be closed and protected by a fusible link)

Smoke relief dampers above stage.

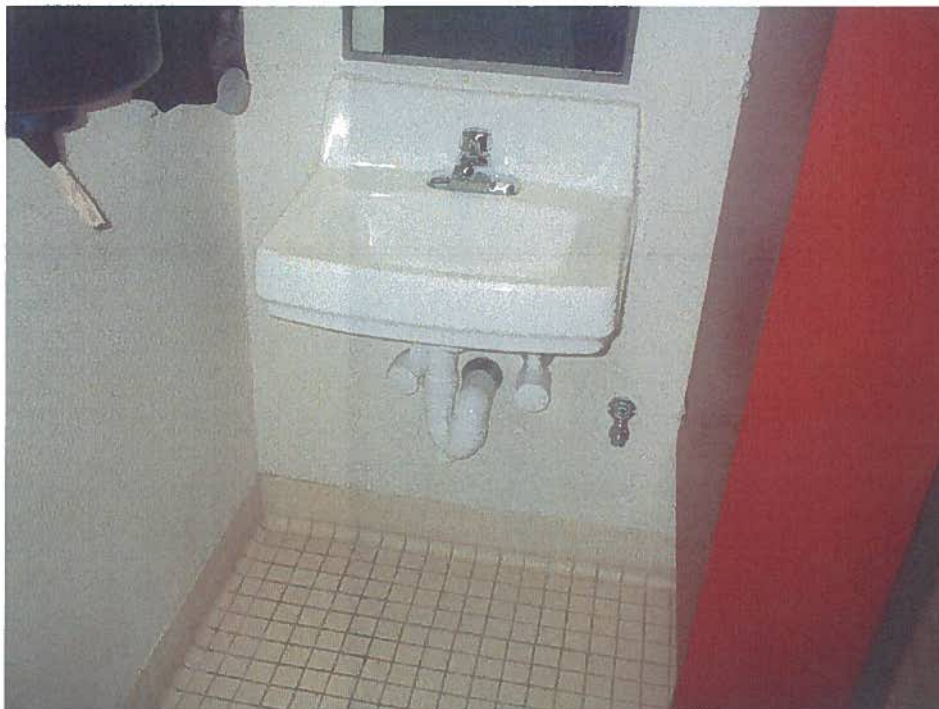
Sink not up to accessibility code requirements.

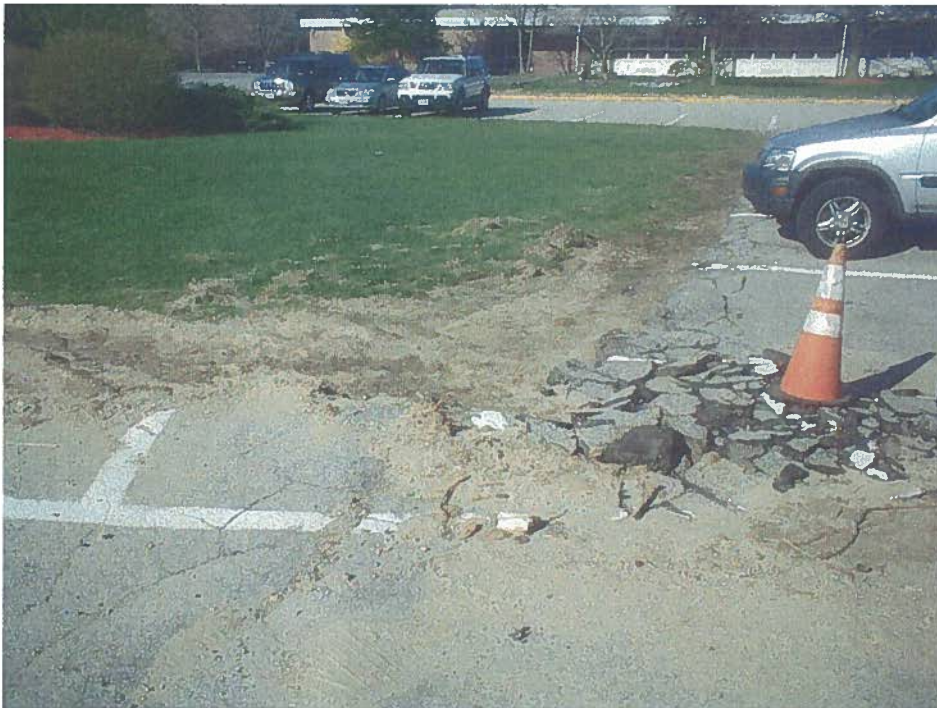
Broken pavement, tripping hazard.

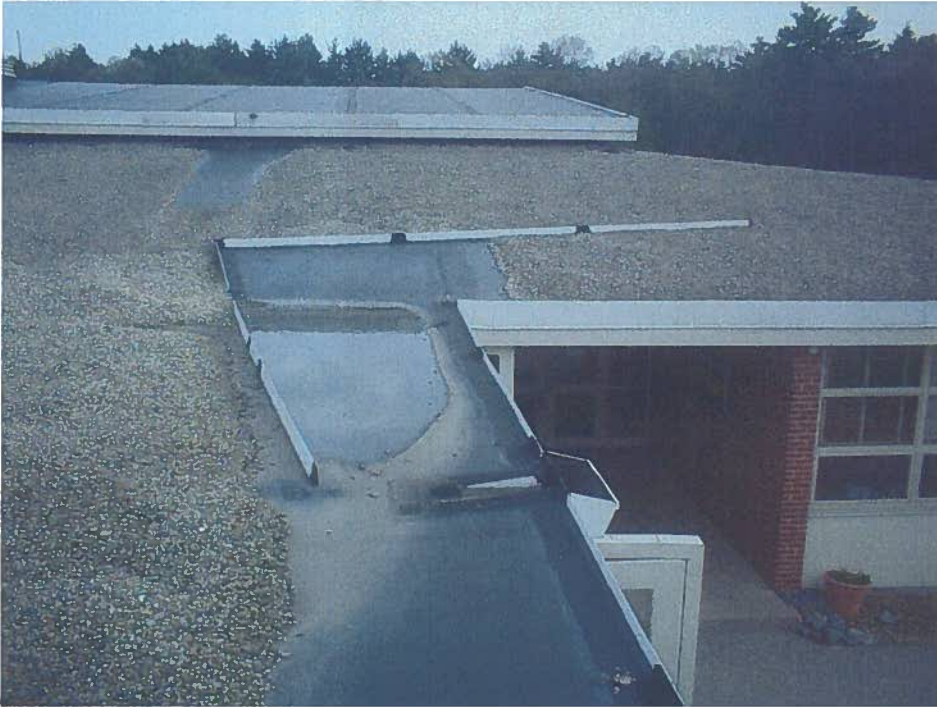
Detail of water ponded on roof.

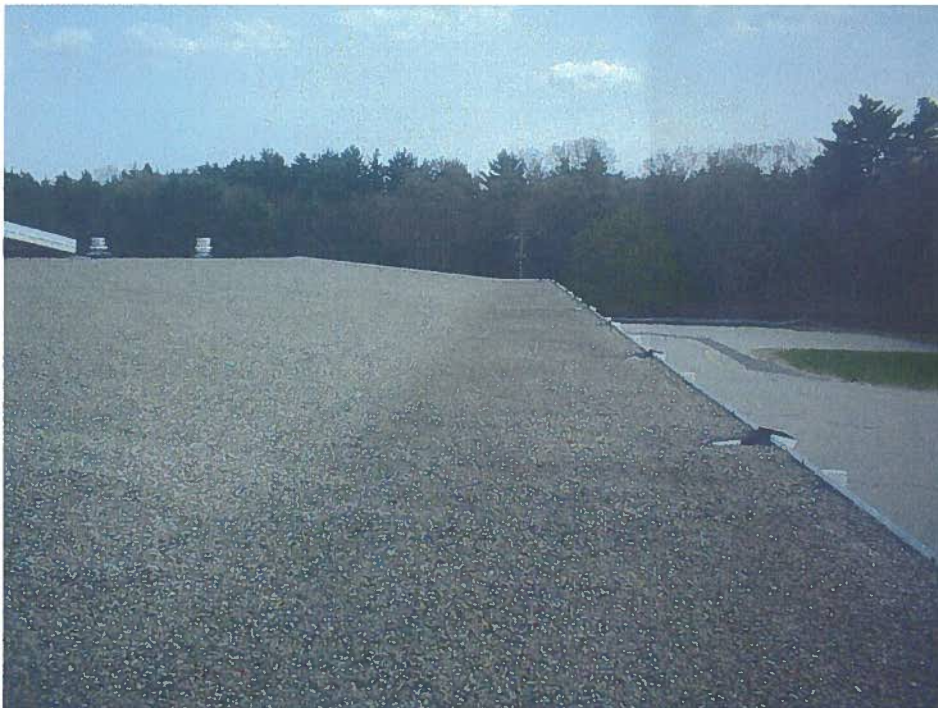
General roofscape - discoloration indicates moisture.

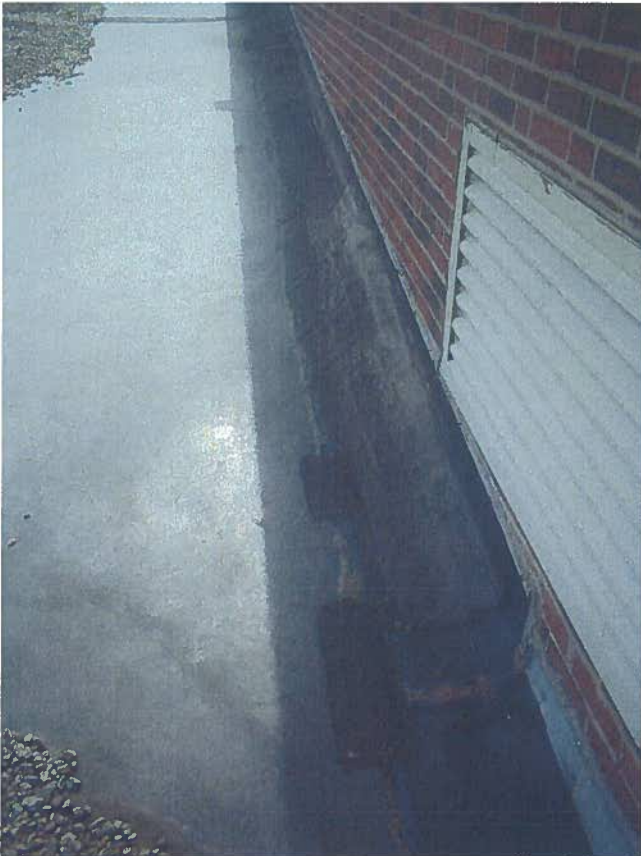
Roof detail at base of wall - area of frequent leaks & multiple repairs.

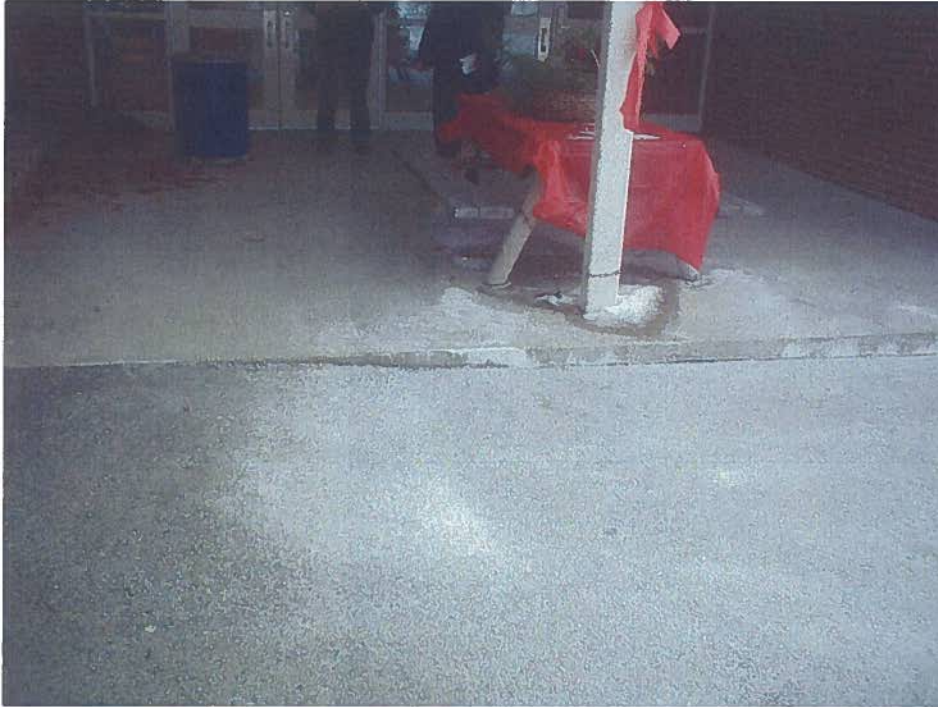
Entrance is non-accessible. Dangerous, uneven pavement; should re-grade across entire front step.

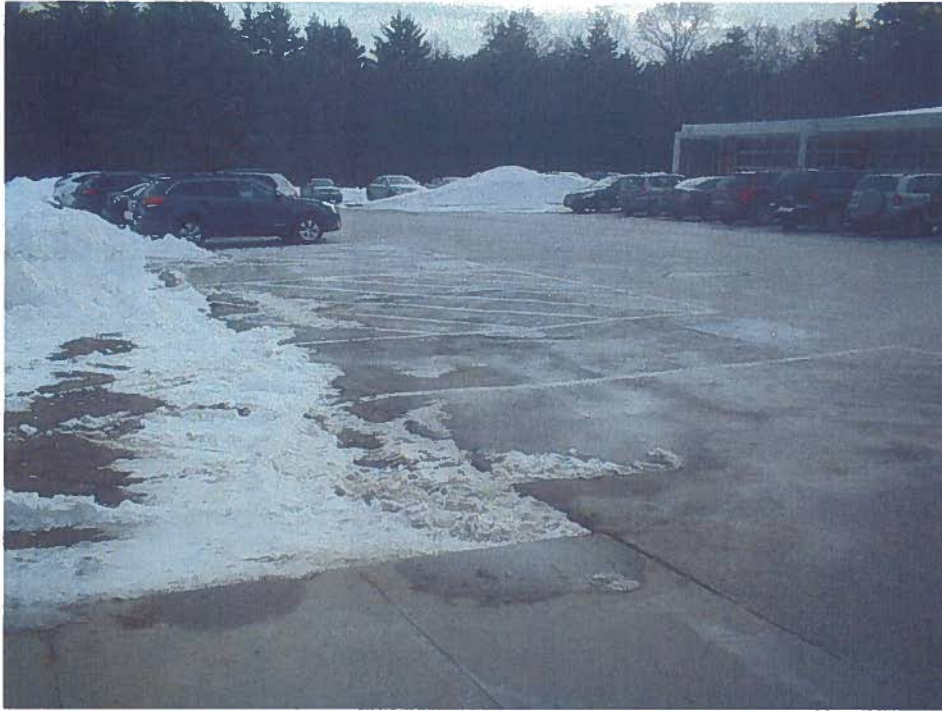
Accessible parking near rear entrance, needs signage on posts.

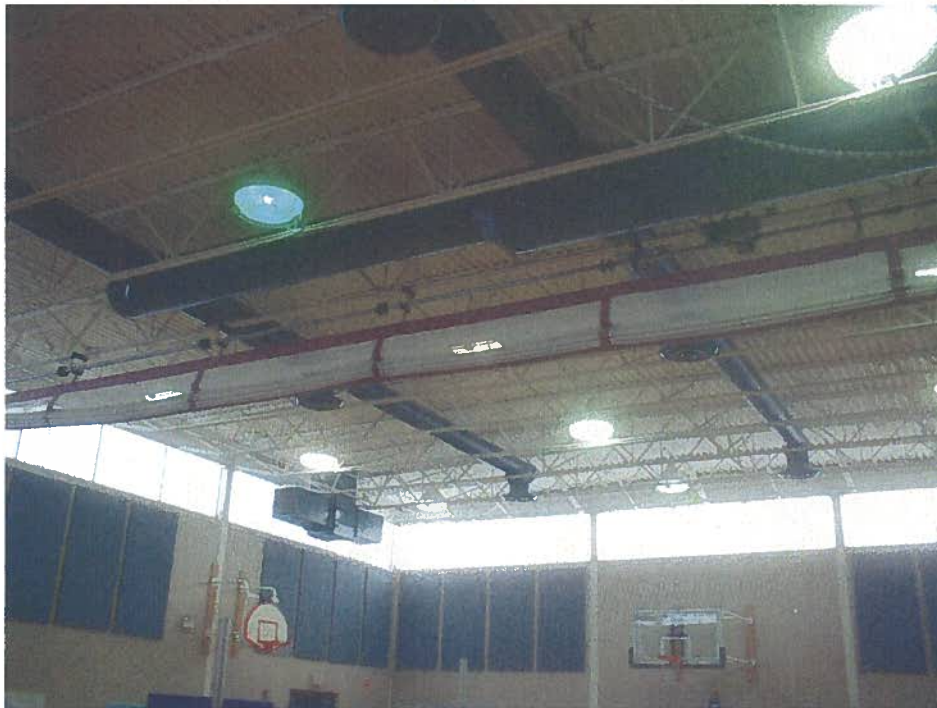
Divider curtain in gym

Teacher wants it taken out; swinging bottom rod is a hazard (according to the teacher).

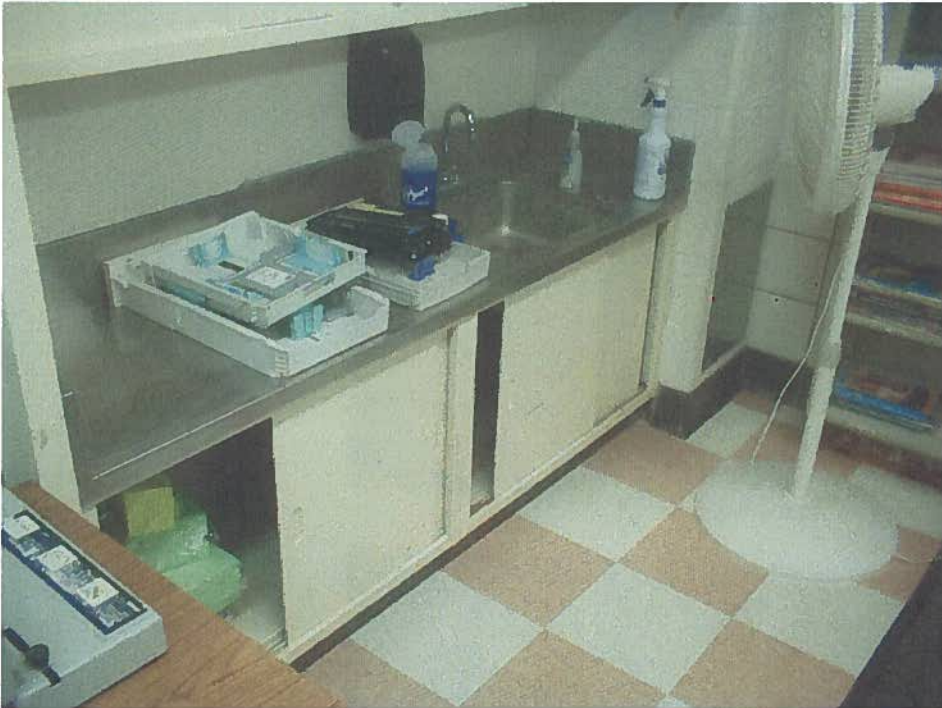
Sink in teachers' workroom; non-accessible.

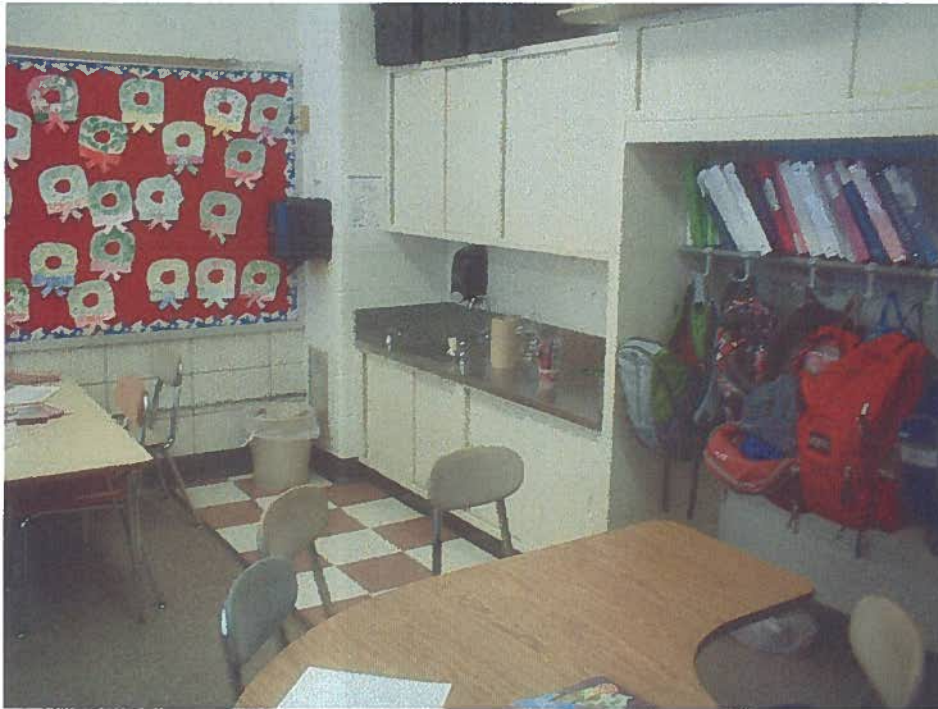
Non-accessible sink in classroom, old wing.

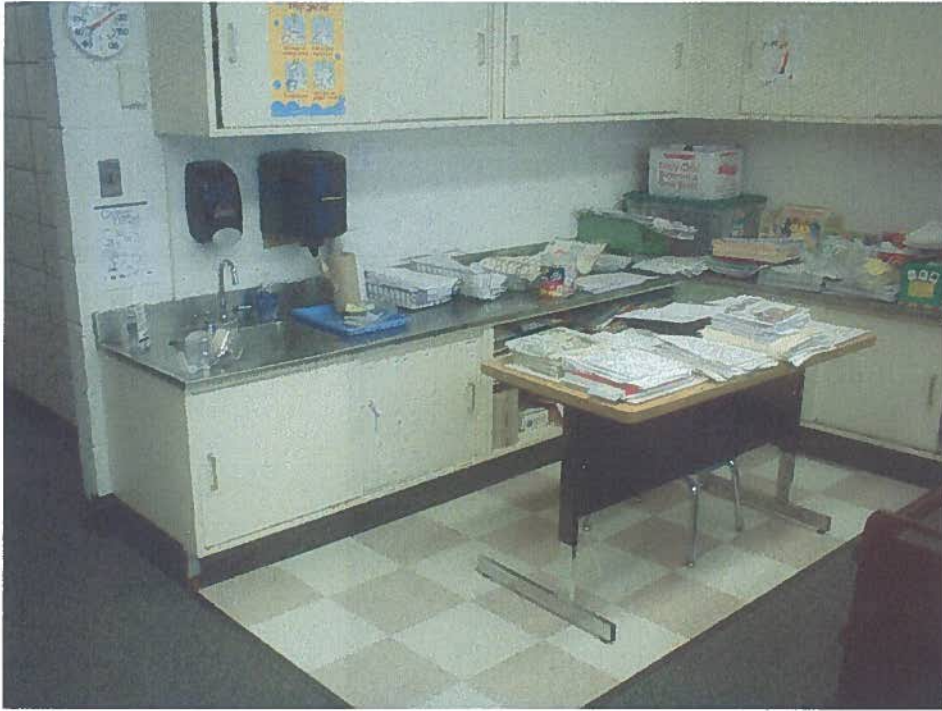
Non-accessible sink in classroom.

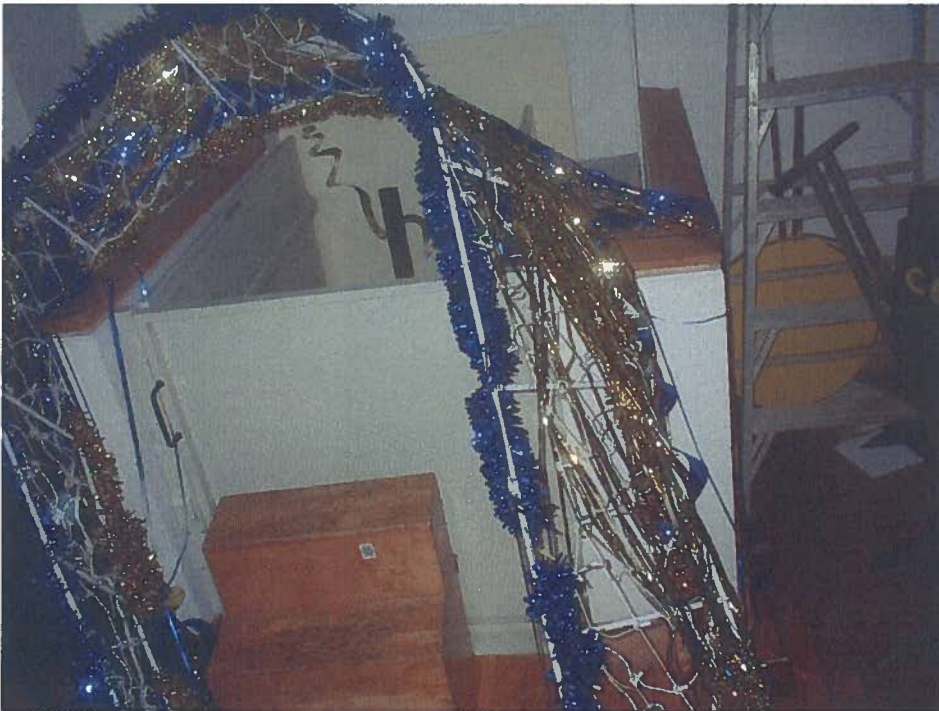
Handicapped lift at back of stage. Obstructed from use.

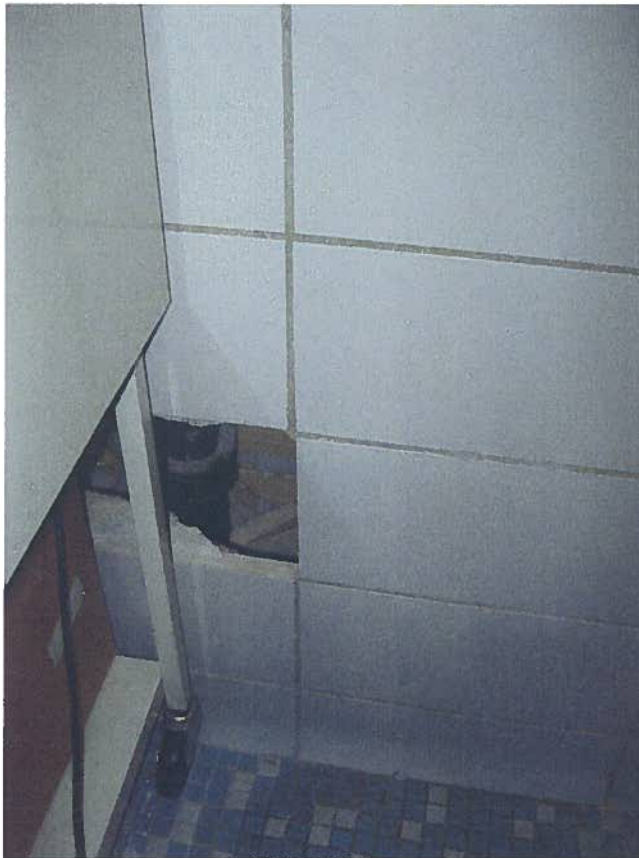
Broken tile. Hole in wall.

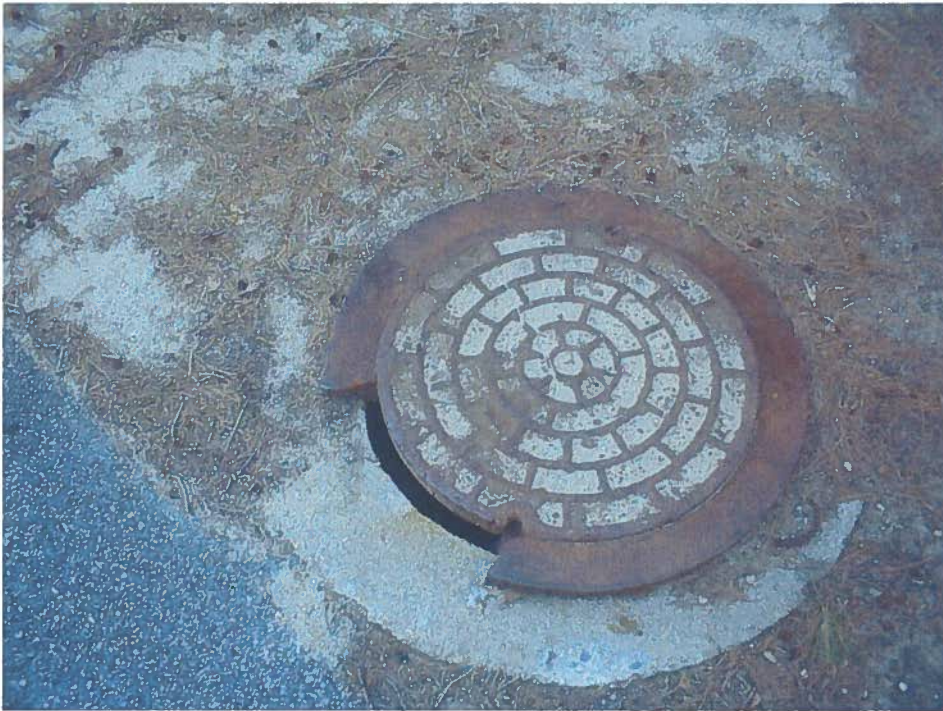
Gap in drain cover.

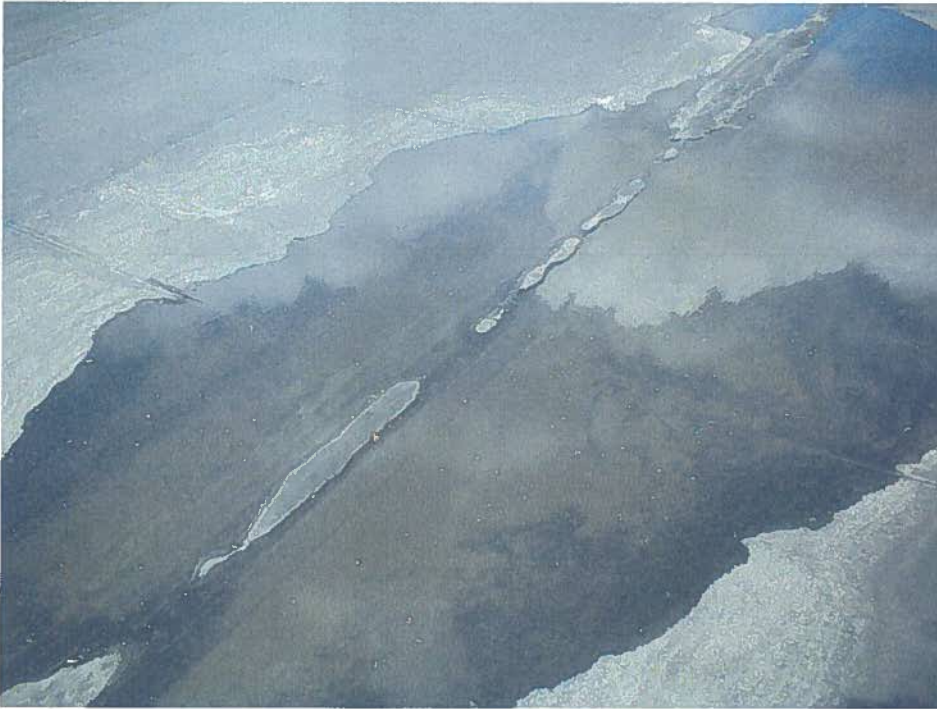
Most areas of the roof are now 18 years old, EPDM rubber membrane. This type of roofing material often only lasts about 20 years. The roof has some bubbled areas along seams, and some minor ponding. The roof should be inspected on an annual basis with a program of repairs to extend its useful life, and planning should begin now to re-roof the building within 5 – 10 years.

Roof drainage-ponding & blistered seam.

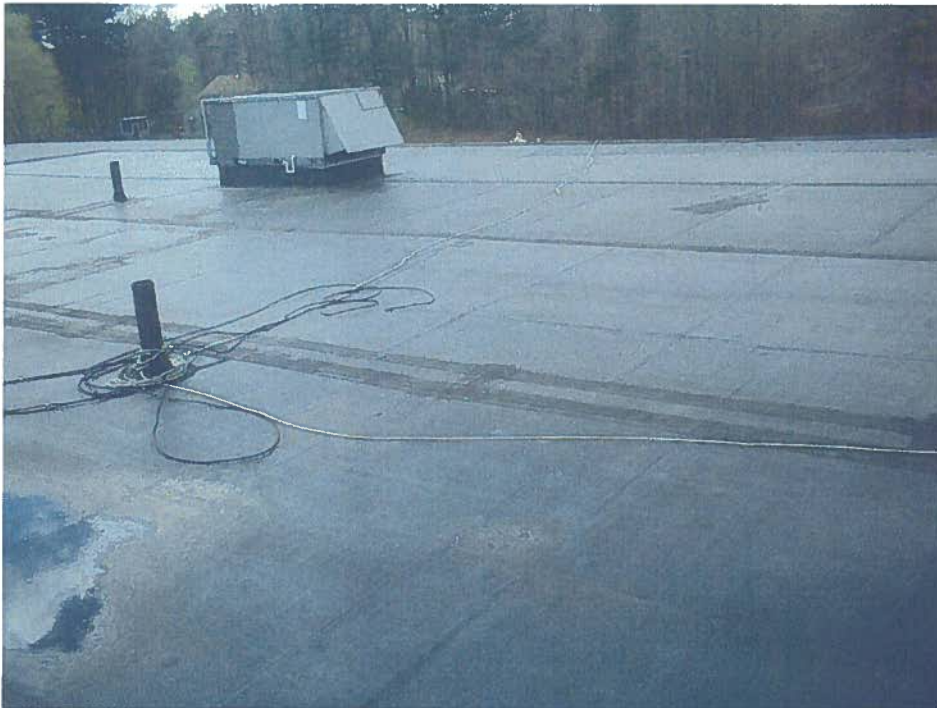
General roofscape-loose wires should be secured to prevent chafing.

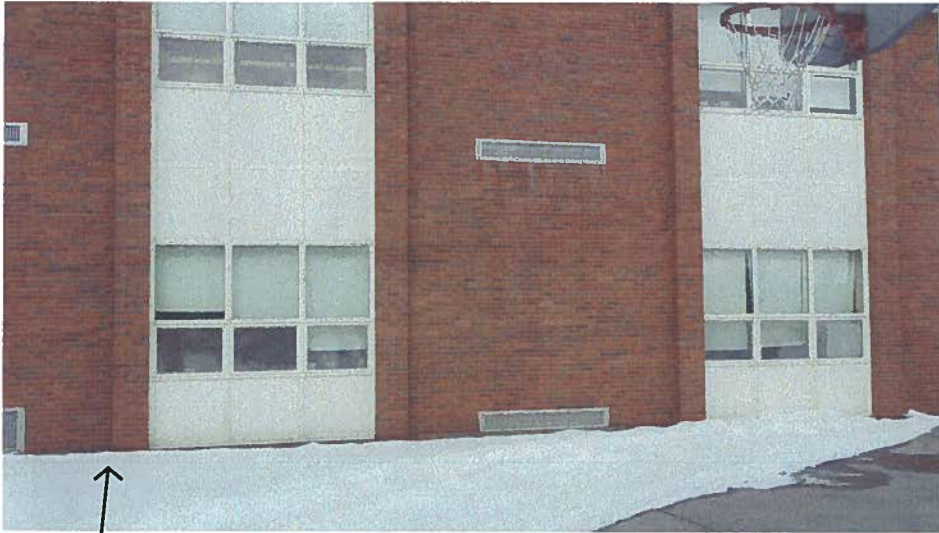
Exterior, leaky windows; plugged condensate line is in this area.

- Investigate and repair leaky conditions at one set of exterior windows.
- Repair or replace one set of doors with broken operating hardware, in corridor on ground level, leading towards exit doors.
