**Municipal Facilities Assessment-2011  
Capital Improvement Committee  
Hanover, Massachusetts  
September 2011**

# Building Study

# **Town of Hanover - MUNICIPAL FACILITIES ASSESSMENT - 2011**

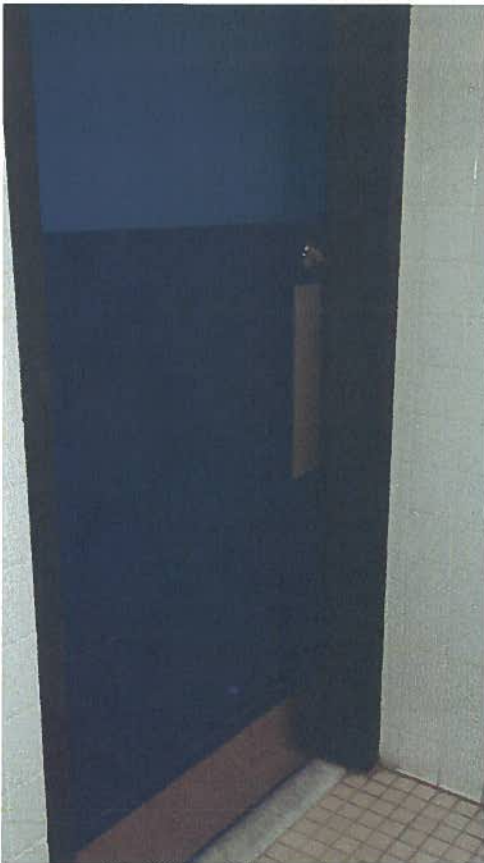
Non-accessible clearance at boys' toilet room door.

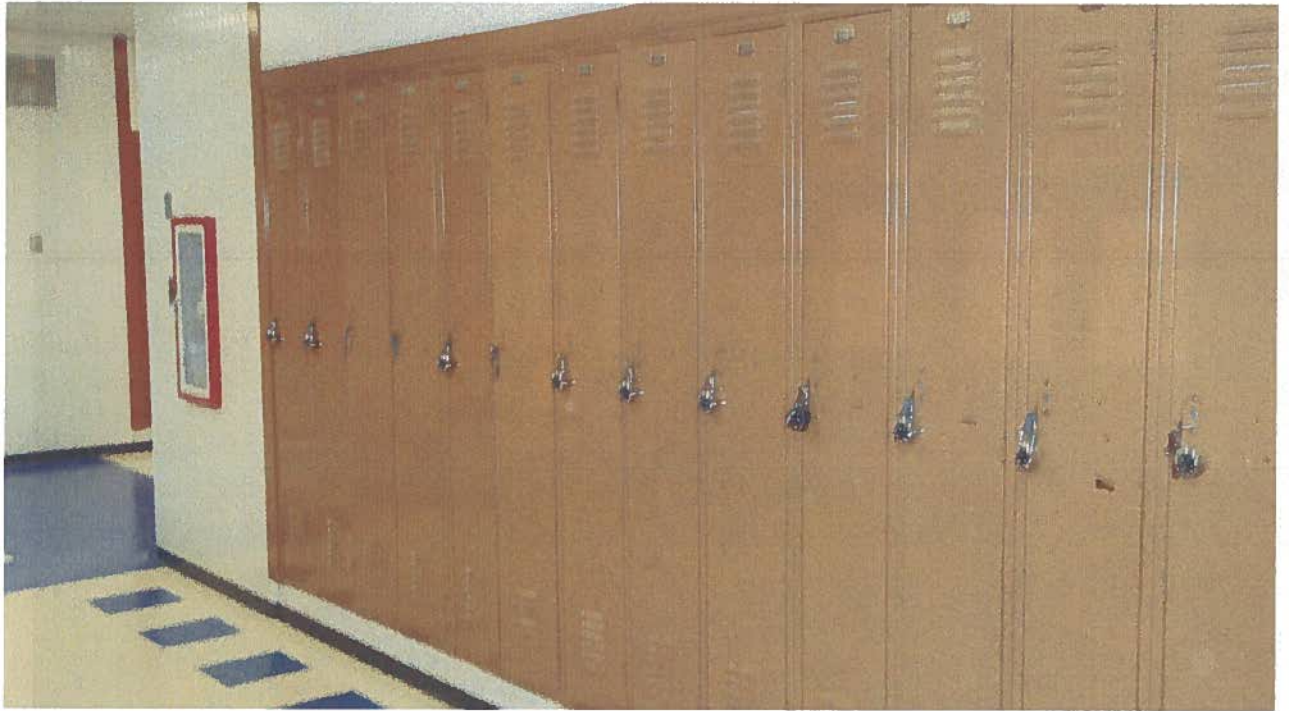
Typical lockers at this school. No designated accessible lockers.

- Remove barriers to universal accessibility: provide new handrails at stage, provide dual-height drinking fountains, provide accessible sink units in classrooms that have sinks, provide accessible student lockers, insulate drain and hot water piping under accessible sinks, provide automatic operators at doors with inadequate clearances.

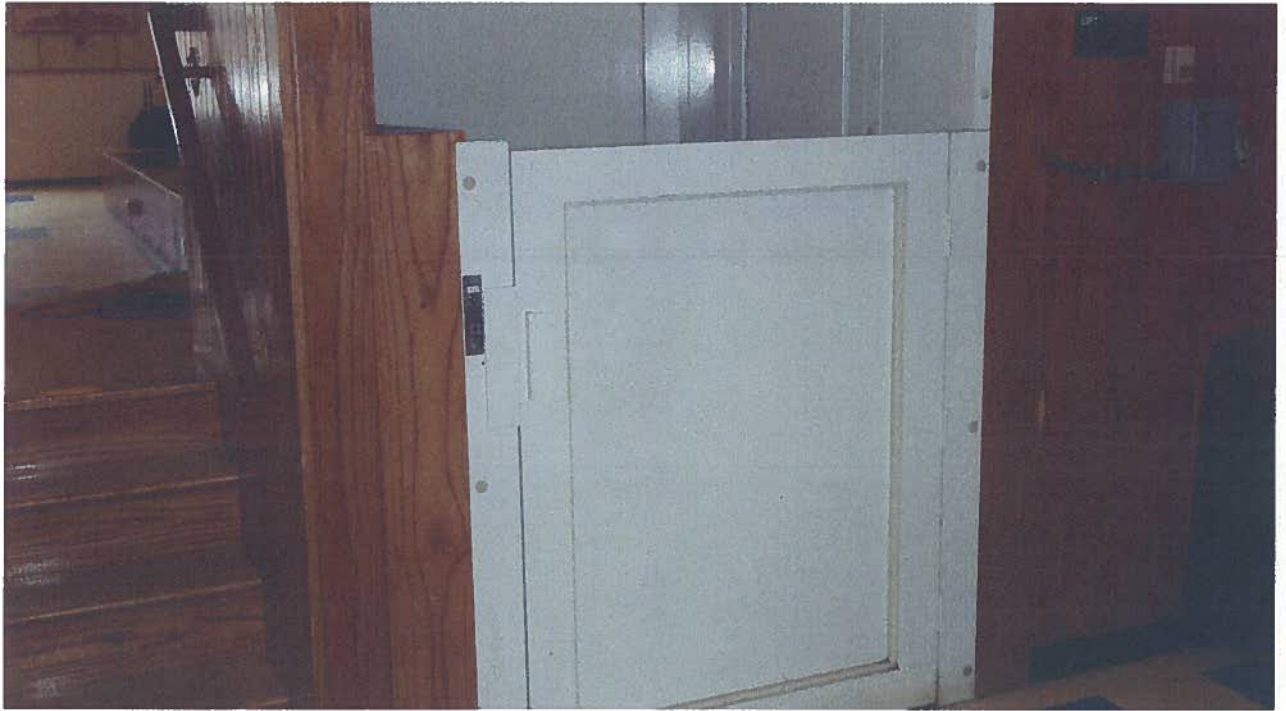
Lift at cafeteria stage; does not meet code at steps.

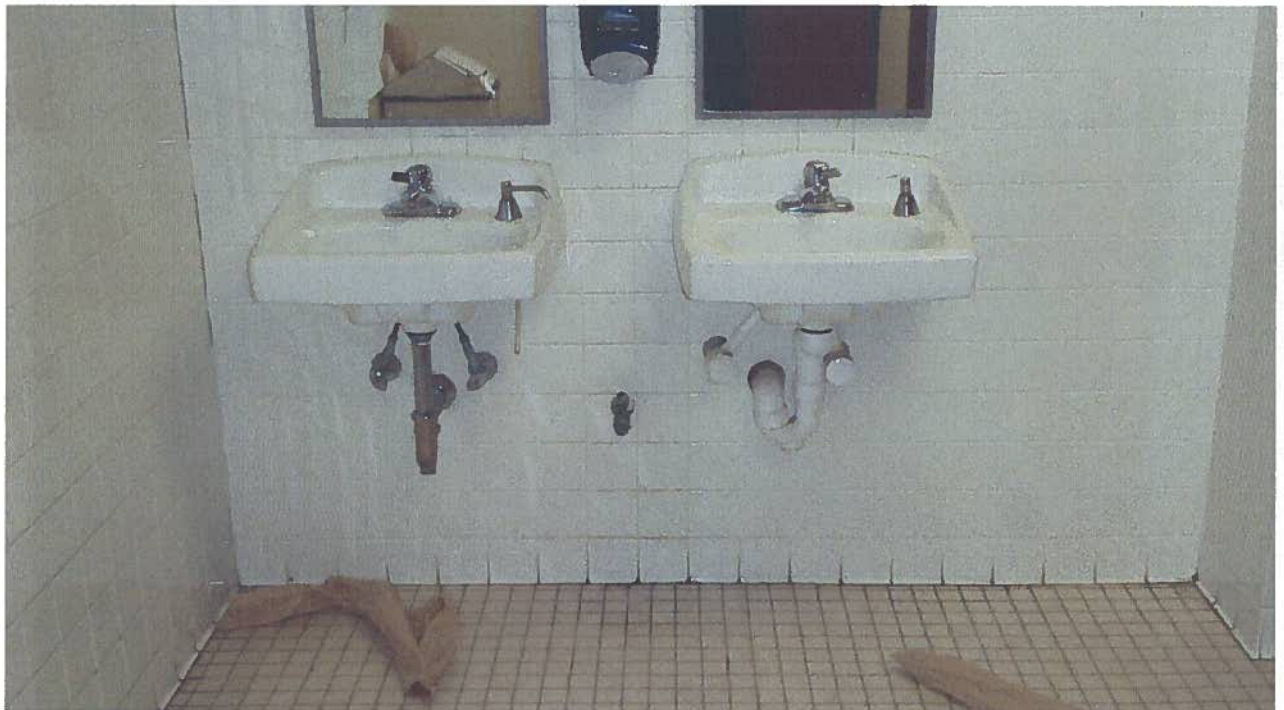
Handicapped accessible toilet near cafeteria. Accessible sink not correct depth.

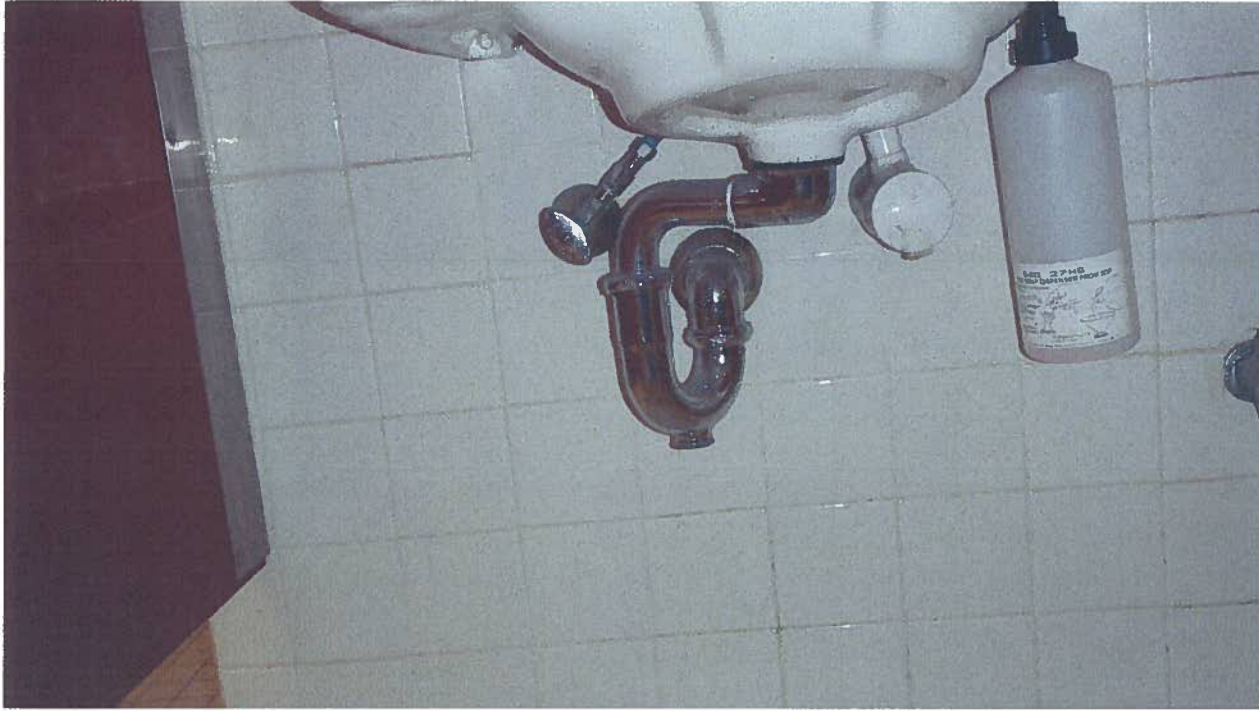
Faculty women's toilet--uninsulated trap does not meet accessibility code.

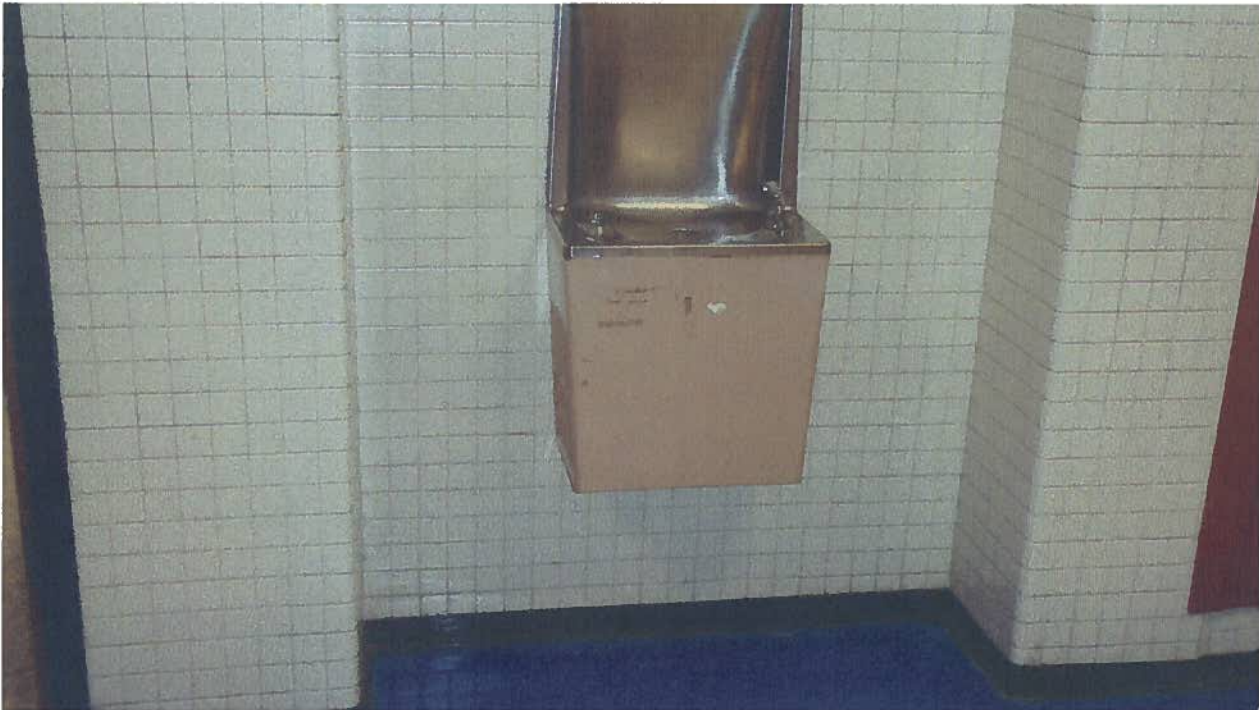
Non-accessible drinking fountain.

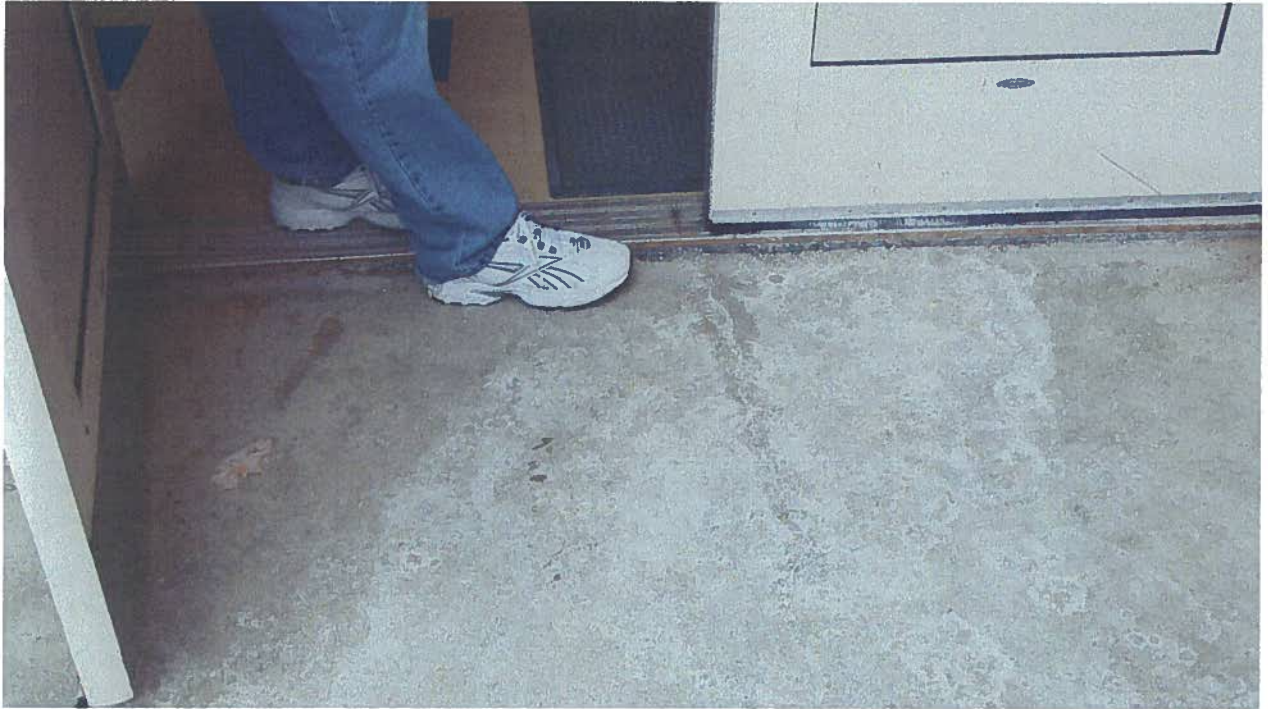
Threshold problem at gym entrance; exterior entrance. This entrance is used for public events.

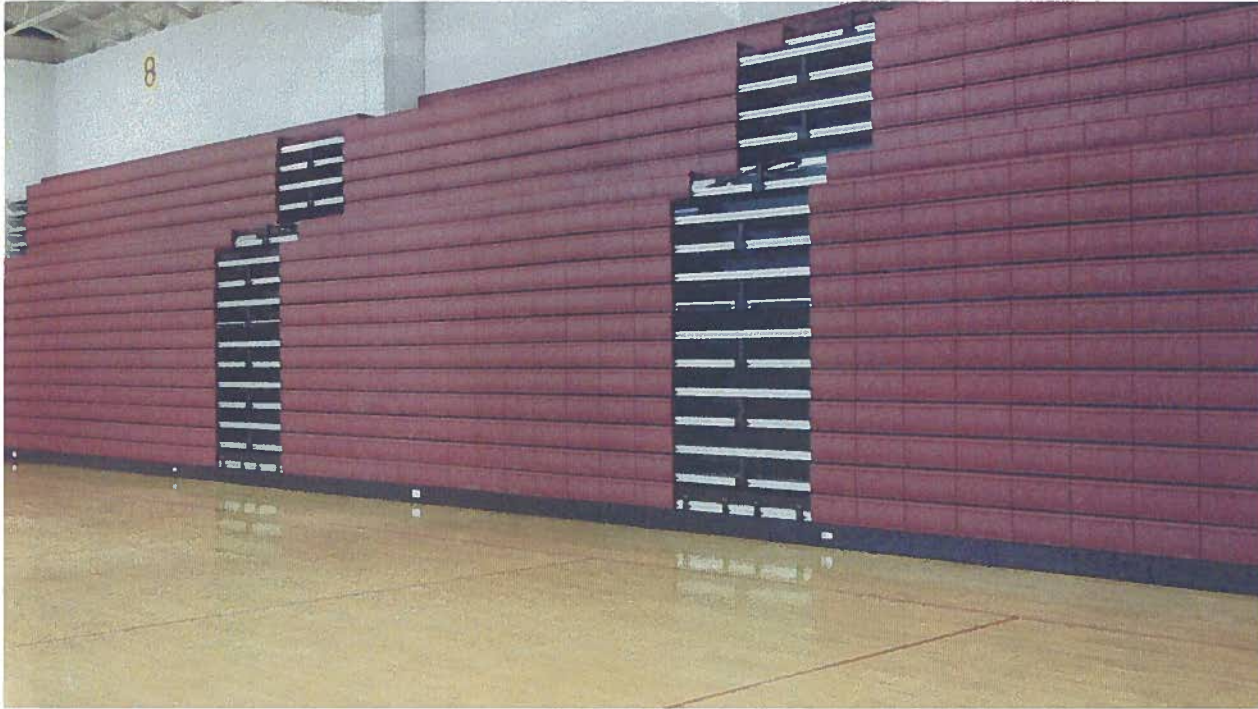
Bleachers in gym have no accessible seating, per description from gym teacher.

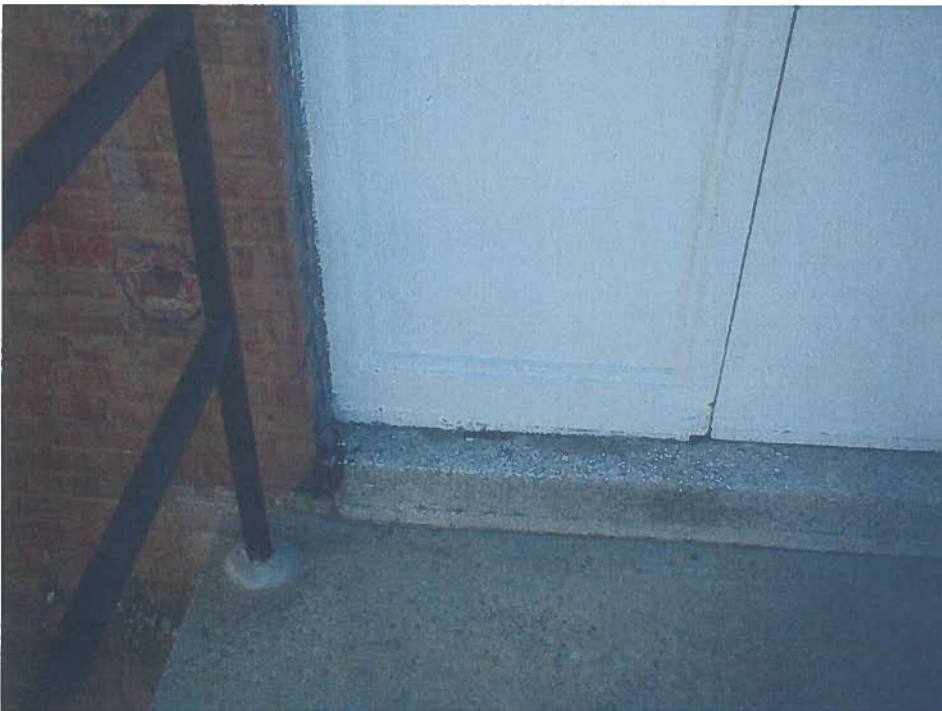
Non-accessible step into entrance.

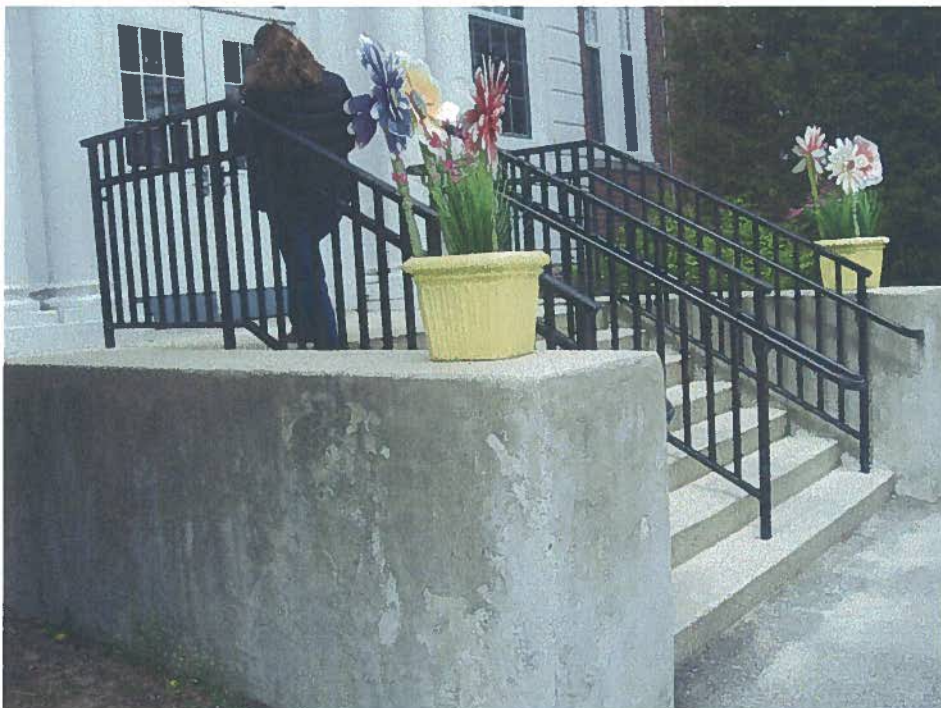
View of entrance stairway.

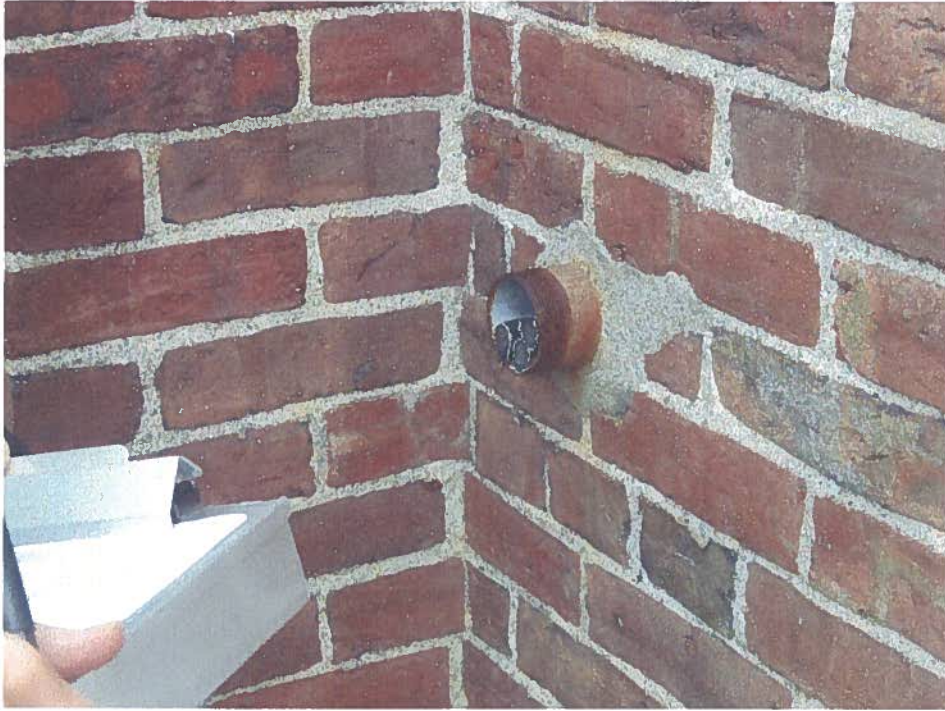
Electrical conduit; large feeder cables inside cut off.

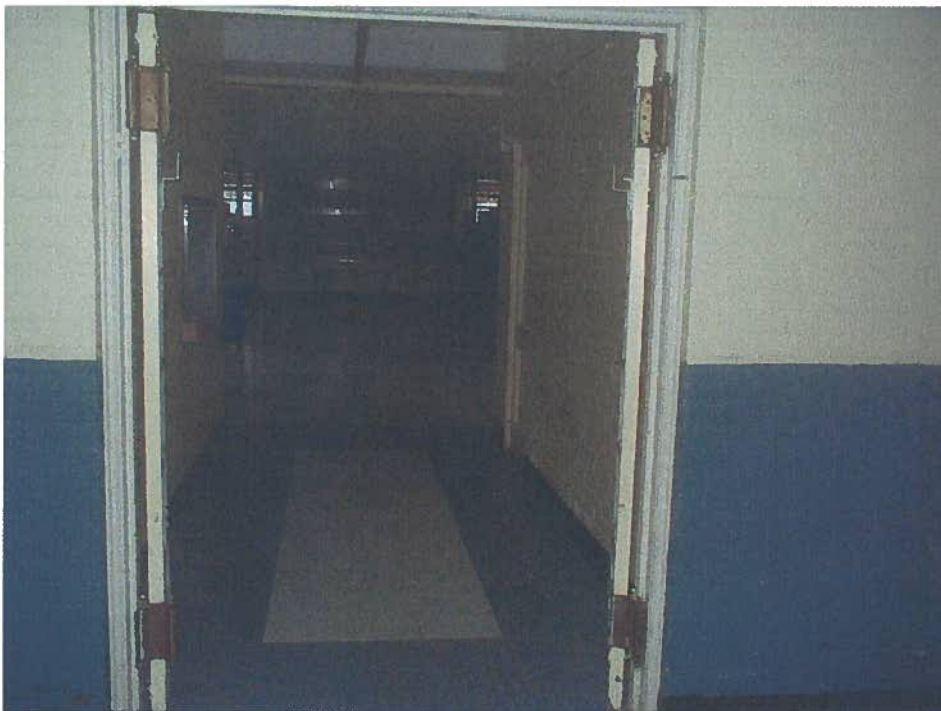
Entrance doors to cafeteria; wood. Narrow doors do not meet access codes.

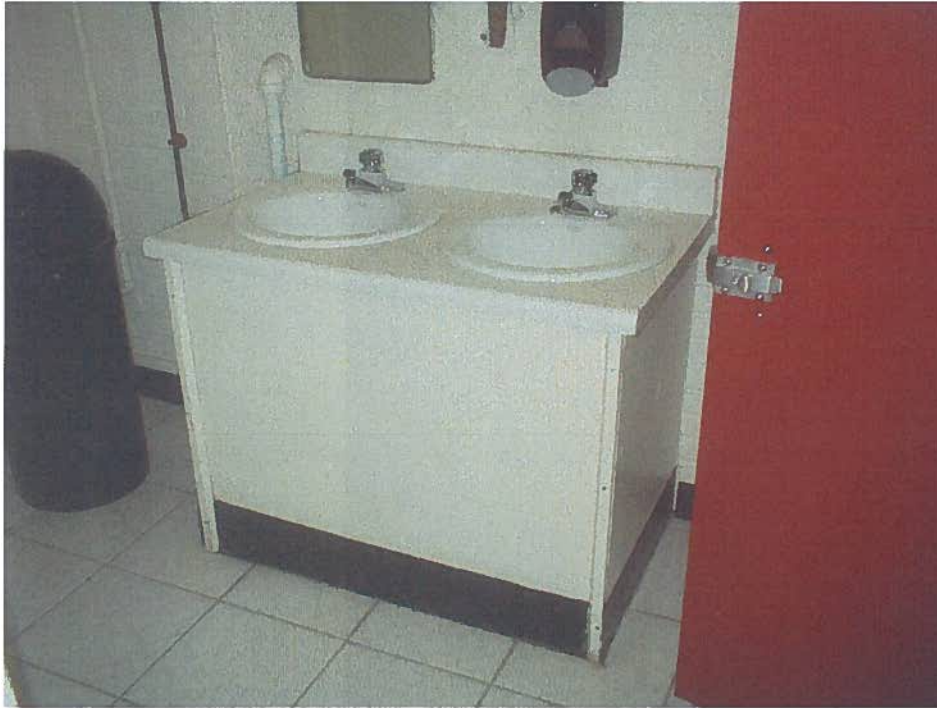
Non-accessible sinks in basement boys' toilets.

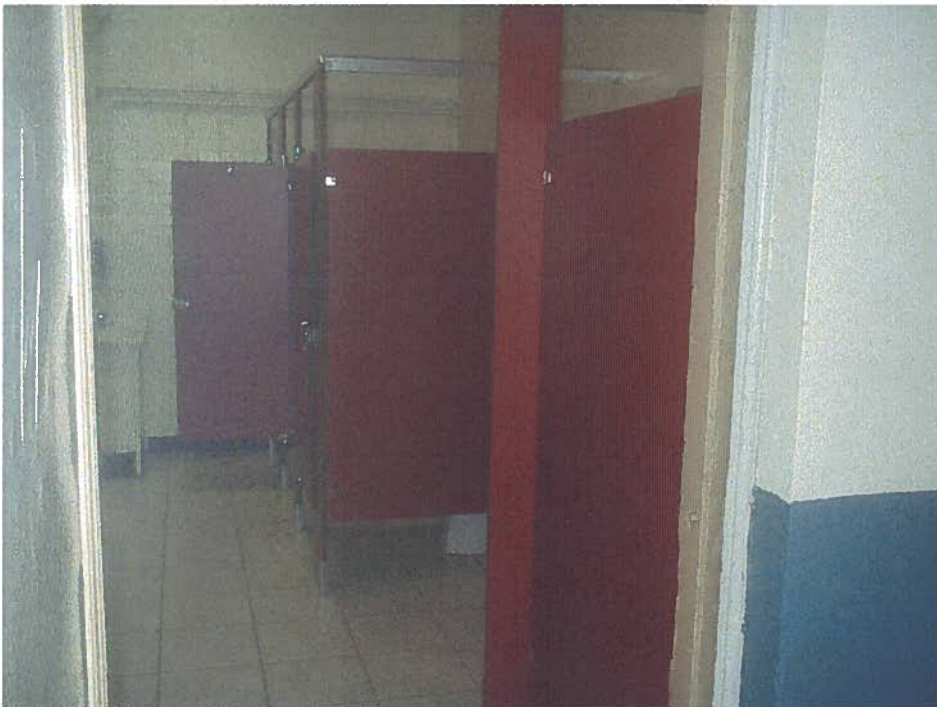
Basement boys' toilets, privacy issues from hallway.

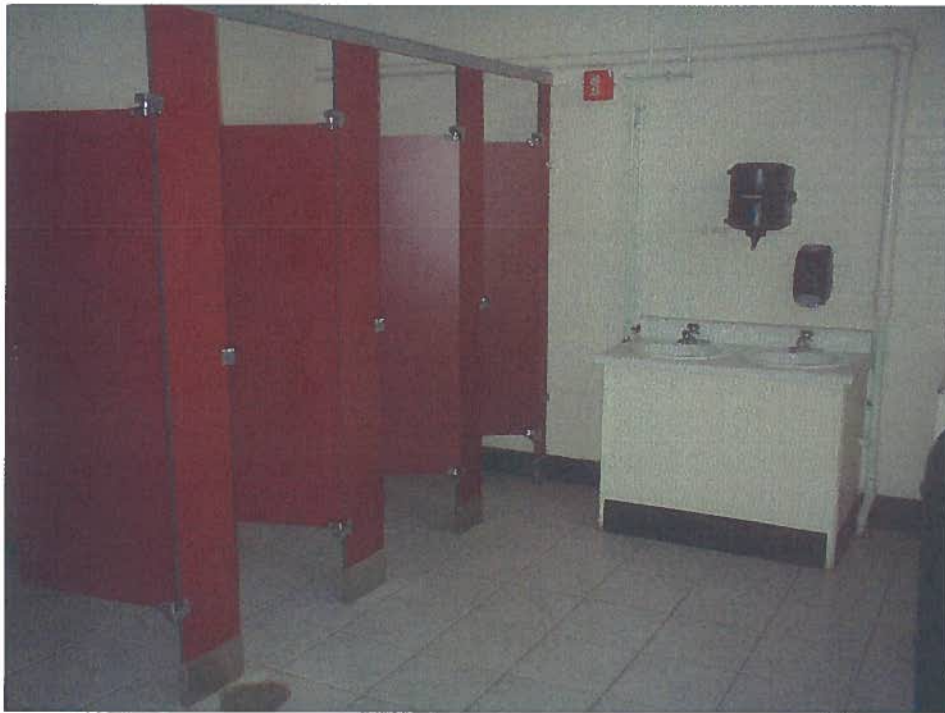
Girls' room lower level, non-accessible.

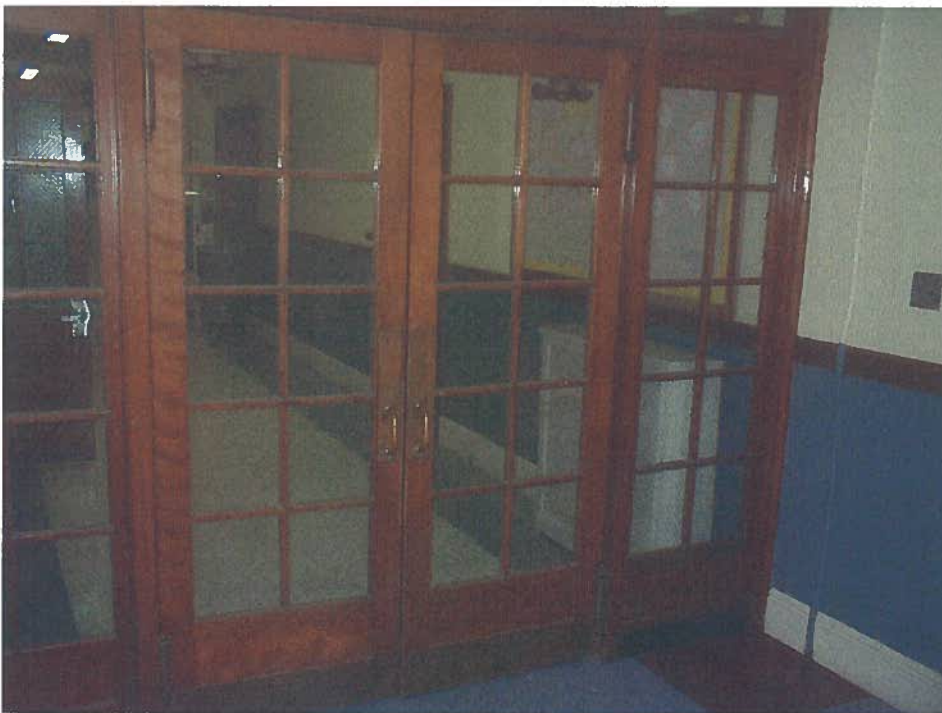
Double 2'-6" doors at stairs; double-acting hinges modified.

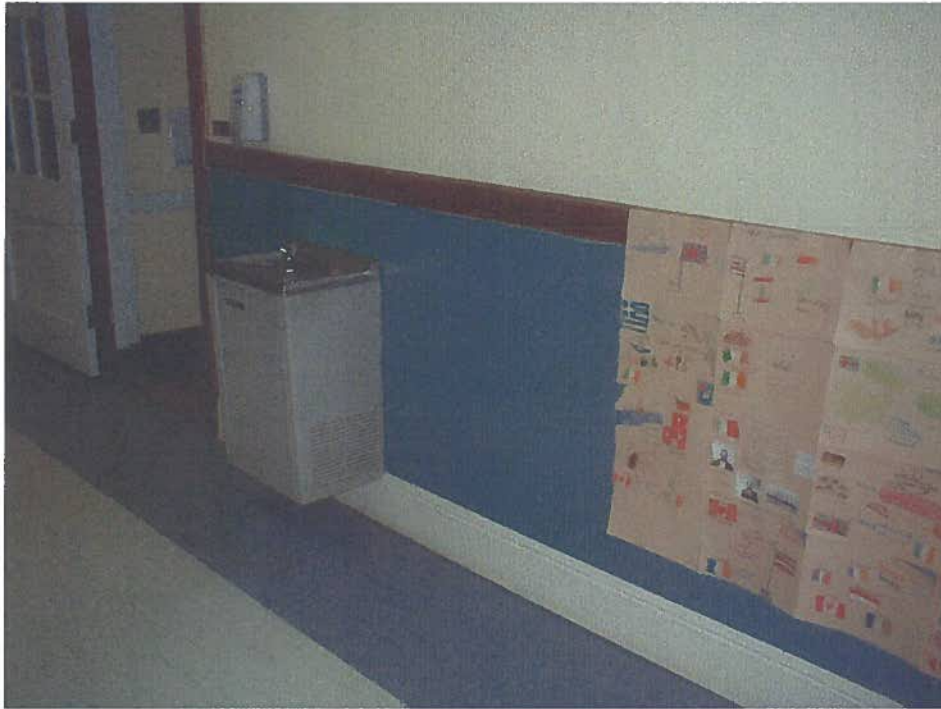
Non-accessible drinking fountain at main lobby.

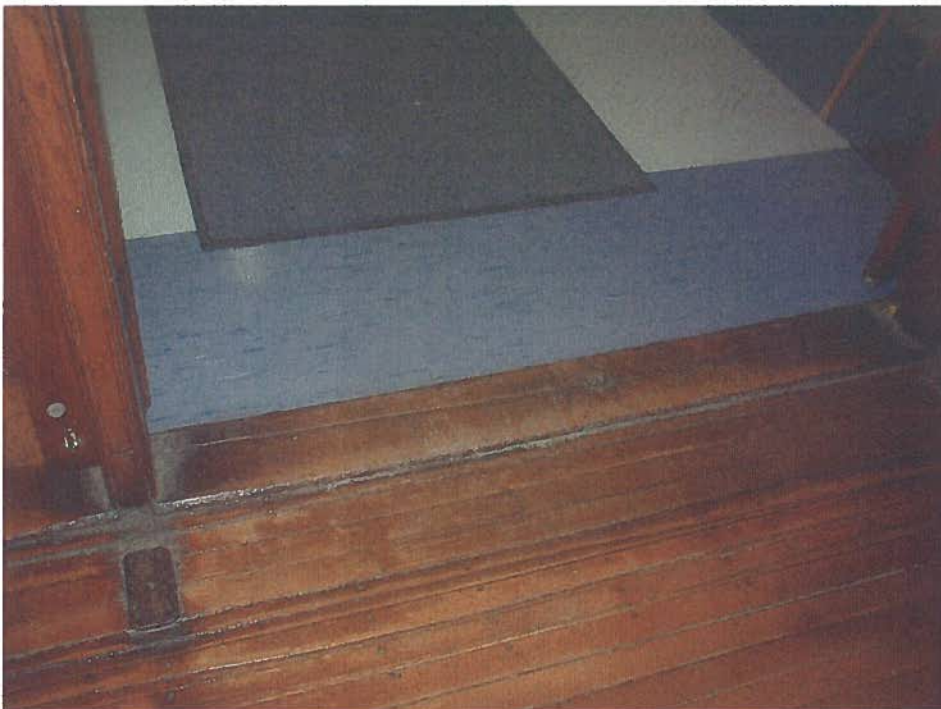
Threshold too high at gym entrance doors.

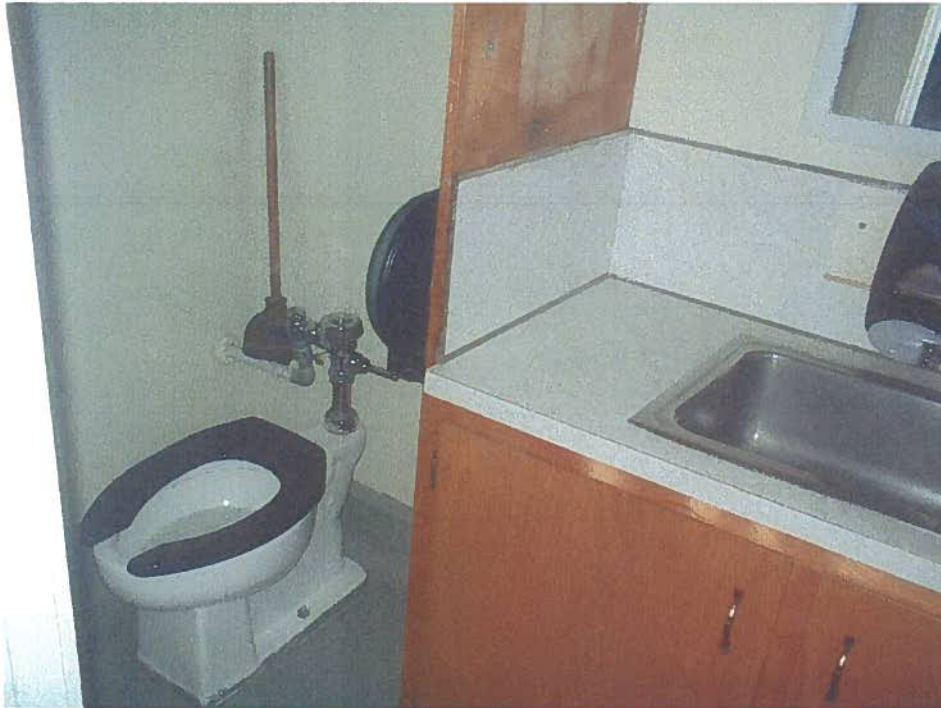
Non-accessible toilet in nurse's room. Non-accessible sink.

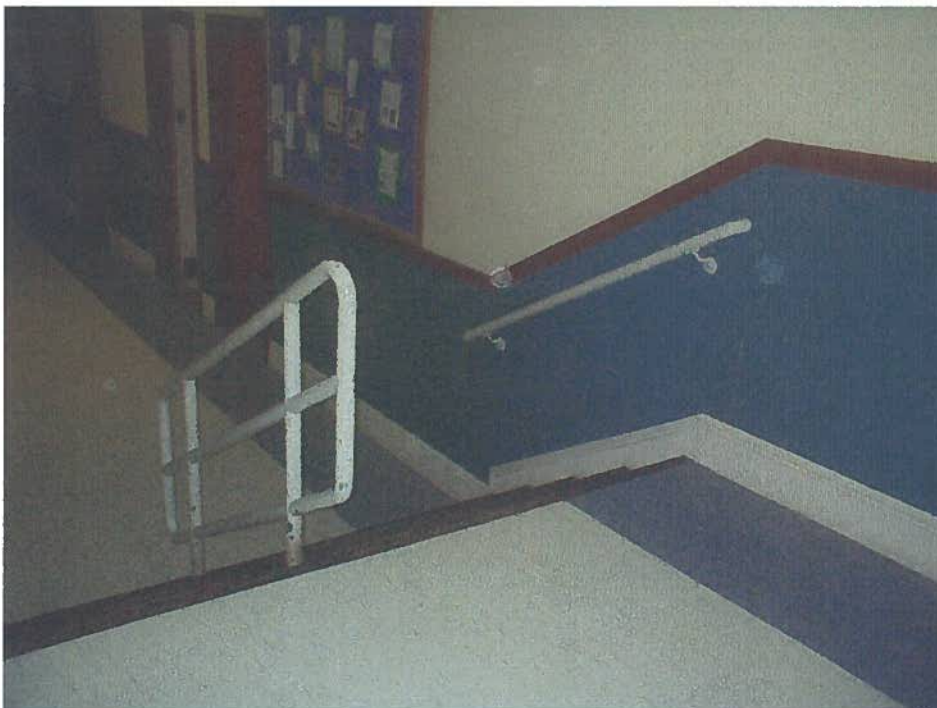
Steps in hallway with no lift. Center hand rail not per code; needs extensions.

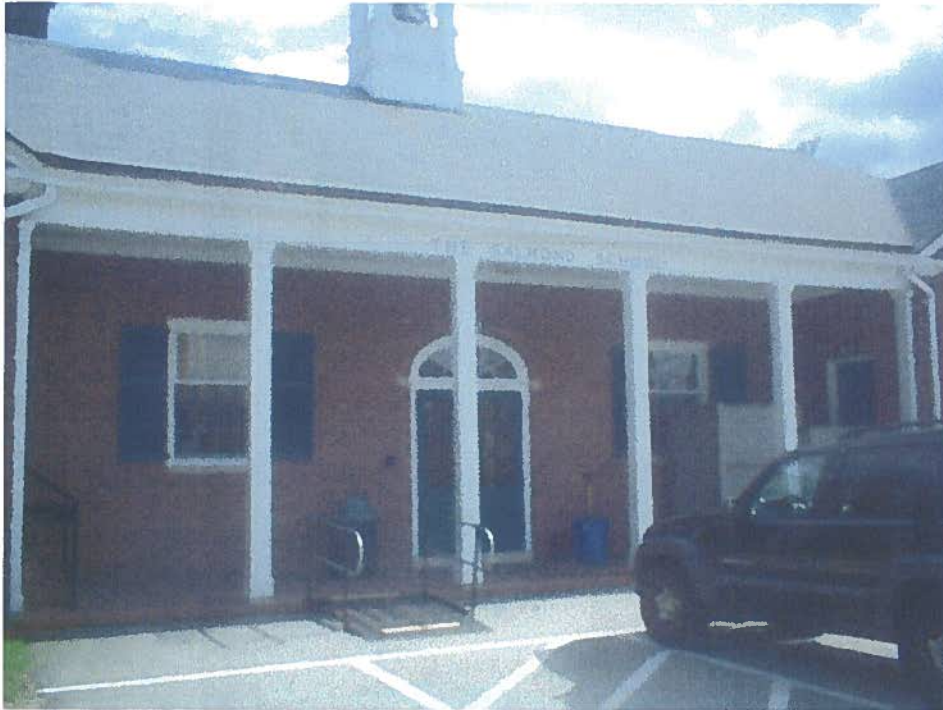
Exterior view of main entrance; non-accessible.

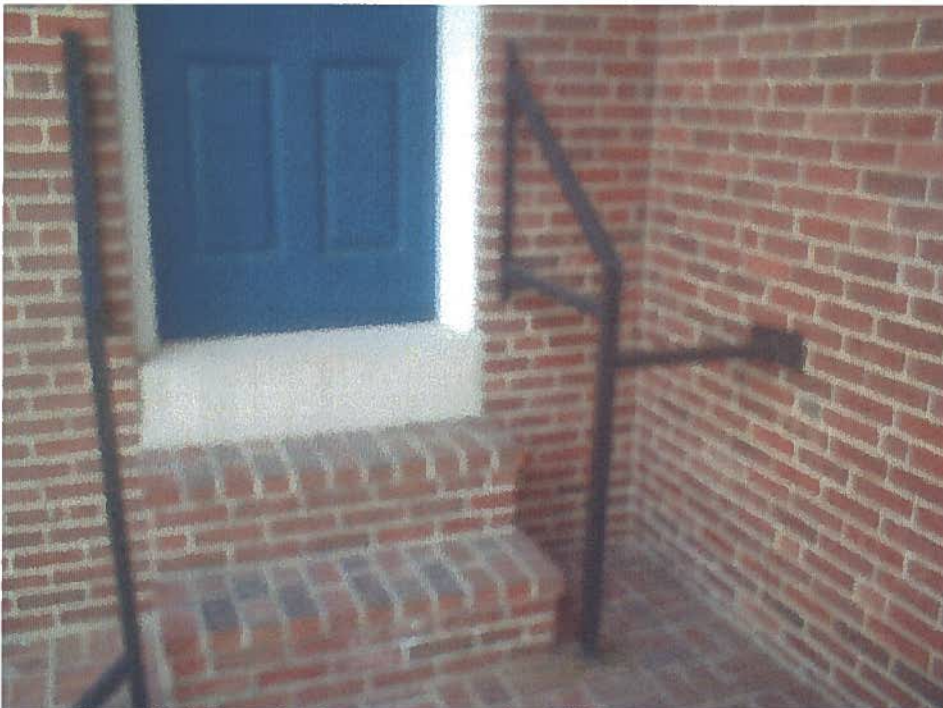
View of steps to side entrance; handrails do not comply with current codes.

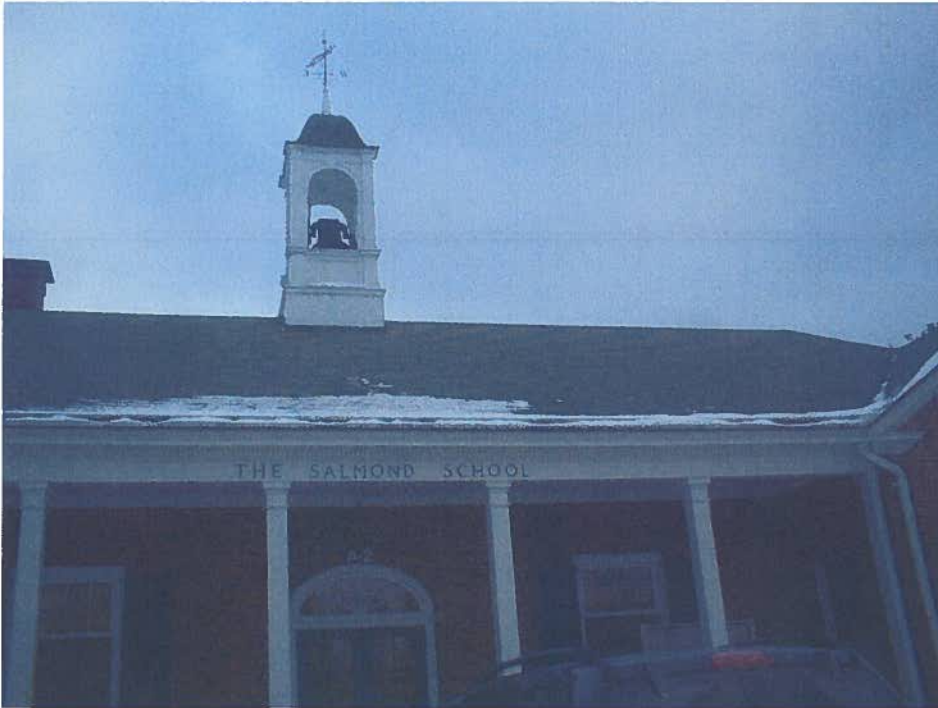
Exterior front roof:  
Asphalt shingles (probably was slate originally)

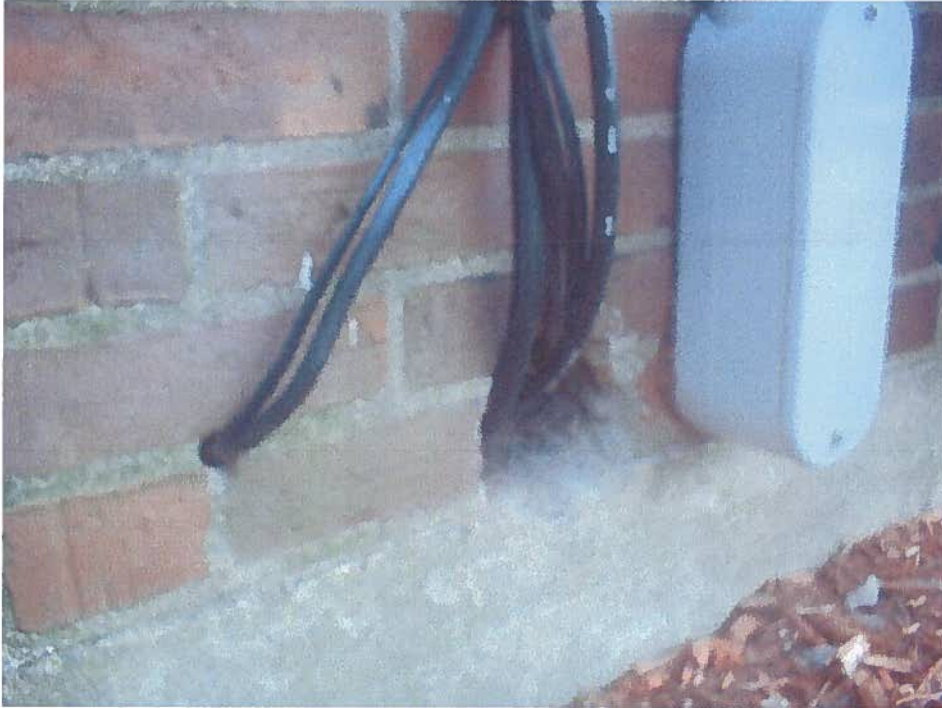
Detail view of wiring penetration into wall-unsealed openings.

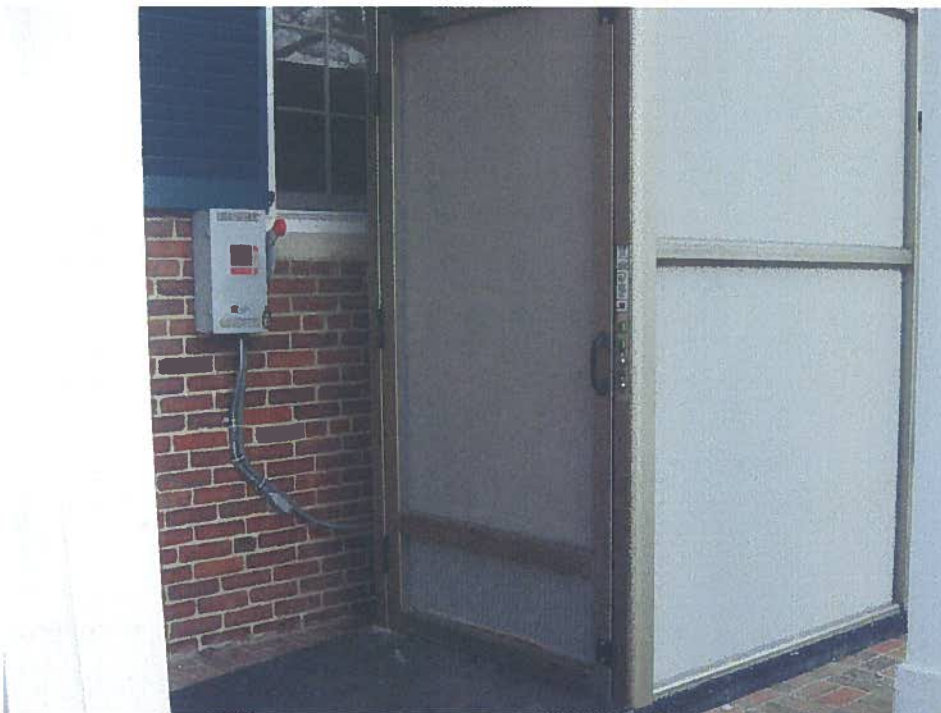
Handicapped access lift-outdoors.

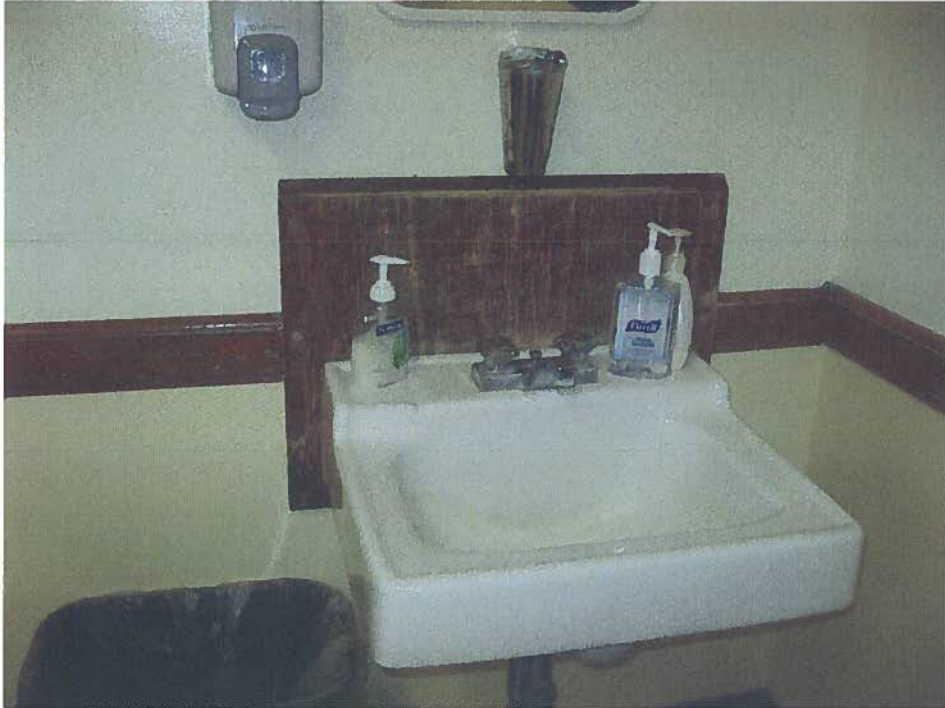
Sink with non-accessible controls.

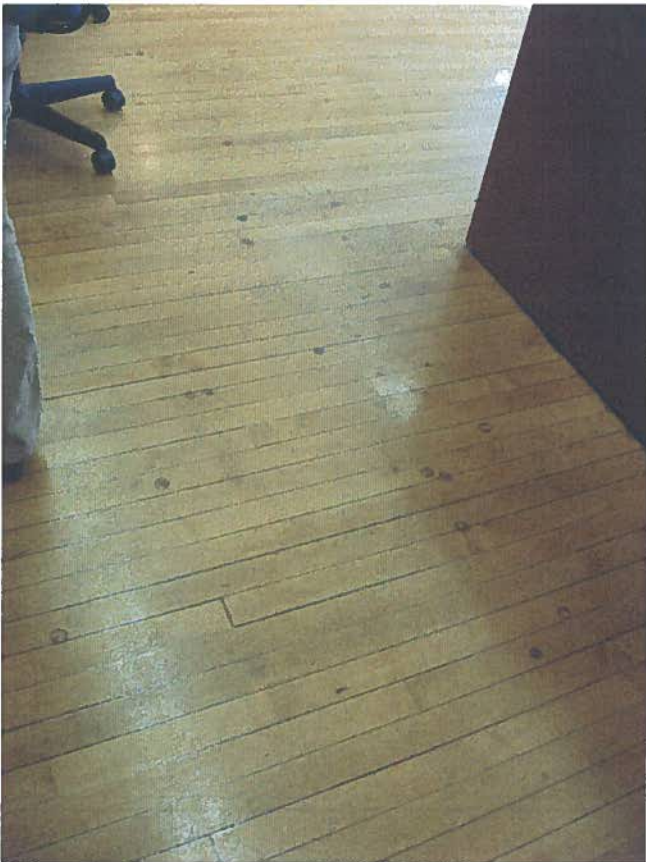
Damaged wood floor, needs repair.

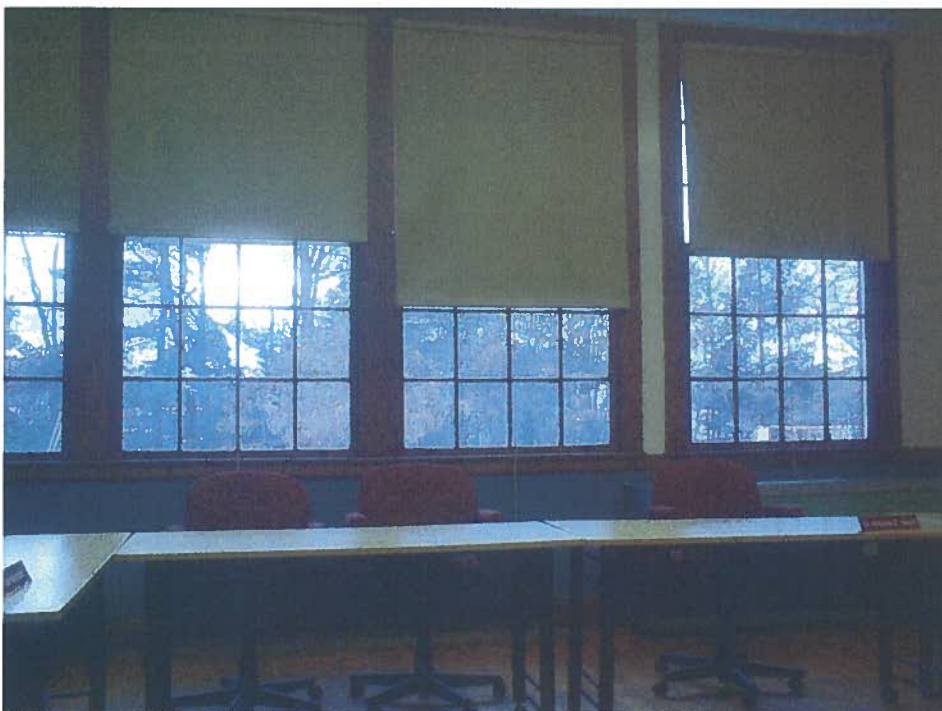
Windows in main meeting room.  
Screens at bottom sash only. No storm windows.

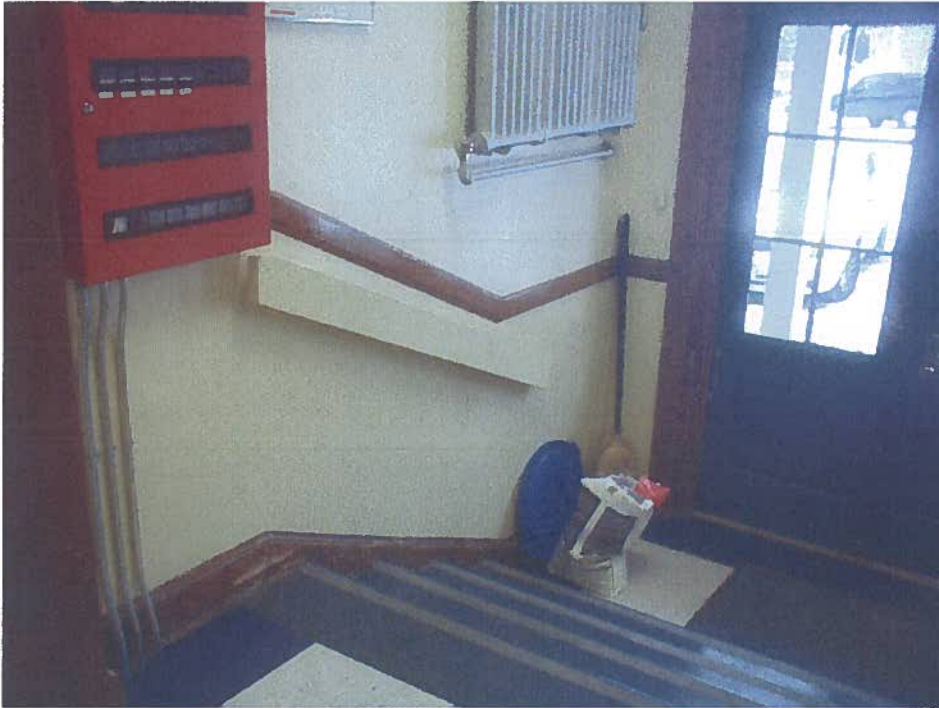
Main entry steps handrail non-accessible.

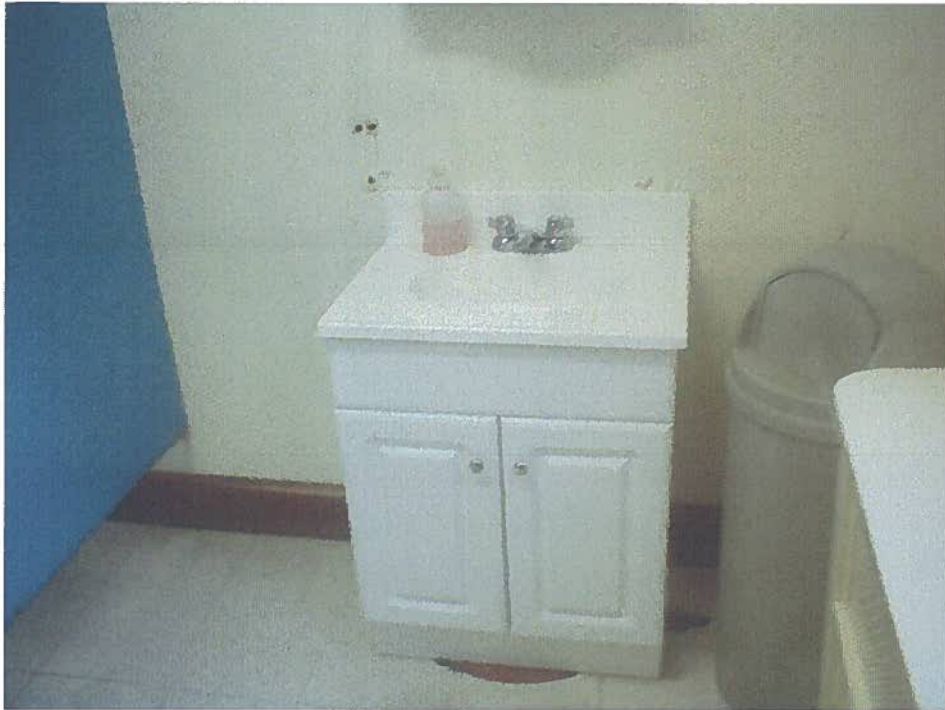
Non-accessible sink in main level toilet room

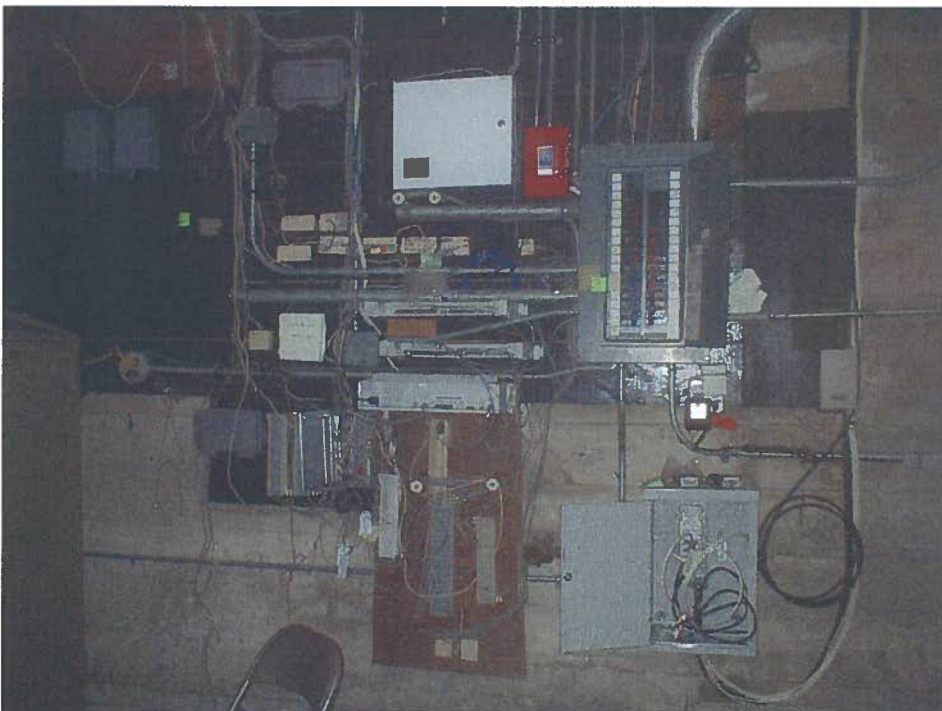
Electrical and tel/data wiring below front entrance
