**Municipal Facilities Assessment-2011  
Capital Improvement Committee  
Hanover, Massachusetts  
September 2011**

# Building Study

# **Town of Hanover - MUNICIPAL FACILITIES ASSESSMENT - 2011**

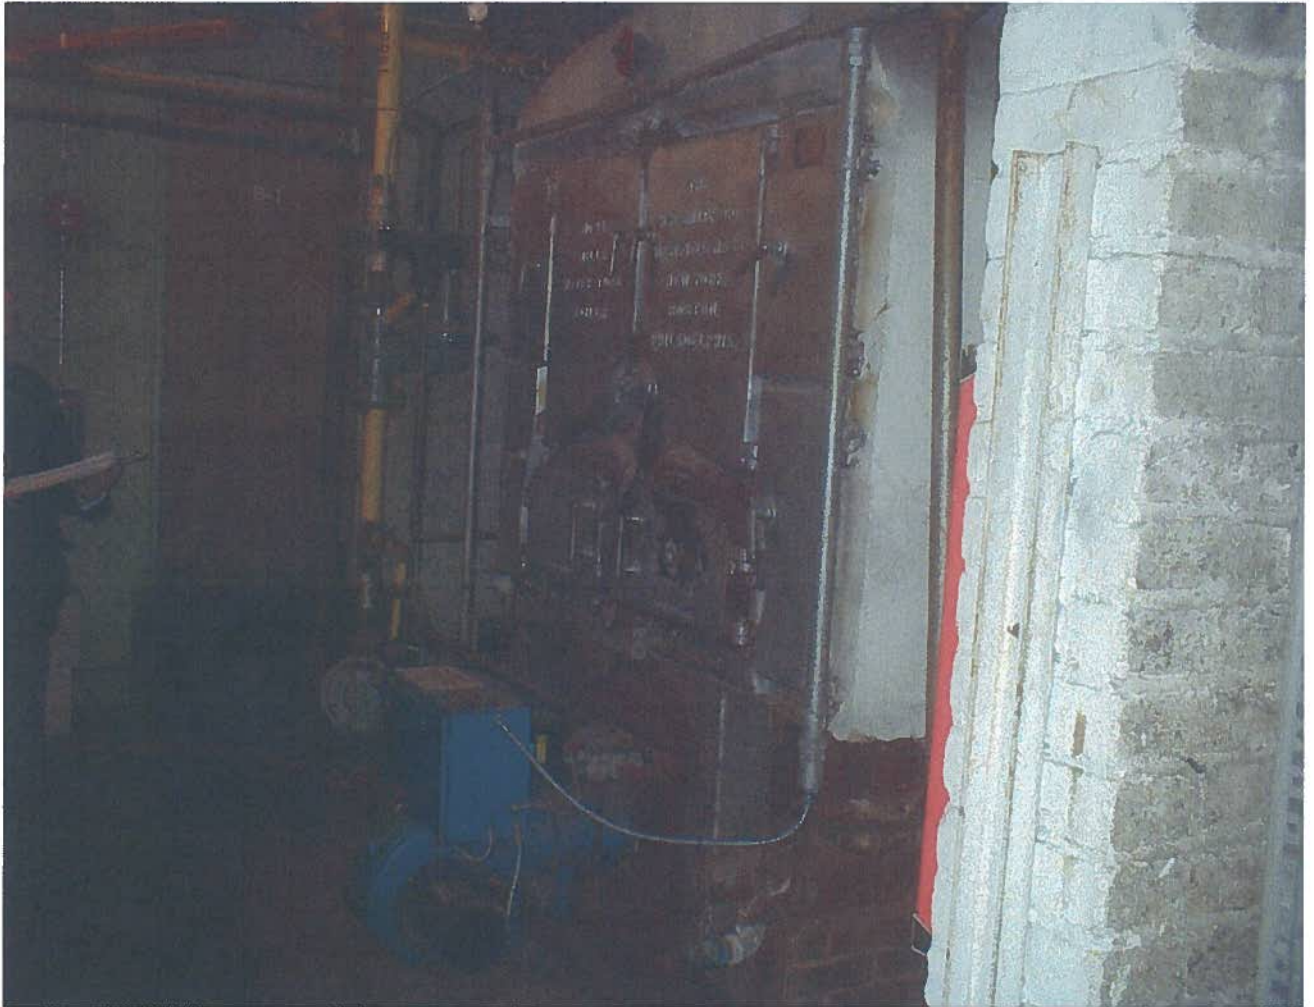
Boiler recently replaced in 2011. This photo shows the older boiler in place at the time the fieldwork for this study was done.

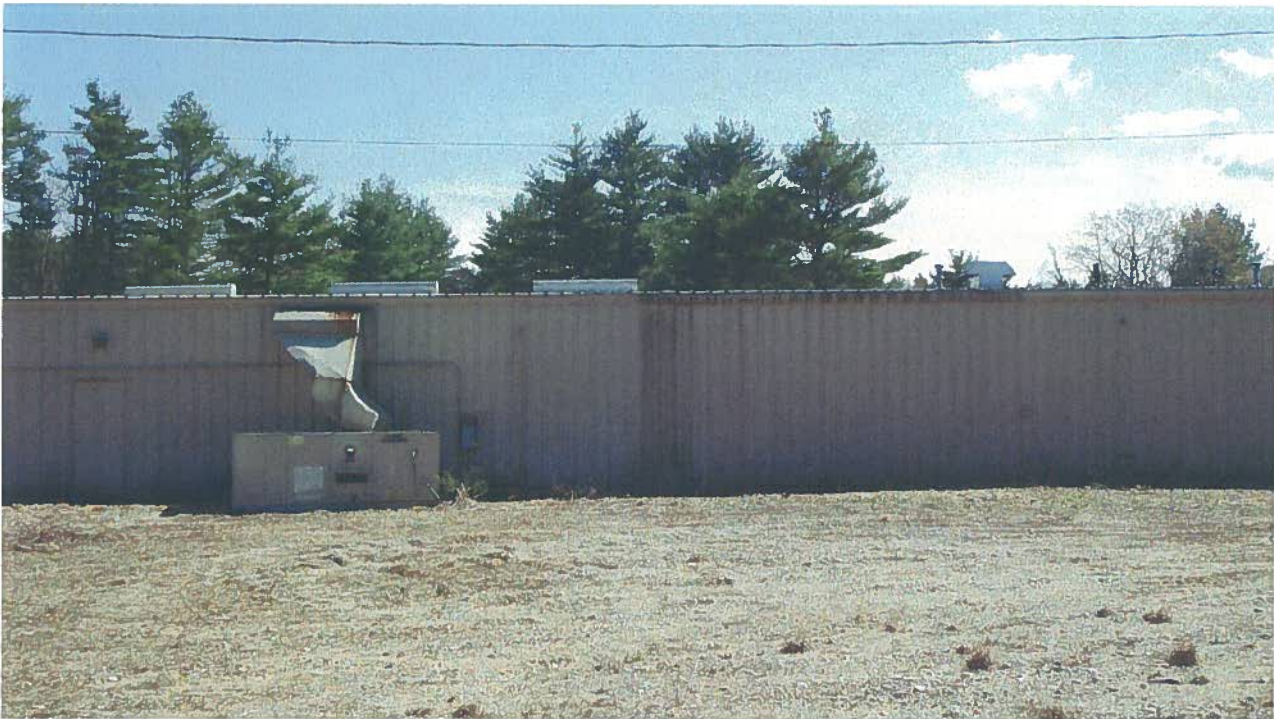
Exterior view of back facade along north side; mechanical equipment pulled away from building.

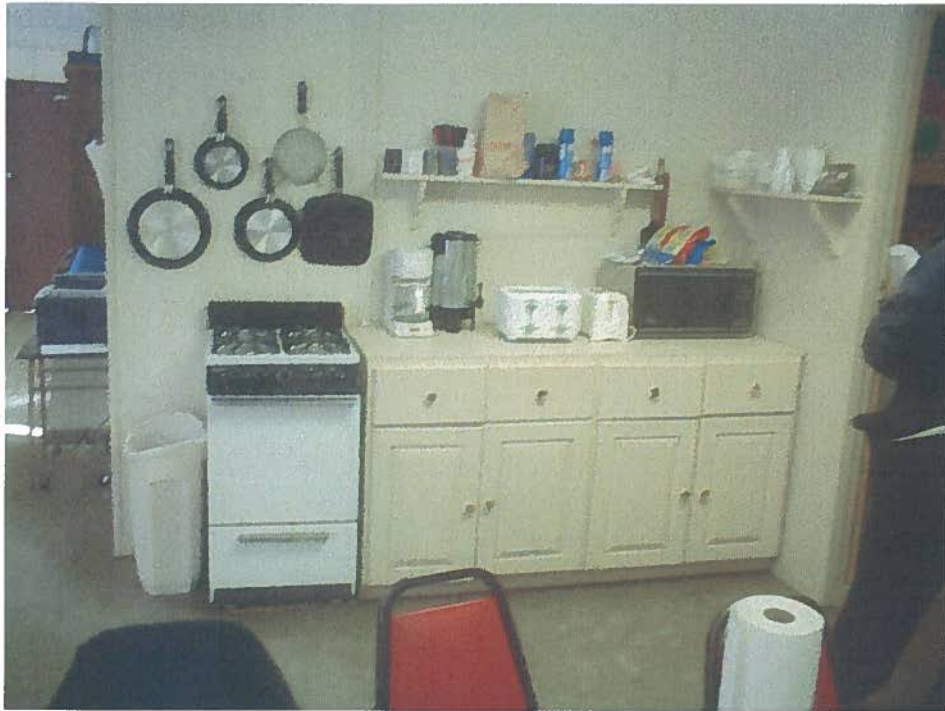
Kitchenette at lunch room; non-accessible sink and stove

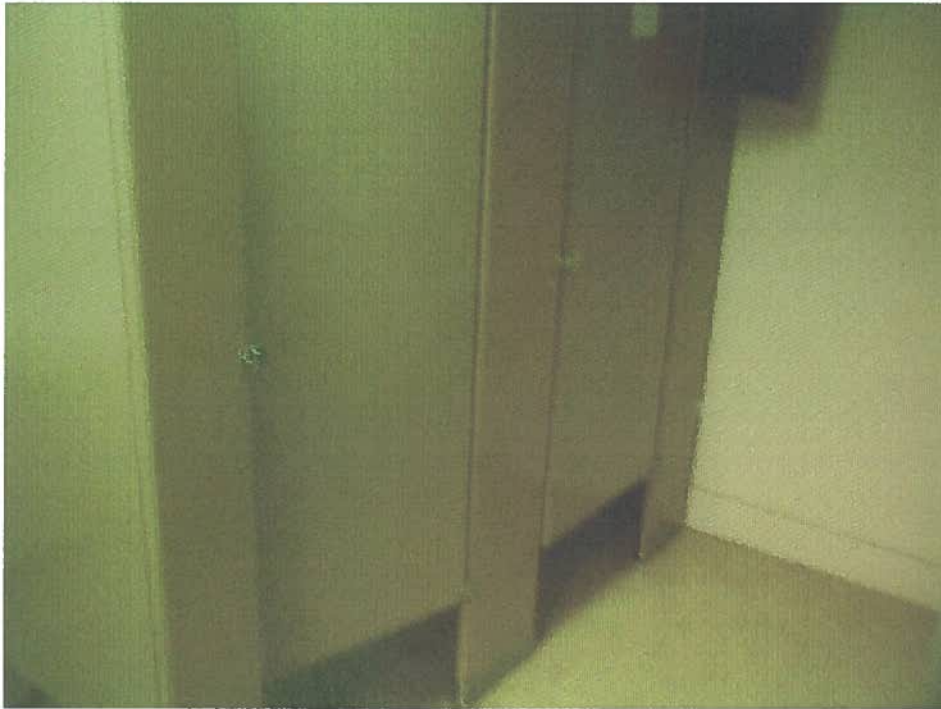
Women's toilet room; non-accessible. There are no women on staff.

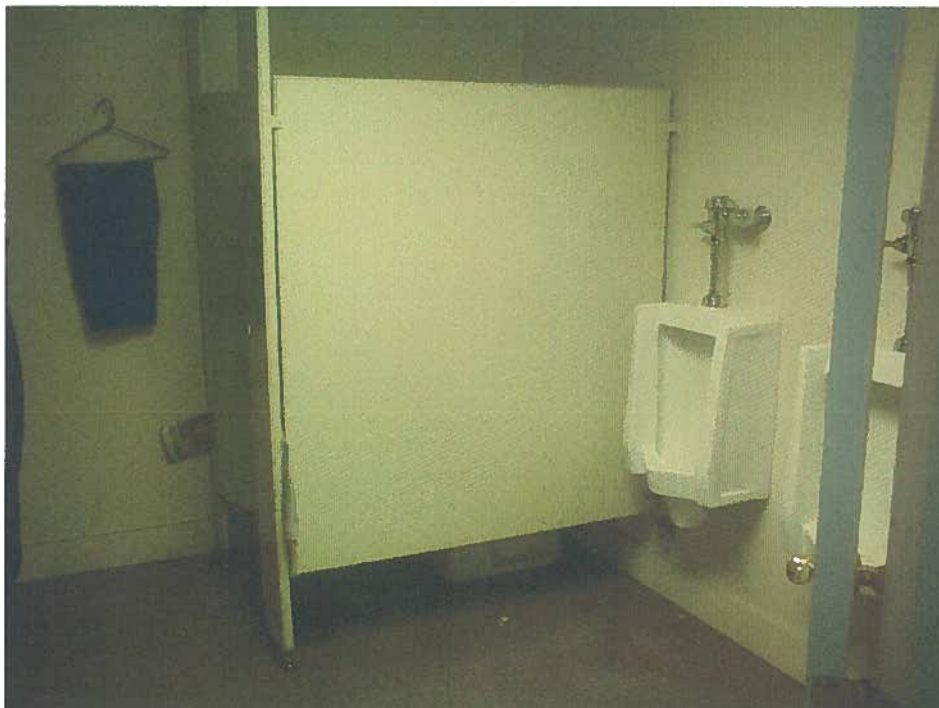
Men's toilet; non-accessible. Lockers are in this space also.

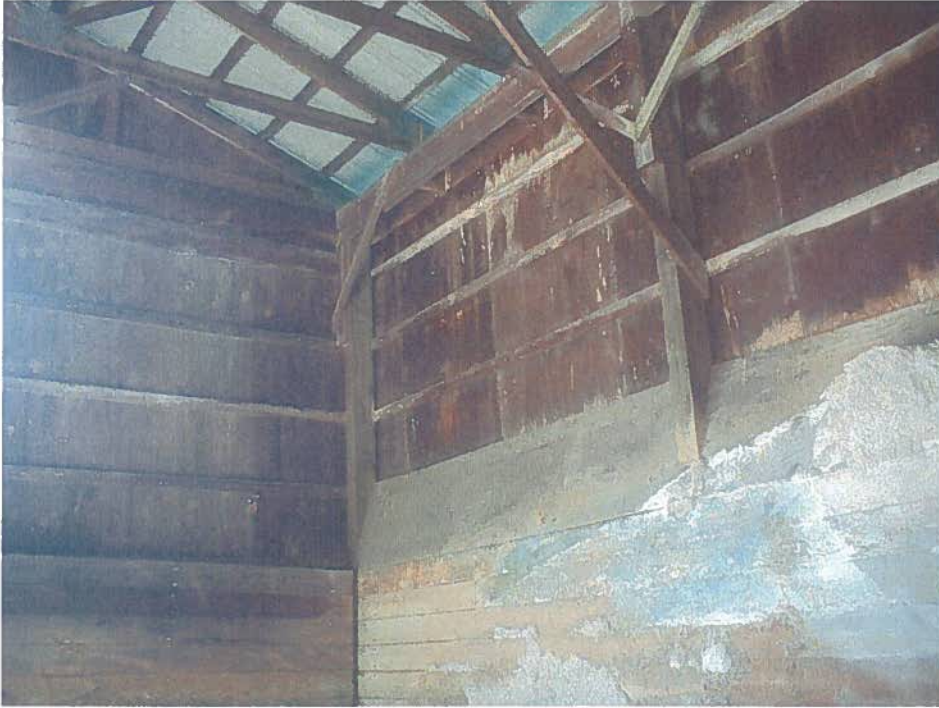
- Structural: Wood framed, 'pole barn' construction. Framing members are bowed and in a state of failure, and have been braced in an ad-hoc manner.
- This structure is an unprotected wood frame, use group Storage, Low-Hazard, Group S-2, and building type V-B.
- No known pre-existing code violations or safety citations by the local building inspector were reported

DPW salt shed, interior of west wall.

- Demolish; replace with new.

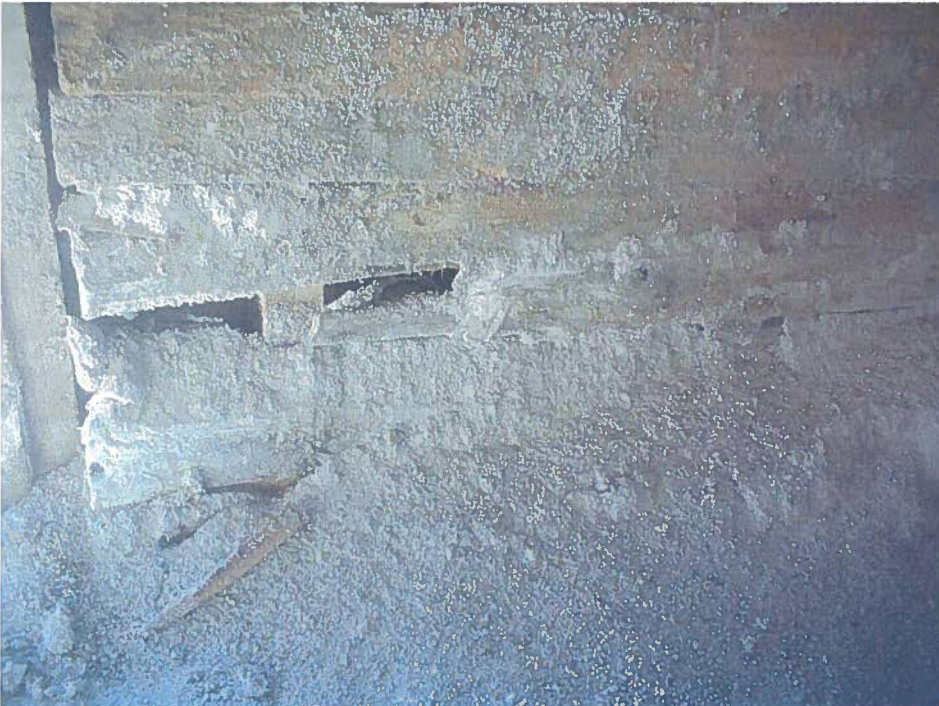
Damage near door-salt shed.

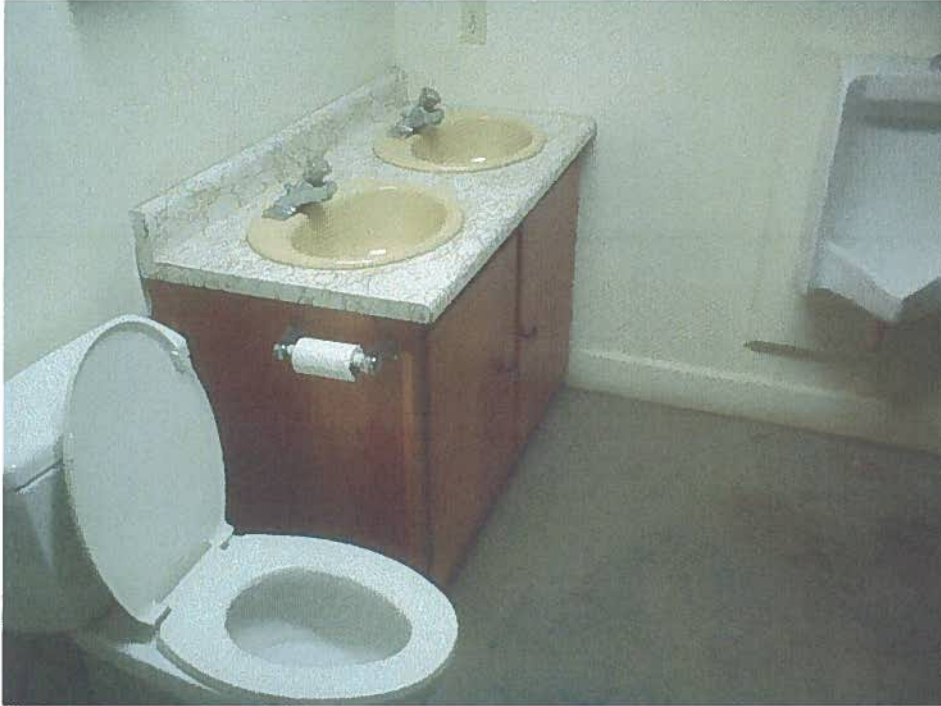
- The Highway Garage is the only occupied building. It is entirely non-accessible. Although it is not a public building, the existing condition exposes the Town of Hanover to potential complaints from employees, or potential employees, who might feel that the non-accessible conditions are essentially discriminatory against them, if they have special needs and are prevented from performing essential work functions.

Non-accessible men's toilet room-Highway Garage.

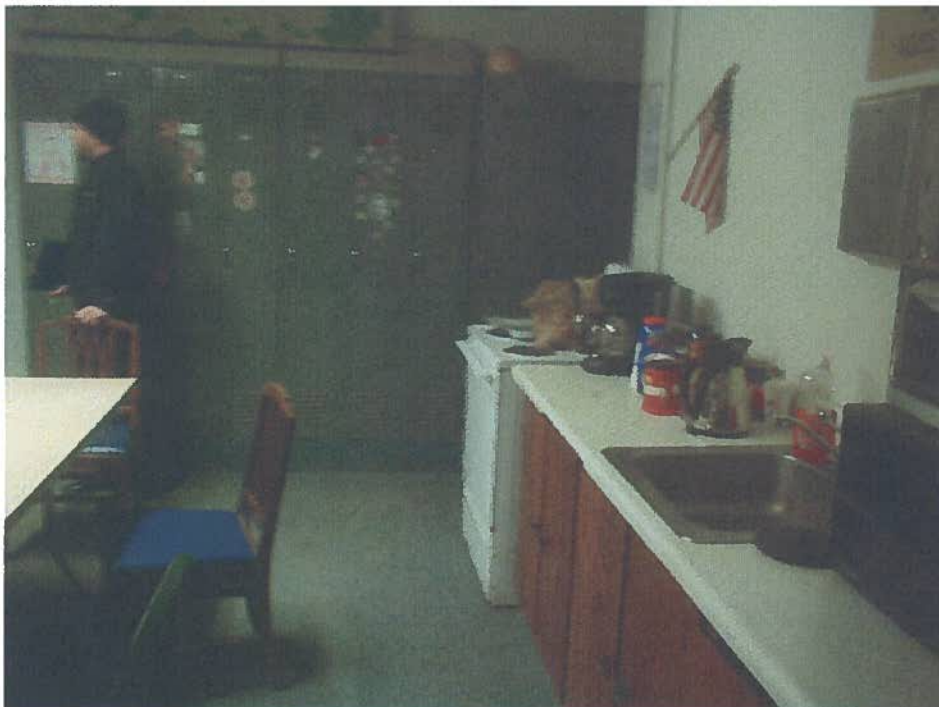
Non-accessible sink at lunchroom locker room-Highway Garage.

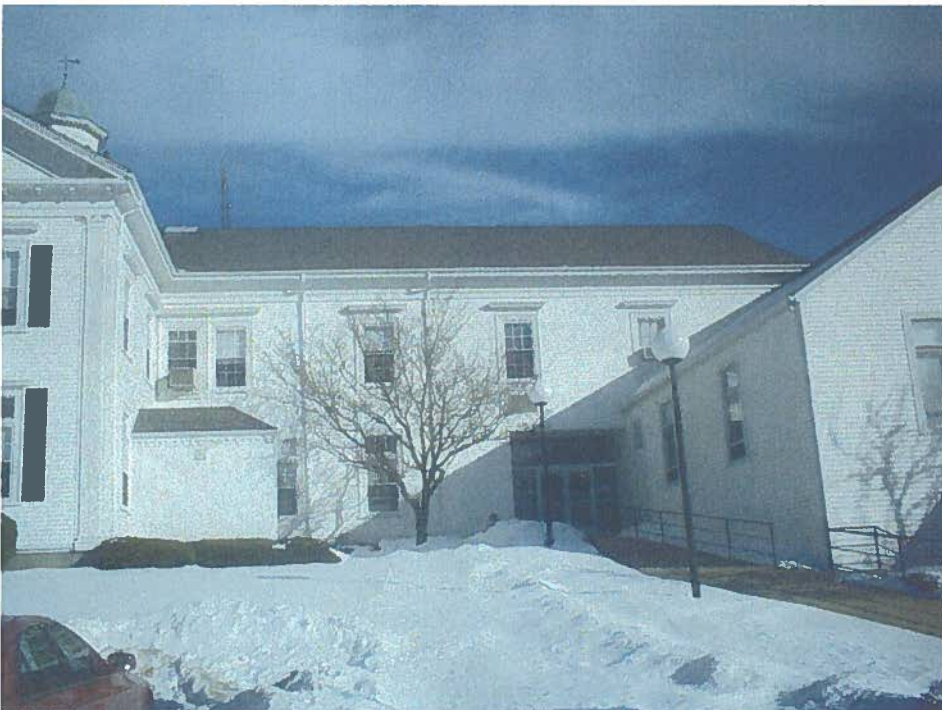
View of side entrance at west facade; ramp is too steep for disabled access.

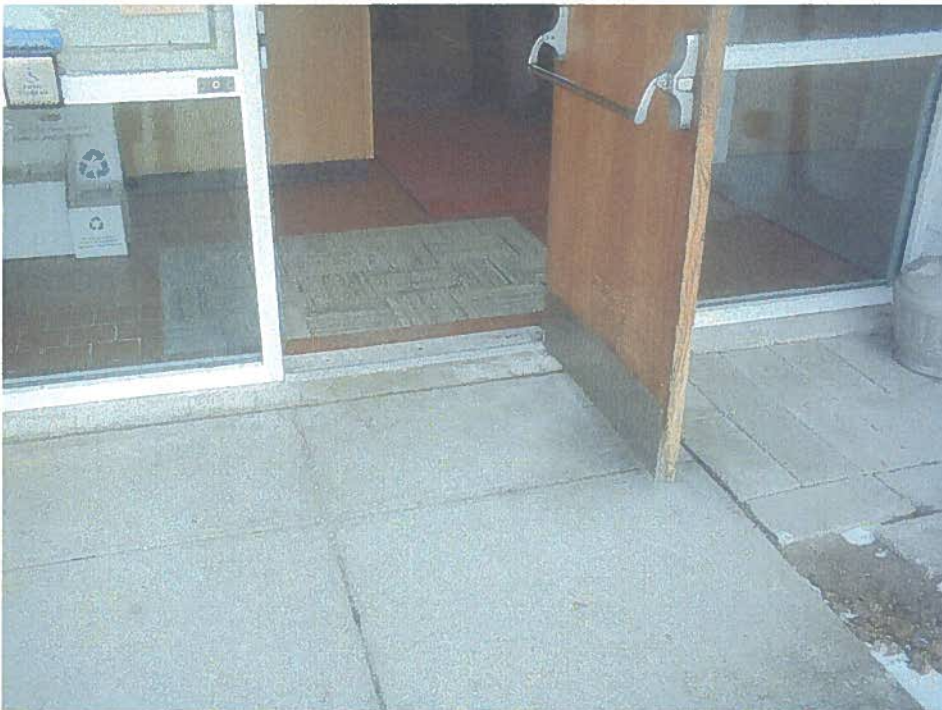
Non-compliant entrance at lower level.

Public entrance has issues; threshold too high, pavement has deep grooves and is not level.

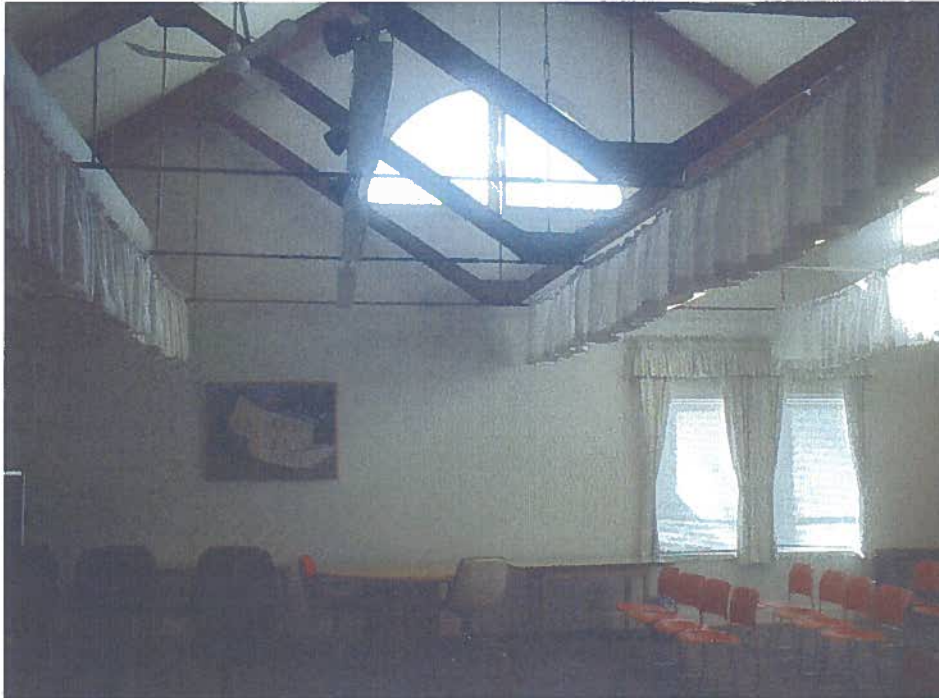
Hearing room, acoustical issues (echoes and fan noise)

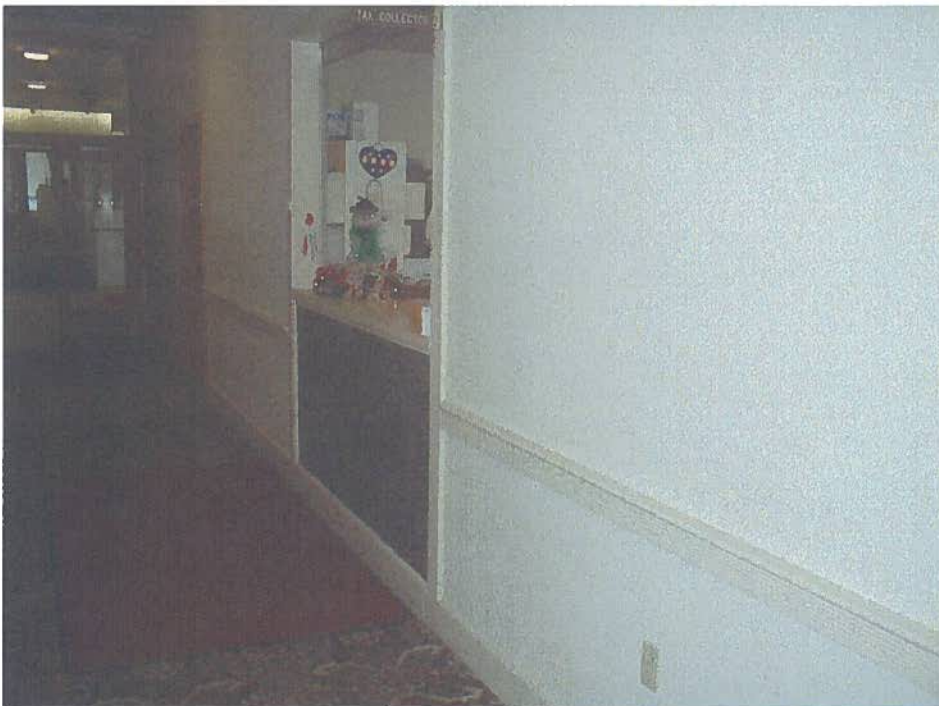
Service counter at Tax Department; non-accessible, too high, no knee space. Others are similar.

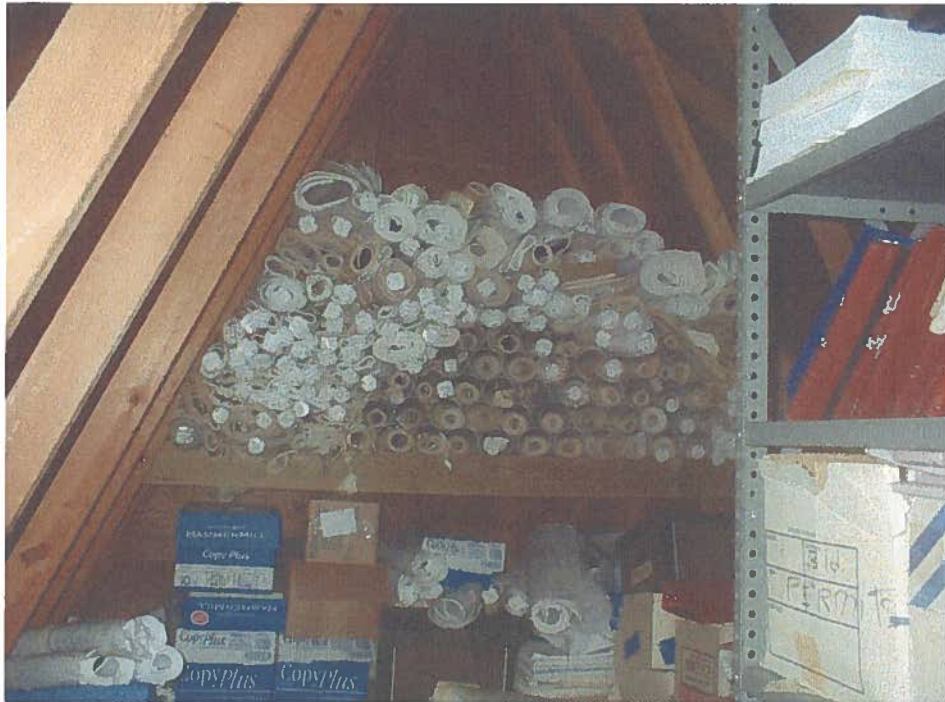
Plans storage in attic space; 2nd floor.  
Overloaded roof trusses.

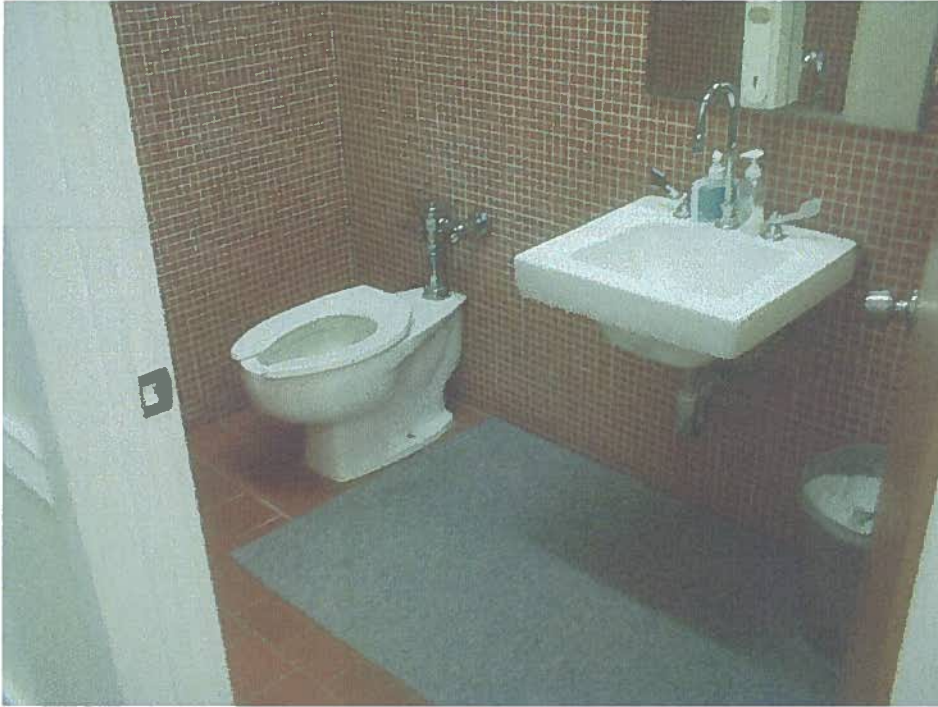
Non-accessible toilet at VNA office area.

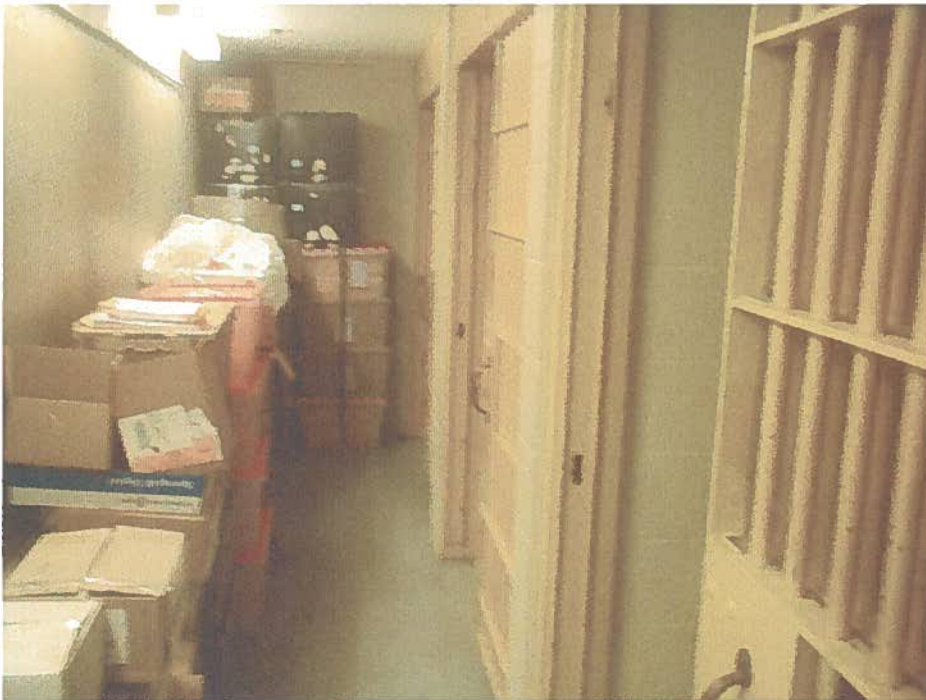
Cells at lower level (former police station; now storage).  
Locks need to be deactivated; location of key unknown.

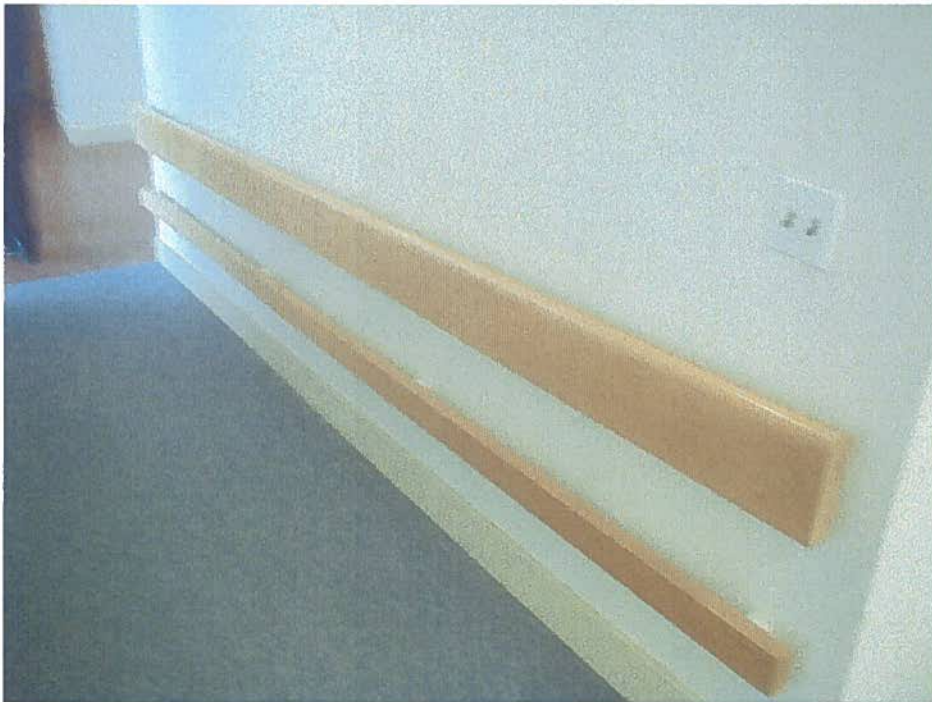
Non-compliant handrail at ramp; no handrail on opposite wall.

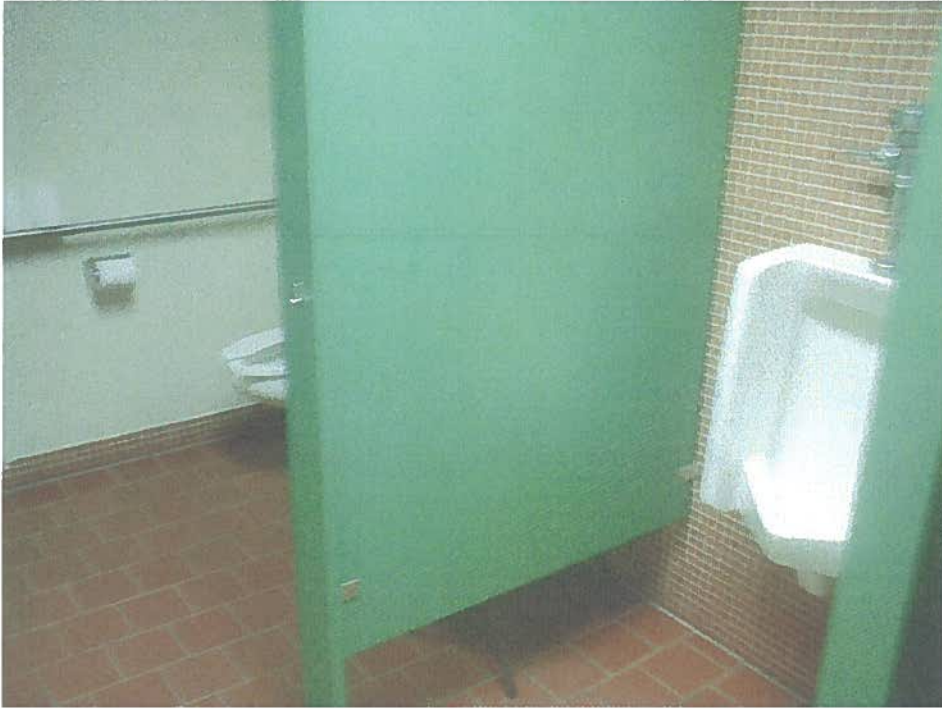
Men's room near Town Manager's office. Urinal mounted too high.

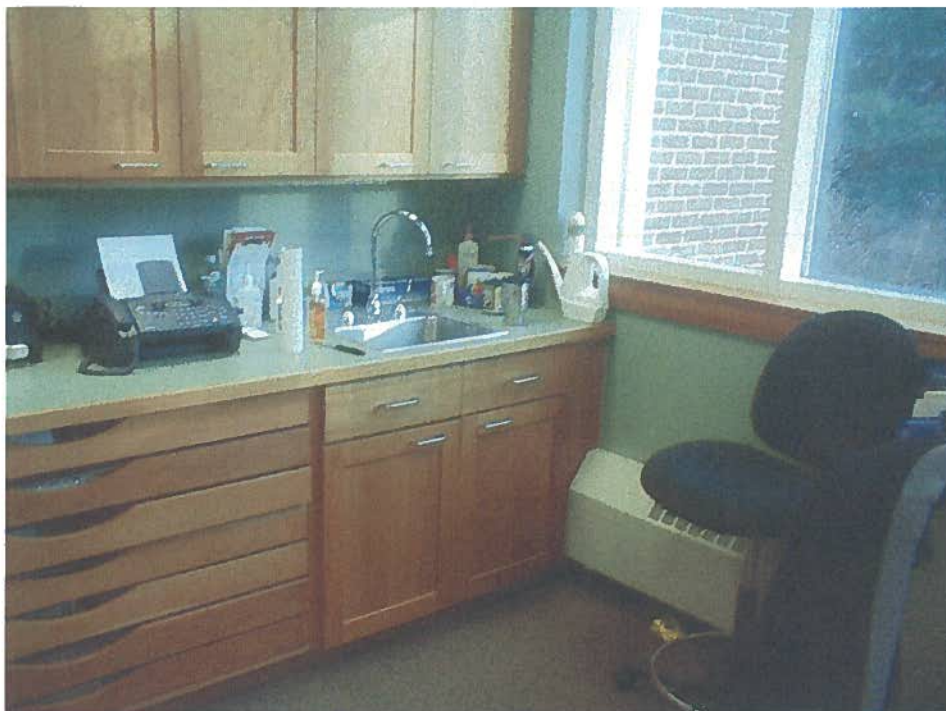
Office with non-accessible sink.

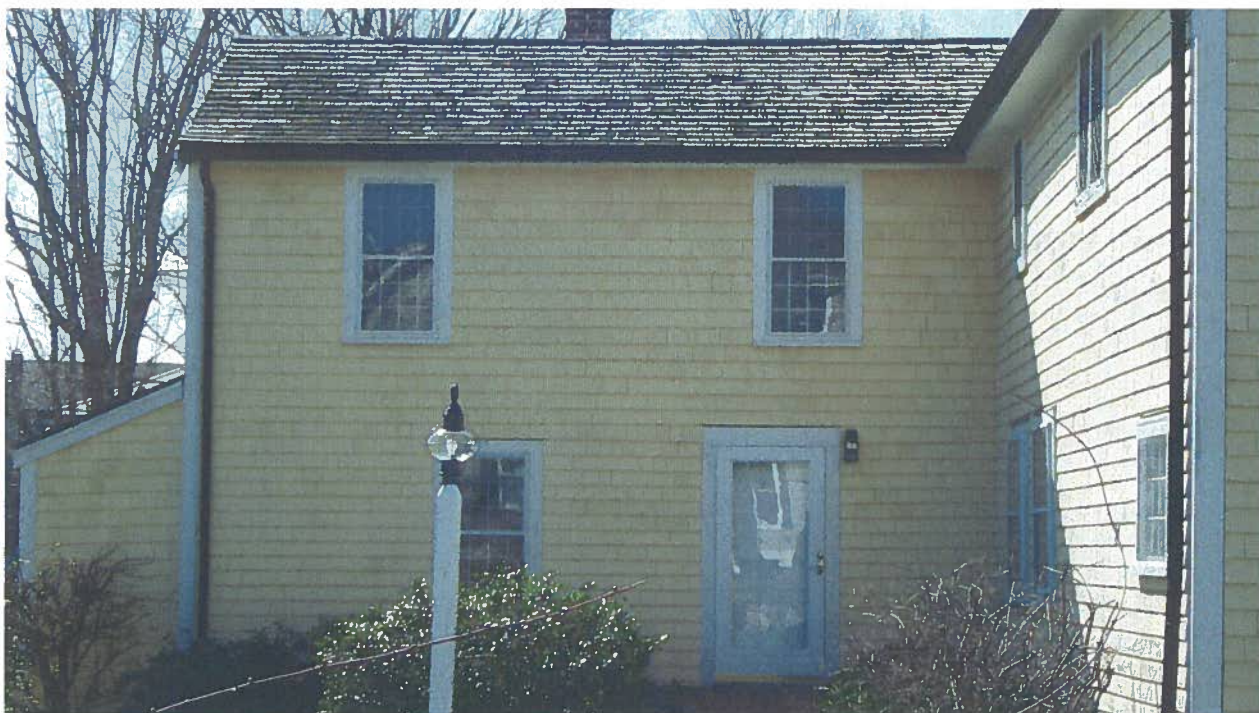
Detailed view of side entrance on east facade; this is the main visitor entrance and it is non-accessible.

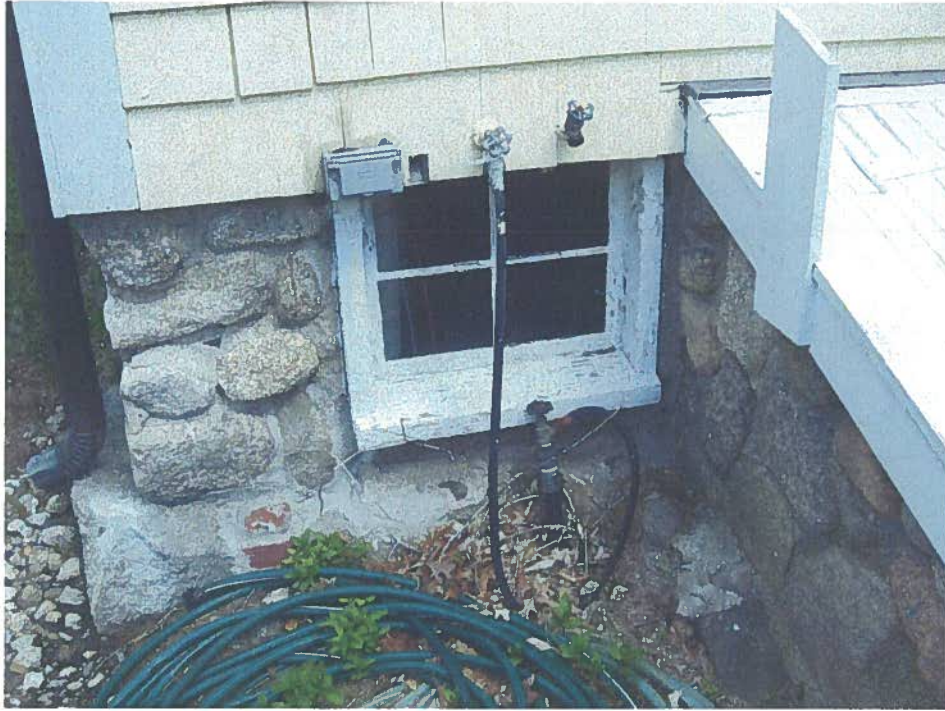
Detailed view of foundation, near bulkhead.

- Repair stairs to basement under rear 'el'. (Unstable support.)
- Repair outside bulkhead door to rear 'el' basement, and seal holes in foundation (heat loss and security issue).
- Building needs to have an advance warning / detection perimeter security alarm system, that illuminates the grounds and broadcasts an audible warning, upon after-hours intrusion onto the site.
- General building security system upgrades.
- Study, using Historic Preservation standards, of heating and humidity control in the historic portion of the building.
- Remove type 'BX' electrical cable from the crawl space of the building, and replace with 'romex' of the appropriate type.

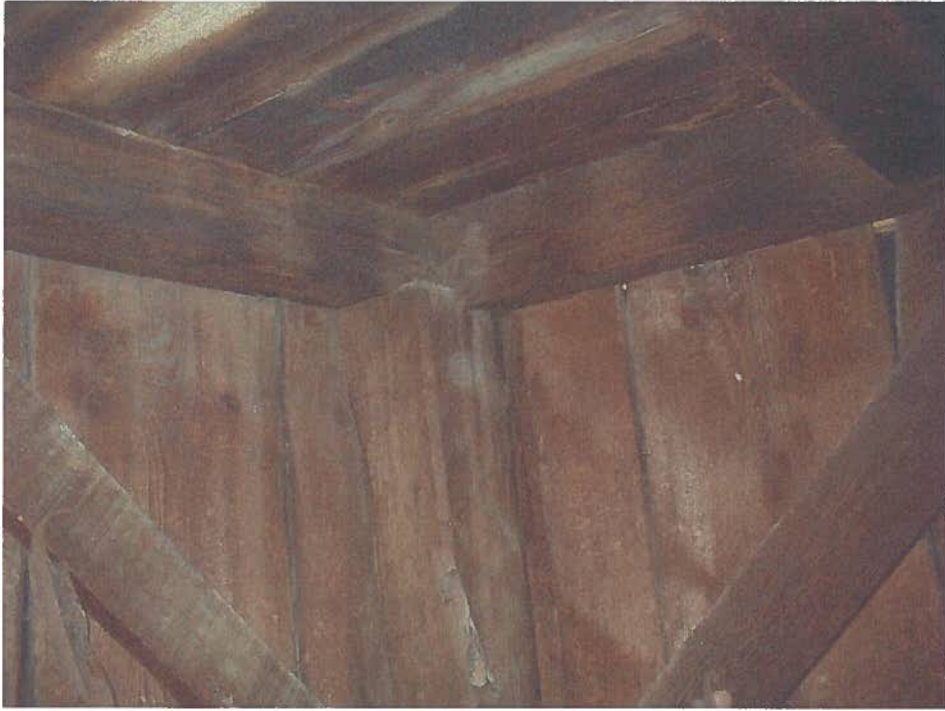
Detail view of framing.

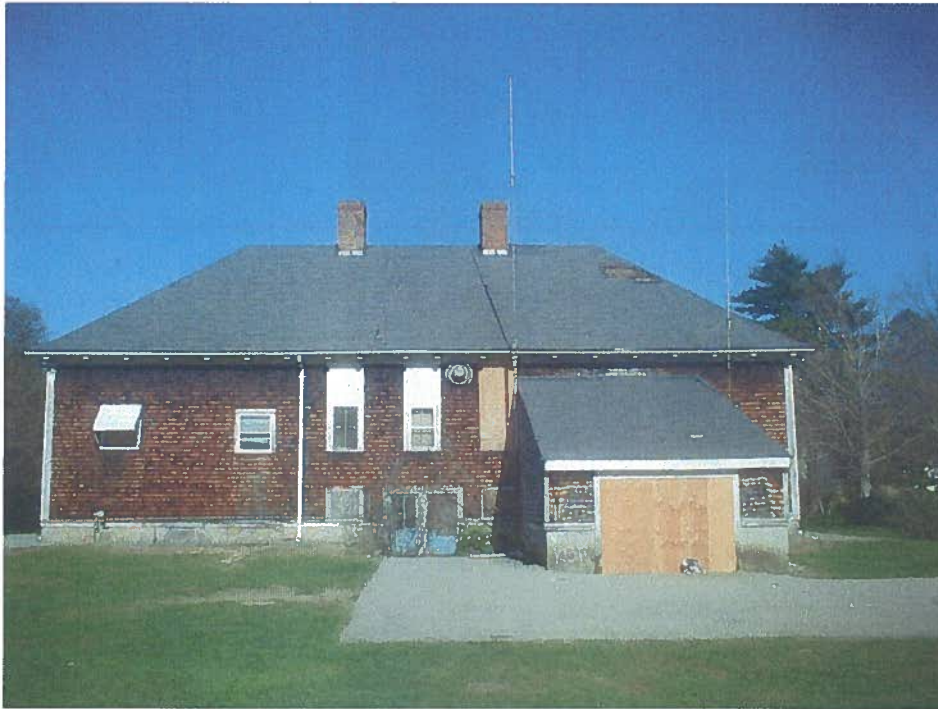
- Existing exterior cedar shingle siding on the rear of the building is in poor condition. Cracked and weathered.
- Windows are broken and some boarded, in poor condition.

Exterior view of back facade.

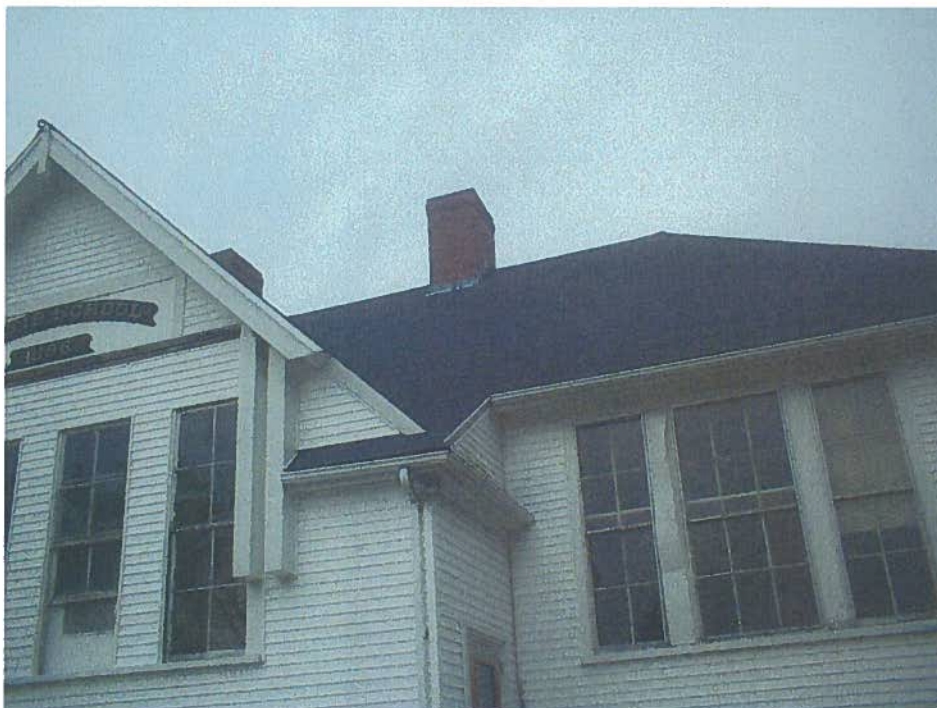
The building is in very poor condition overall, and is in danger of deteriorating to a point where re-use would become infeasible. There are observed areas of worn and missing roof shingles, where water is getting into the building. There are broken windows and deteriorated doors. Woodwork is deteriorating at several areas due to moisture.

Exterior detail view of roof condition.

- Repairs to roof, walls, doors and windows. Temporary repairs to stabilize the structure and halt infiltration of water and pests.
- Installation of a temporary ventilation system, to prevent further mold and help stabilize the structure.

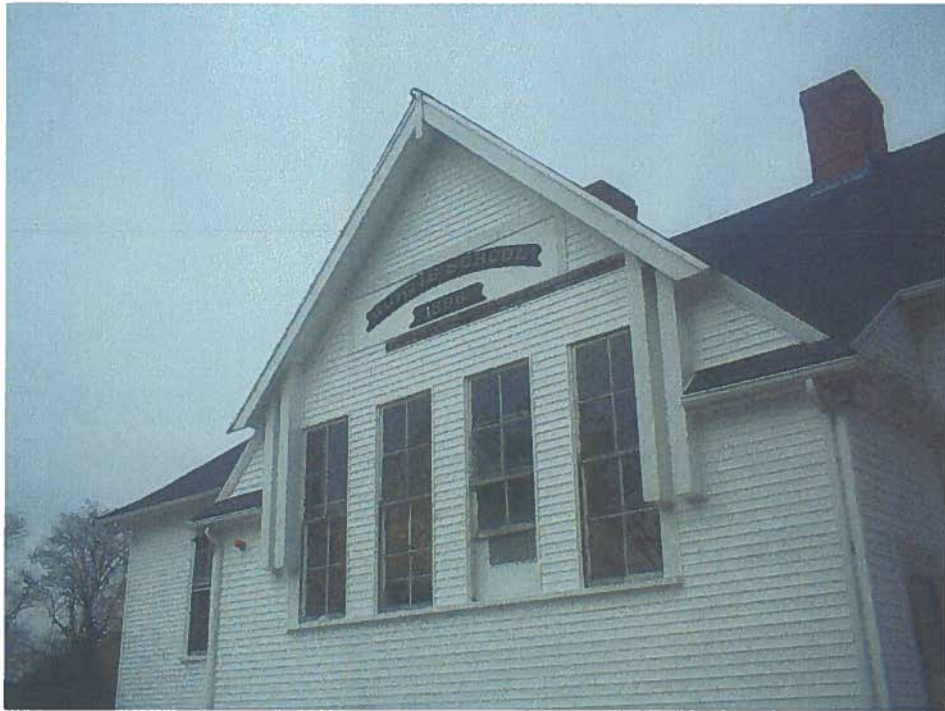
Exterior, detailed view of front windows.

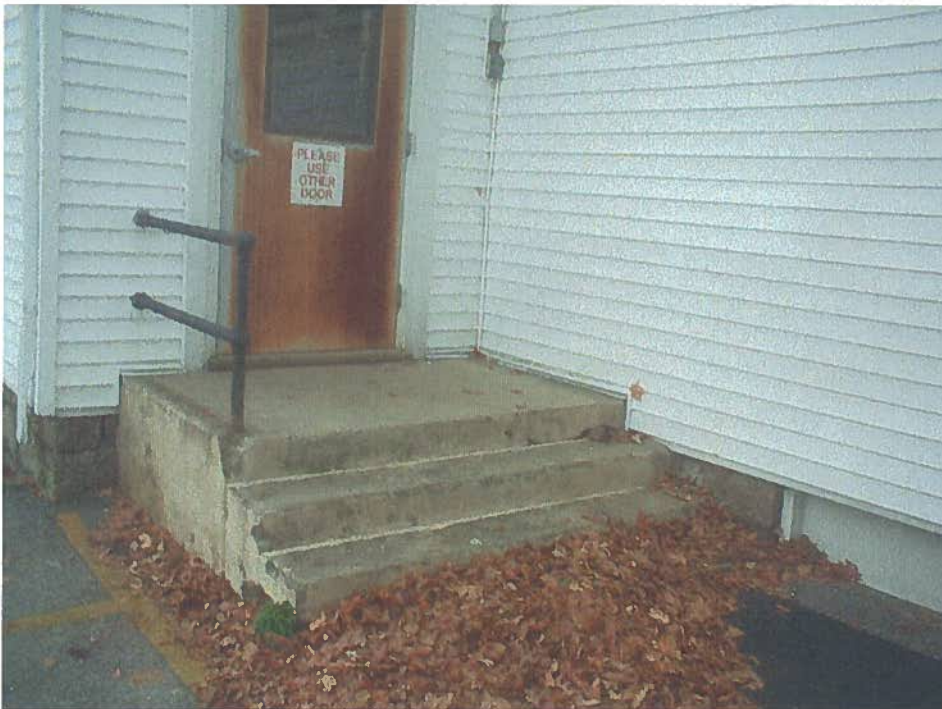
- All foundation stones on south side need repointing.
- Concrete Steps on right side entry are deteriorated.
- Mildew at roof edge.
- Rear garage addition not in keeping with rest of building.

Exterior, detailed view of stairs. Non-accessible, no guardrails/handrails.

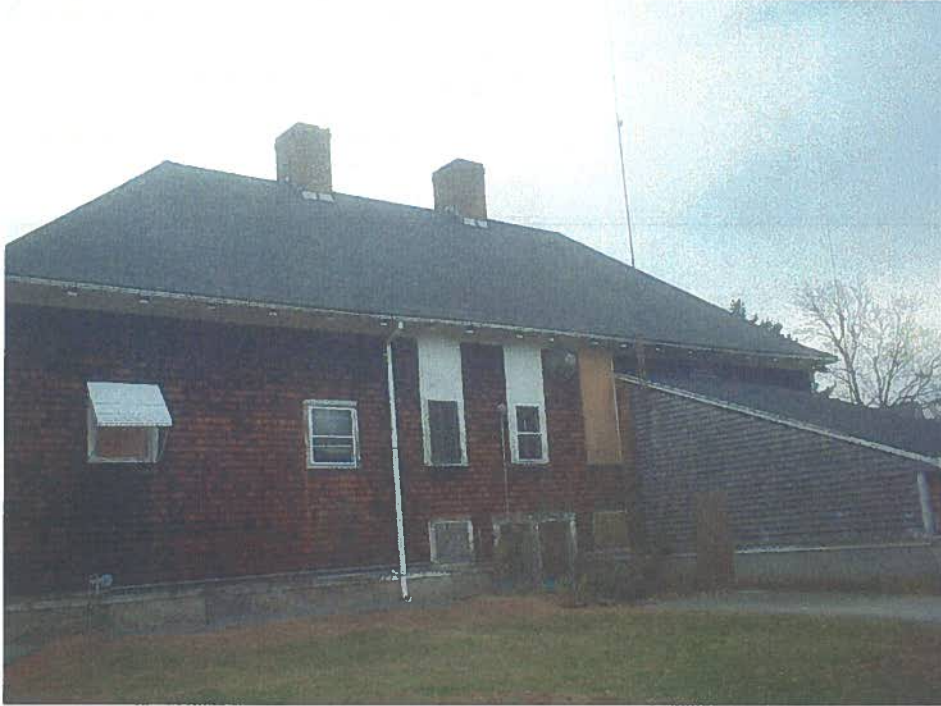
Exterior, view of back facade looking at cedar shingles.

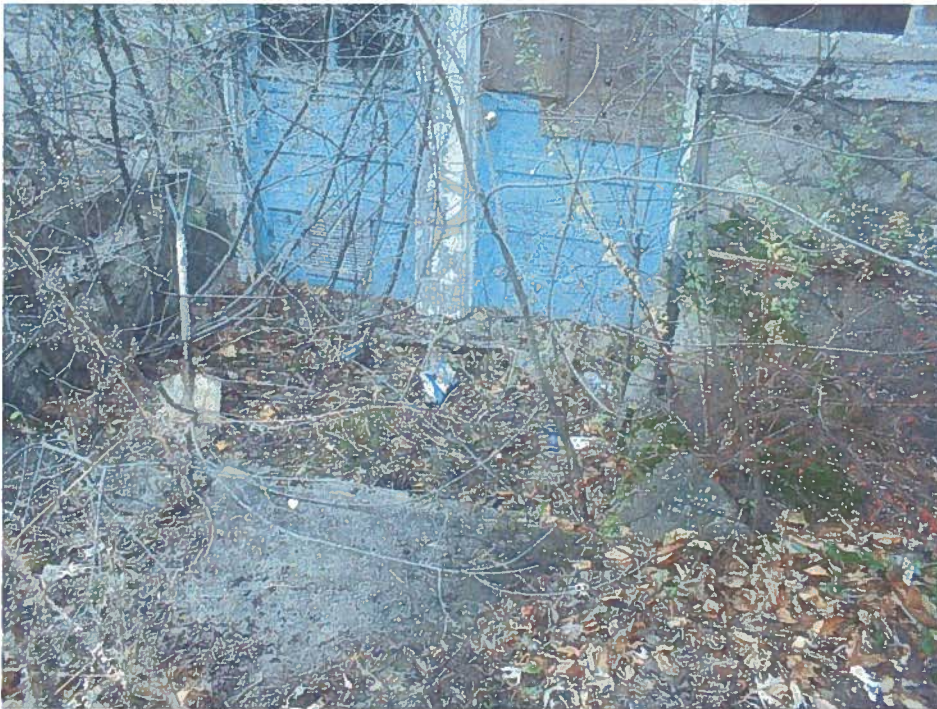
- Rear basement entry choked with plant growth.
- Holes in vertical corner wood trim appear to be caused by pests.
- Broken window on south side, glass debris on ground.

Exterior, doors to basement.

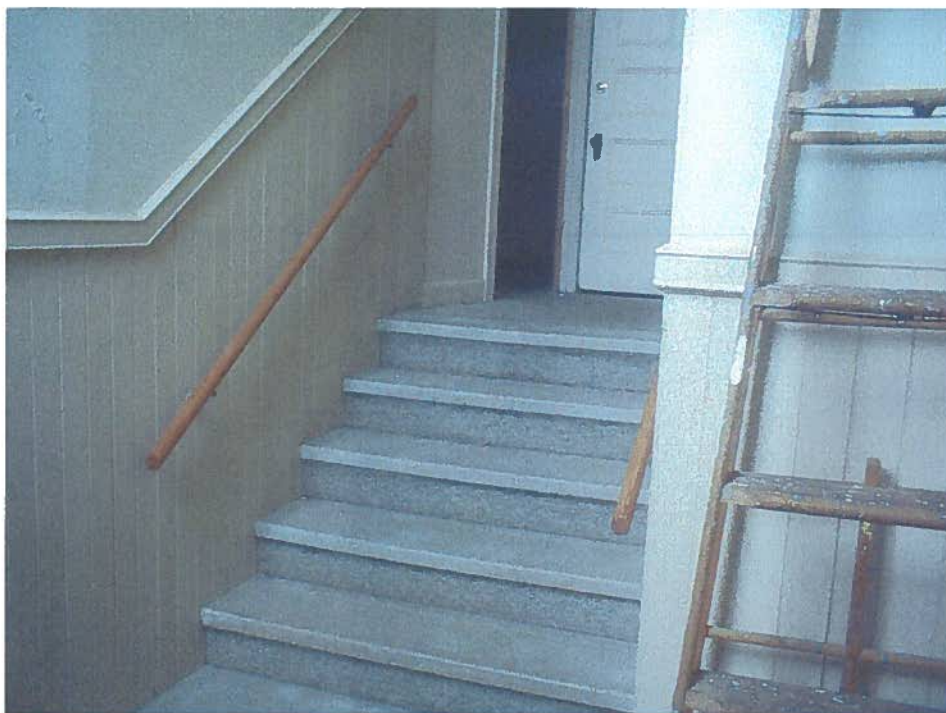
Interior, view of stairs at main entrance.

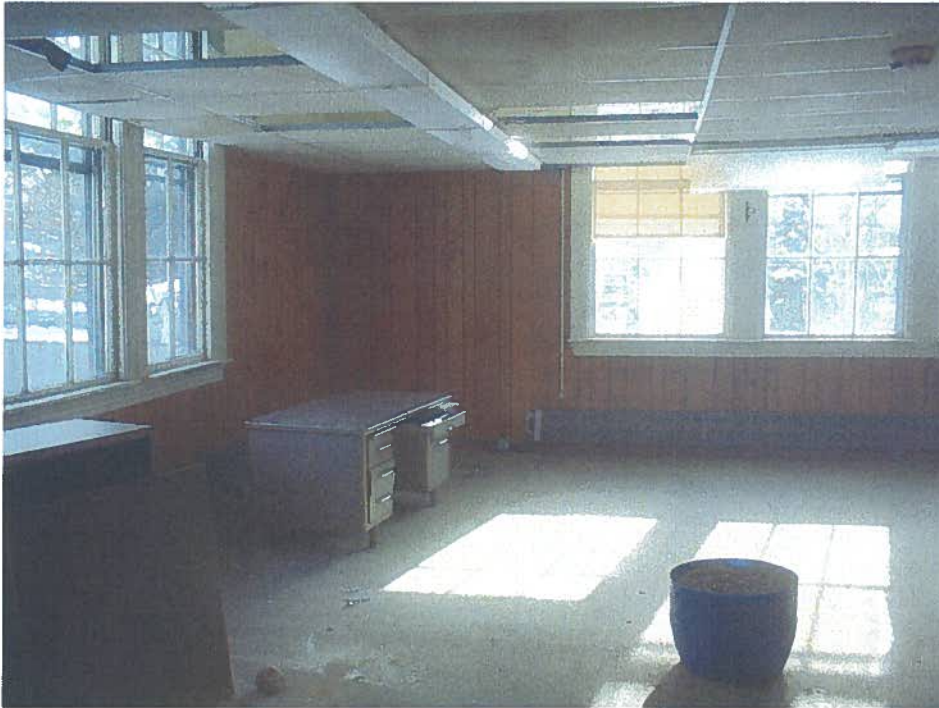
Interior, empty office.

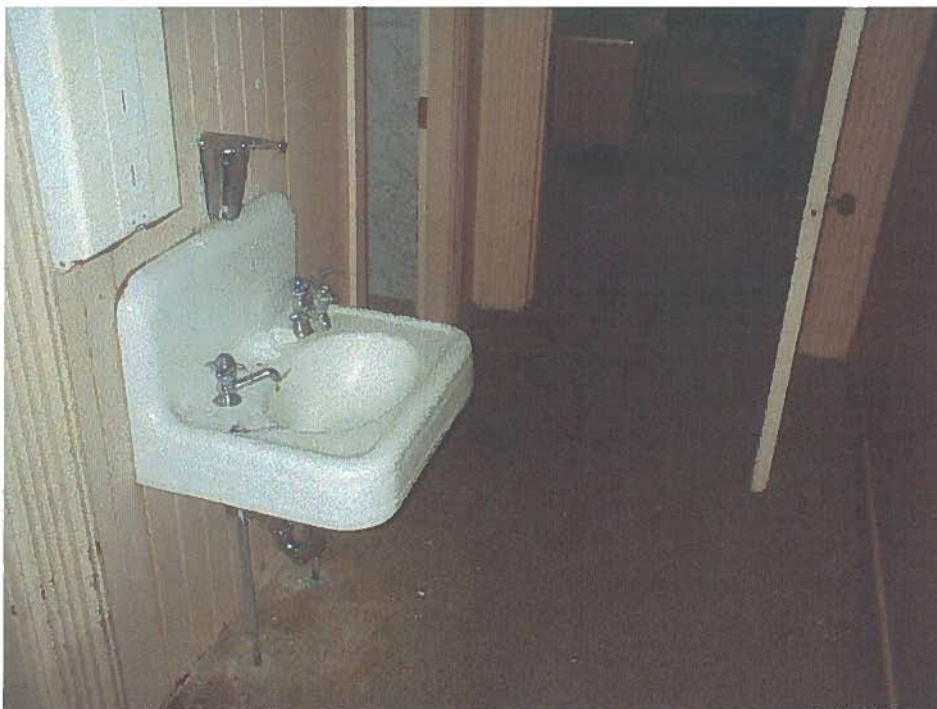
Interior, view of sink.
