**Municipal Facilities Assessment-2011  
Capital Improvement Committee  
Hanover, Massachusetts  
September 2011**

# Building Study

# **Town of Hanover - MUNICIPAL FACILITIES ASSESSMENT - 2011**

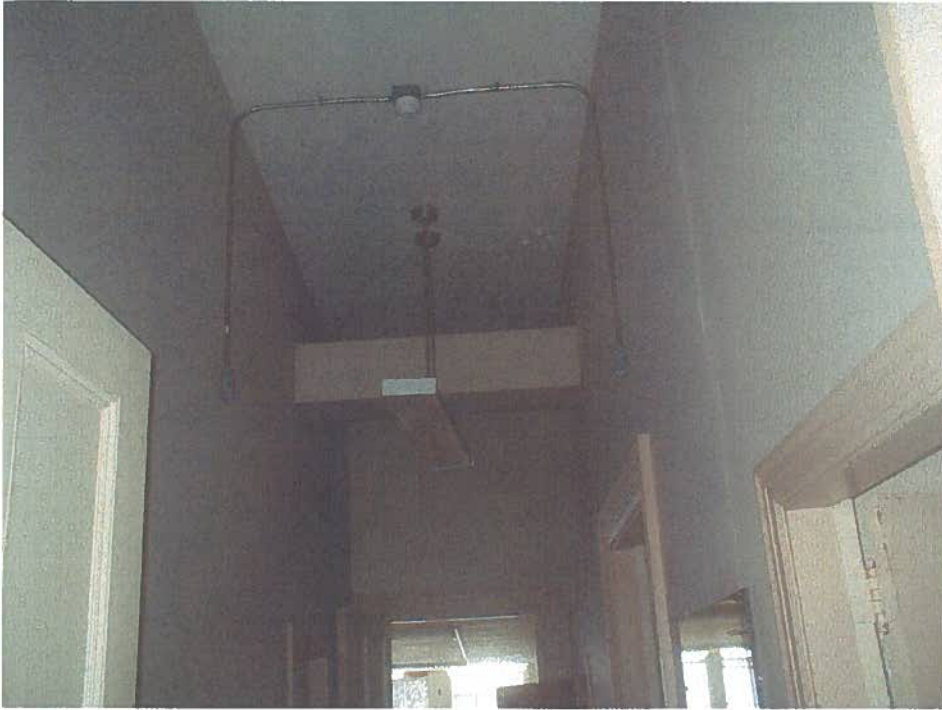
Interior, view of exposed wiring conduits.

- Warning signage and area alarm system, to prevent vandalism and reduce Town liability.
- Remove all electrical wiring and boxes from the building as part of the stabilization repairs program. Remove all plumbing fixtures and cap lines. Remove all heating equipment.

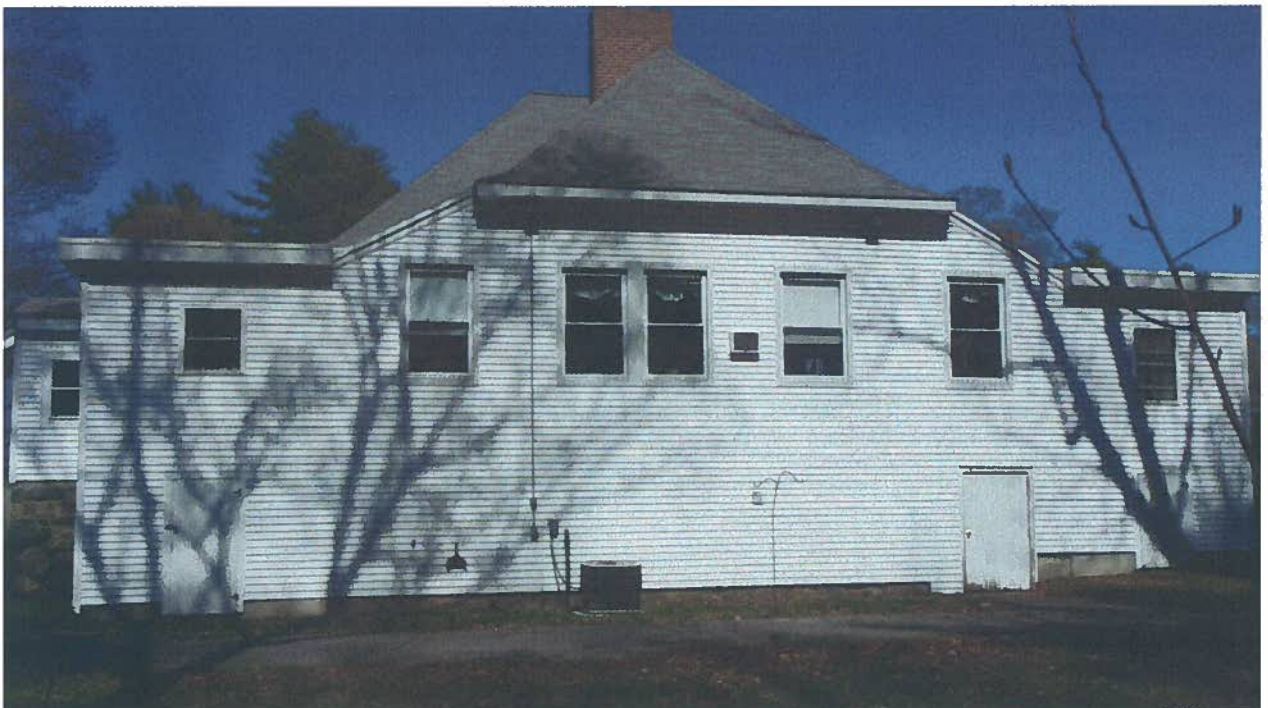
Exterior, back facade. Doors are not suitable for public program access.

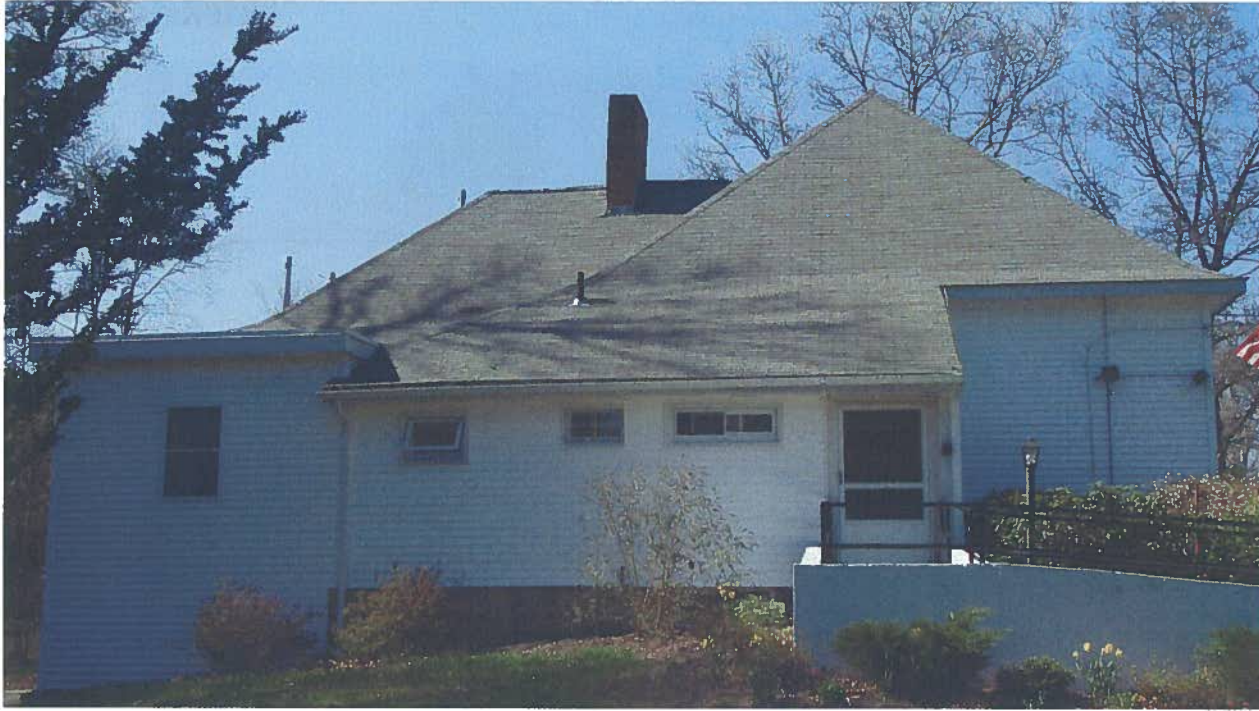
Exterior, southeast facade. Entrance and ramp access.

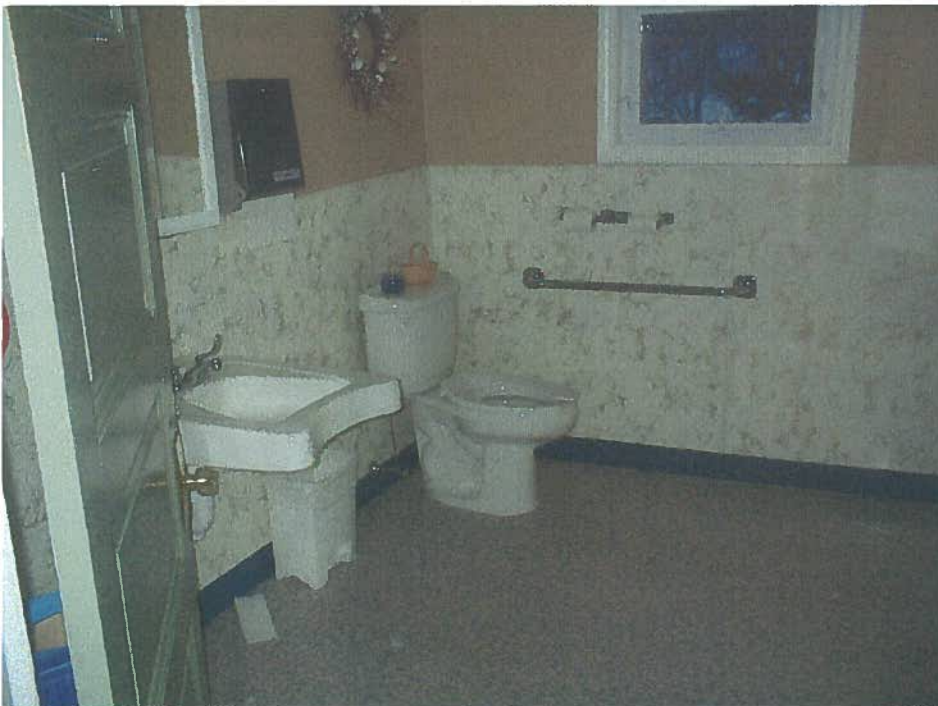
Non-compliant toilet room. No rear grab bar; side bar incorrectly placed, toilet paper too high.

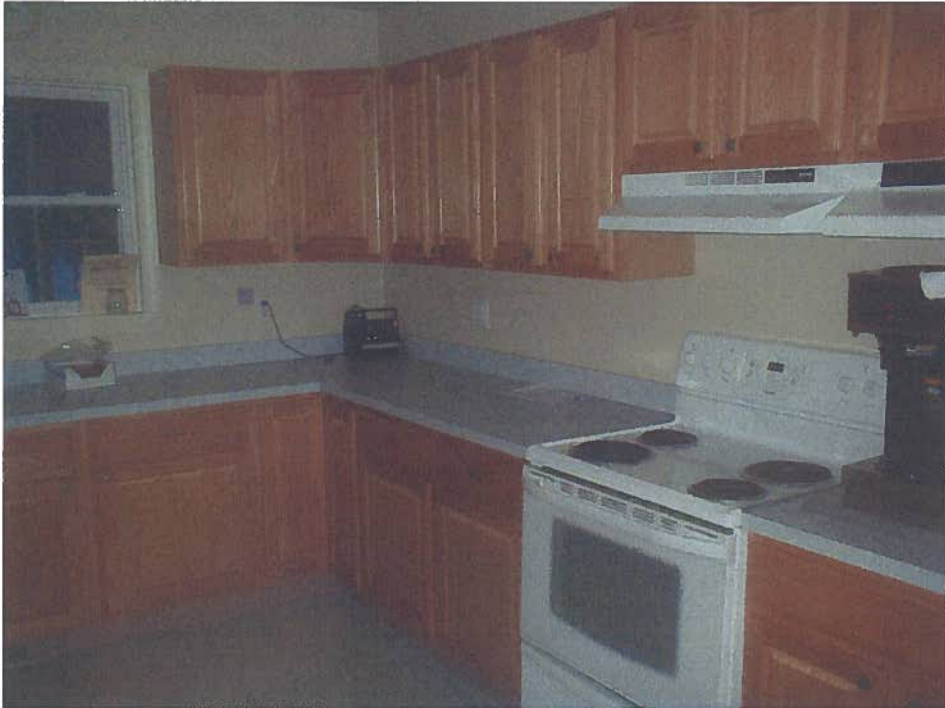
Interior, non-accessible kitchen area.

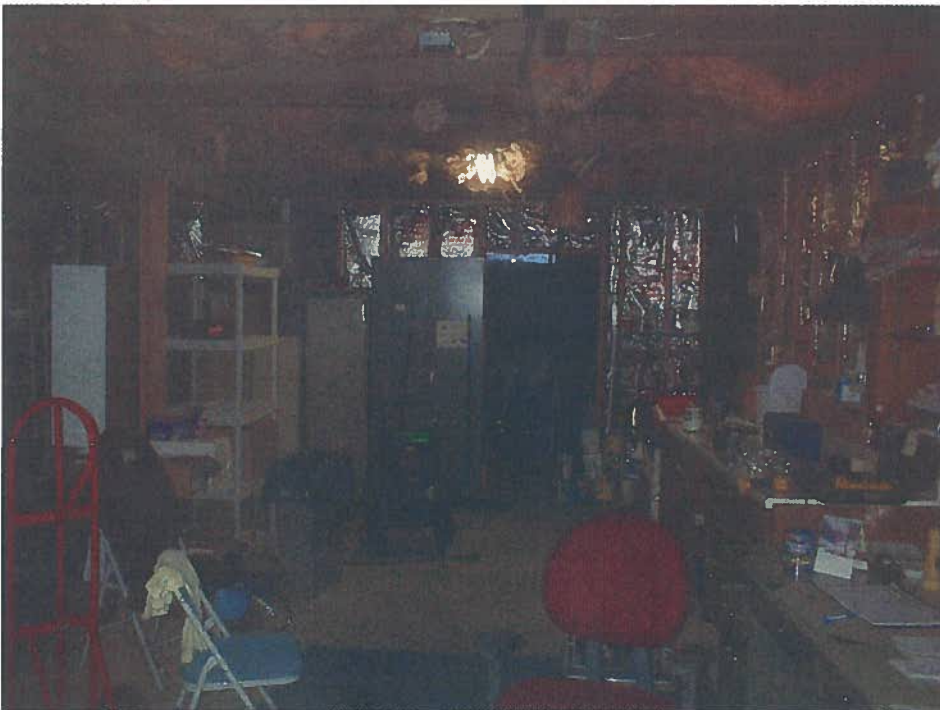
Interior, basement area, looking towards boiler room.

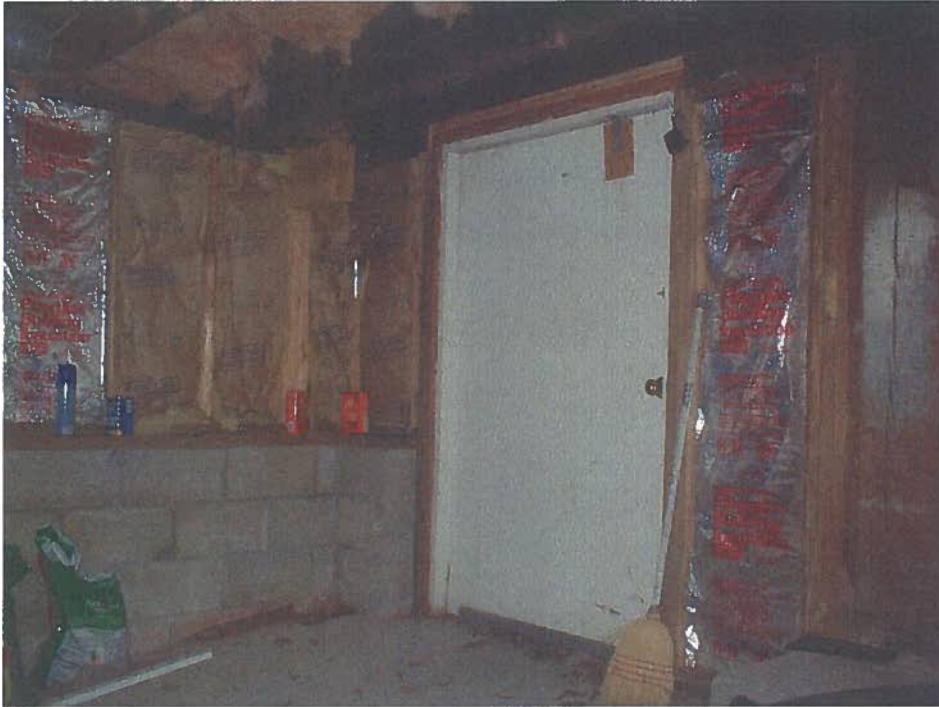
Interior, basement ramp entry; not good for accessible entrance.
